<b>Project Name</b>	COASTAL GASLINK PIPELINE Project	<b>Inspection Status</b>	Final
<b>EA Certificate #</b>	E14-03	<b>Inspection No.</b>	IR2021-014
<b>Project Status</b>	Certified	<b>Inspection Start</b>	2021-04-27
<b>Sector</b>	Energy	<b>UTM</b>	10U 533697 E 6071620 N
<b>Trigger</b>	Planned Inspection	<b>Inspection Type</b>	Field
<b>Project Description</b>	The Coastal GasLink Pipeline Project (Project) is an approximately 650 kilometer (km) long natural gas pipeline connecting facilities in northeast British Columbia (BC) to the LNG Canada facility near Kitimat.		
<b>Location Description</b>	The Project is near Groundbirch (40 km west of Dawson Creek) in northeast BC to the LNG Canada facility near Kitimat. This inspection covered portions of focused on work being carried out in Sections 1, 3, 4, 5, 6, 7 and 8 of the Project.		
<b>Inspection Summary</b>	<p>From April 27 to May 6, 2021 Environmental Assessment Office (EAO) Director of Compliance and Enforcement Chris PARKS and Senior Compliance and Enforcement Officer Clayton SMITH (collectively EAO C&amp;E) inspected the Coastal GasLink Pipeline Project (Project) against requirements of the Environmental Assessment Certificate (EA

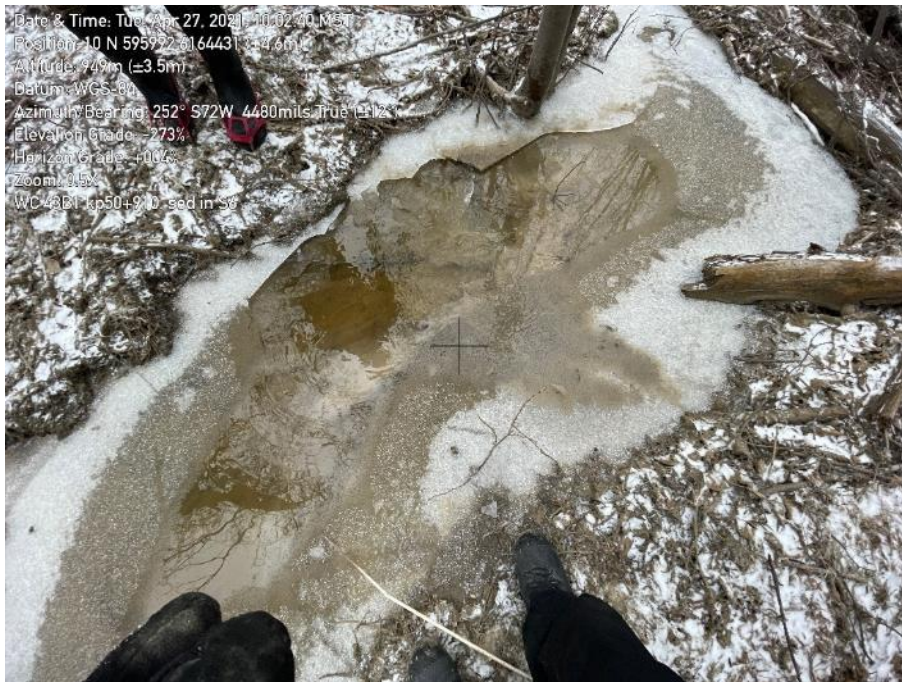
- KP 50+910, watercourse 43B1 (S6). Low chain side of crossing, sediment laden water left the RoW and overtopped a sediment fence. A small scour channel flows directly into the stream feature (S6). Sediment observed in watercourse downstream of crossing.

Photo 1. Section 1, watercourse 43B1, S6. Sediment laden water overtopped sediment fence and observed in channel downstream of crossing.

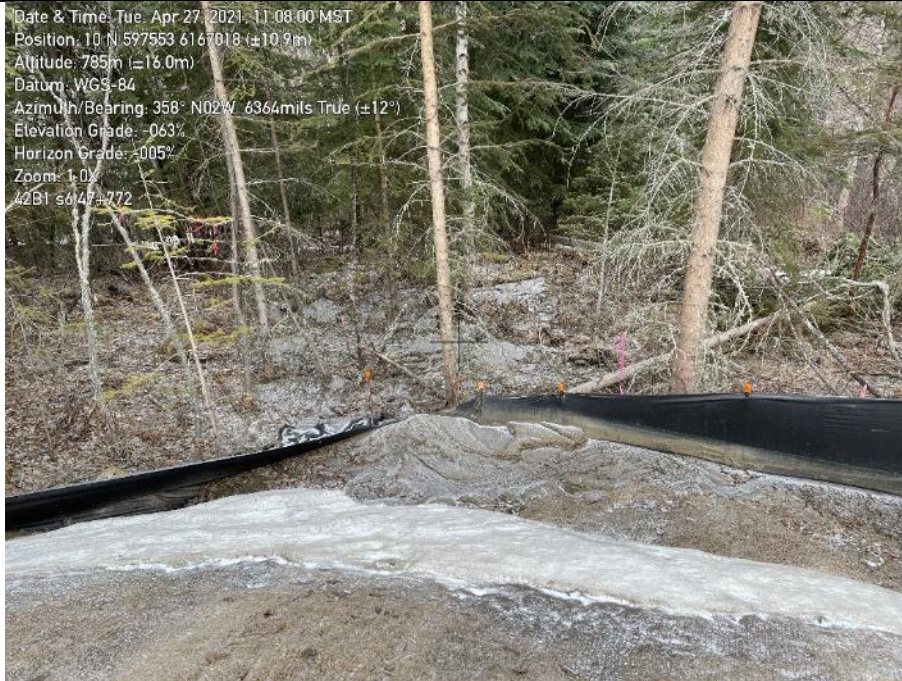
- Watercourse 42B1 (S6) – High chain side approach exposed with steep slope (35-45 percent) containing limited erosion controls. Sediment laden water overtopped sediment fence and was observed in the channel downstream of crossing.

Photo 2. Section 1, watercourse 42B1, S6. Overwhelmed ESC measures with sediment leaving RoW and observed in channel downstream.

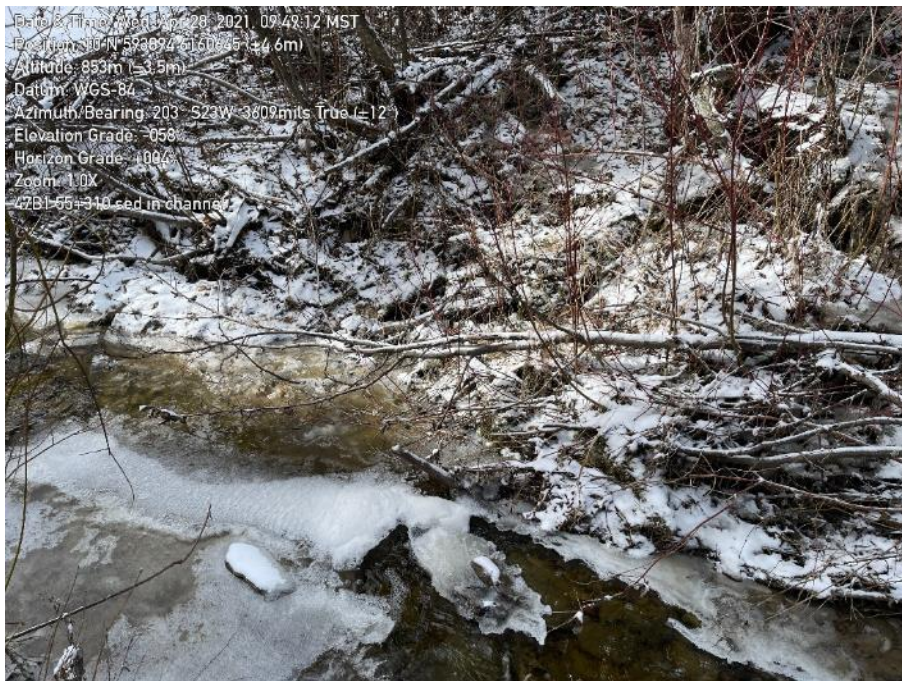
- KP 55+310, watercourse 47B1 (S3). Observed sumps at capacity, and eroded channel directing water off the RoW. Sediment laden water observed within channel downstream of crossing.

Photo 3. Section 1, watercourse 47B1, S3. Observed sumps at capacity, and eroded channel directing water off the RoW. Sediment laden water observed within channel down stream of crossing.

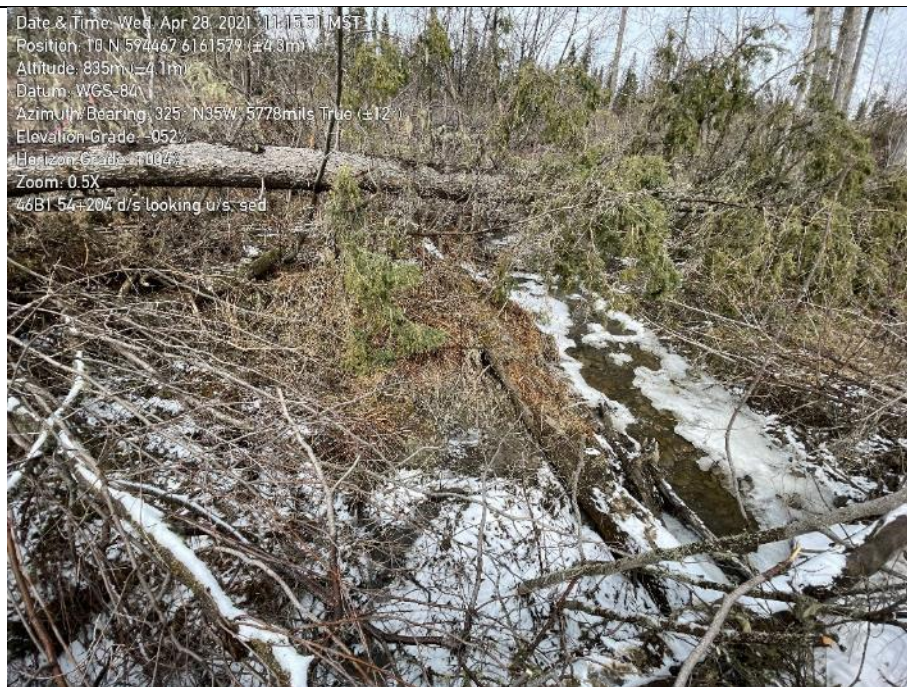
- KP 54+204, watercourse 46B1 (S3). On the high chain approach on the downstream side of the RoW, sediment laden Project water has left the RoW and sediment deposition was observed within the stream feature.

Photo 4: Section 1, watercourse 46B1, S3. Sediment laden water from RoW observed within channel downstream of crossing.

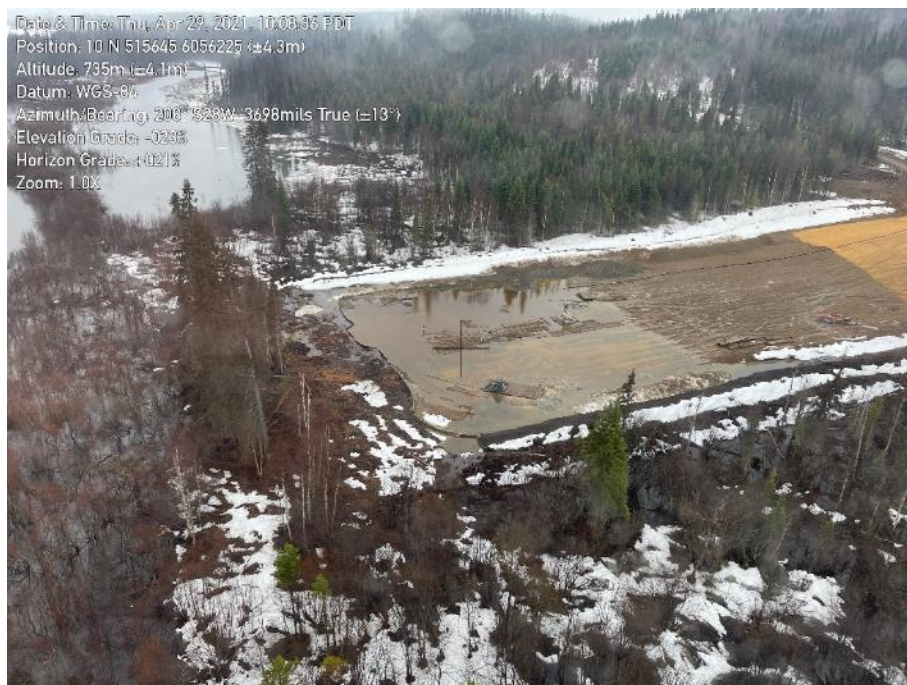
- Crooked River (S1), approximately KP 212+550. High chain approach of RoW slopes towards Crooked River. High flow conditions experienced within the Crooked River causing Project related exposed surfaces and sediment laden water mixing with Crooked River flows. **Update:** during the Opportunity to Respond to this inspection record, the Certificate Holder stated that the events described in this record are a result of overland flooding of the river and are not associated with Project construction. It appears that Project clearing and stripping occurred during a lower flow time of year and took place within the flood plain of the Crooked River. As water levels increased during freshet, this portion of the Project was inundated with natural river flows.

Photo 5: Section 3, Crooked River. High chain approach slopes towards Crooked River. Stripping into naturally occurring flood plain within the Crooked River. Project related exposed surfaces and sediment laden water mixing with Crooked River flows.

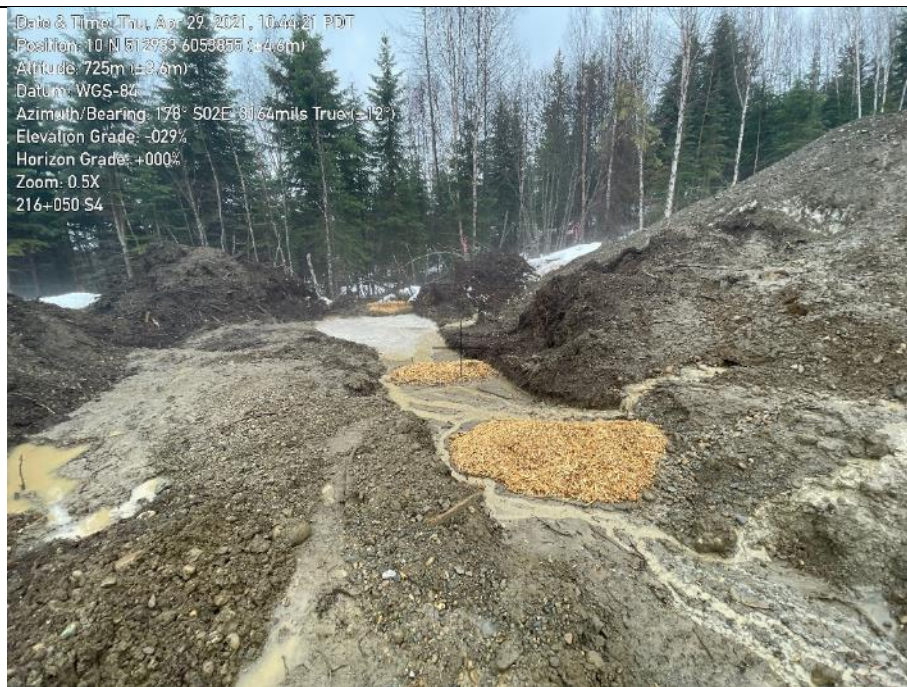
- KP216+050 (approximate)(S4). Sediment laden water observed leaving RoW through water bar on high chain side of crossing and flows downstream into the stream feature (S4). Downstream of the RoW the S4 stream feature then drains into an S3 stream, which crosses the RoW at approximately KP 215+650. Sediment laden Project water observed reaching the S4 and visible turbid plume from within the S4 observed transporting into the S3 stream.

Photo 10. Water bar on high chain side of KP216+050 (S4). From RoW looking at forest.

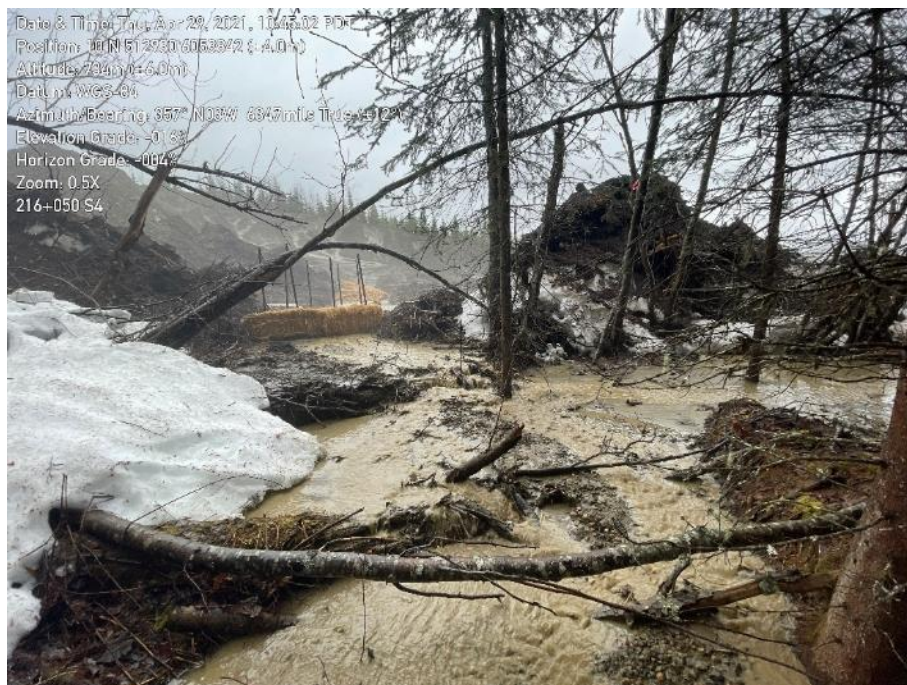
Photo 11. Water bar on high chain side of KP216+050 (S4). From forest looking at RoW.

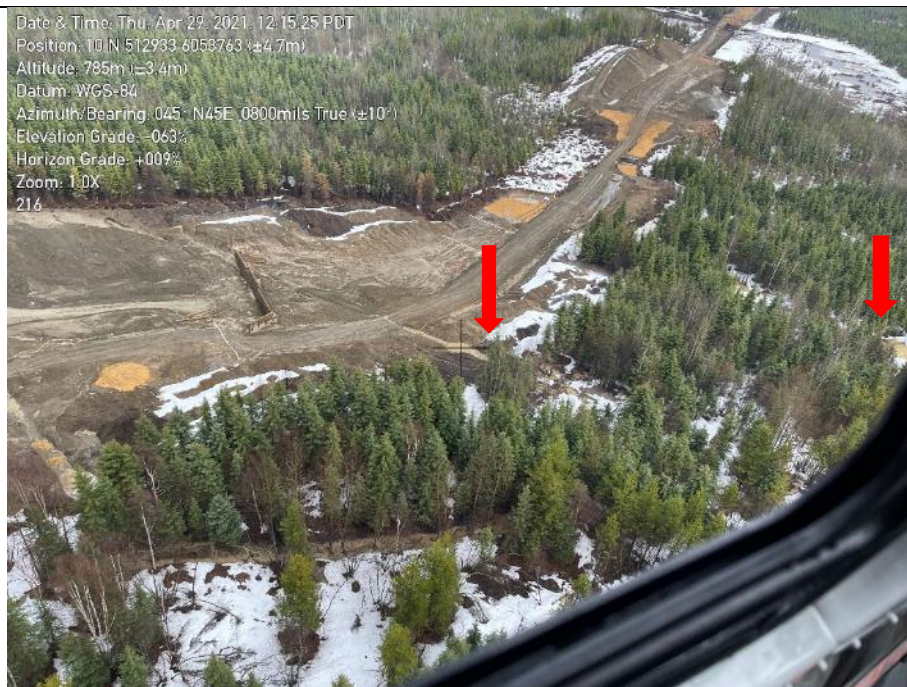
Photo 12. Sediment laden water into S4 at KP 216+100, which then reaches S3 at KP 215+700.

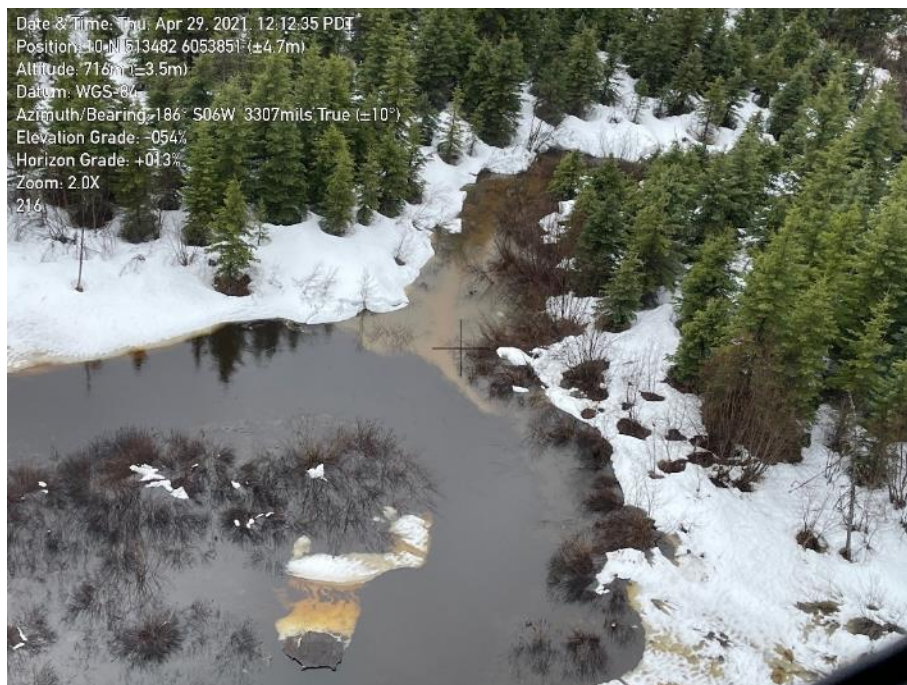
Photo 13. S4 draining into S3 downstream of crossing at KP 215+650.

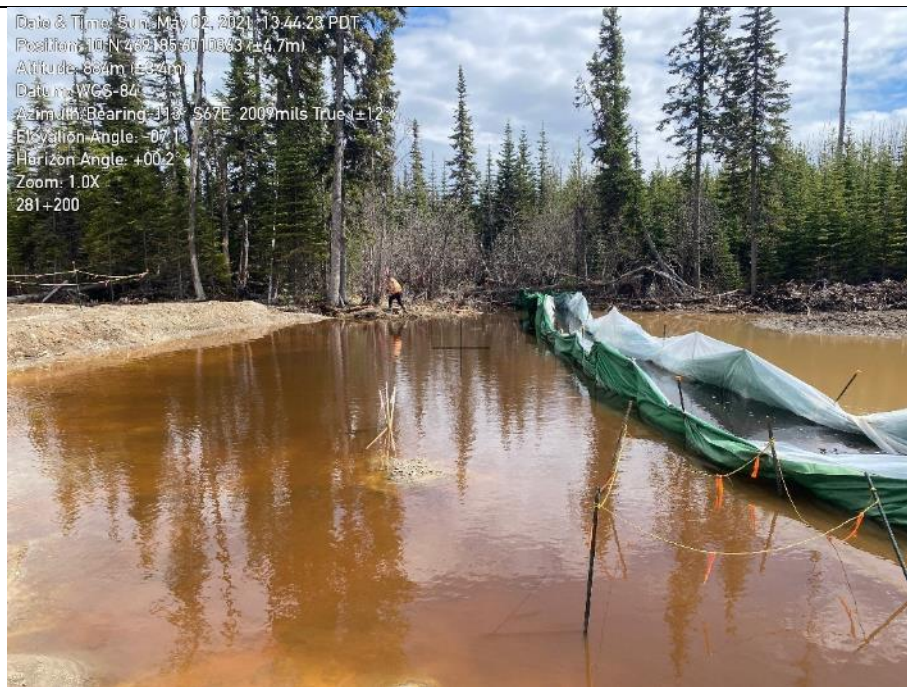
- KP 281+200 (approximately, no signage). Flume like measure installed at crossing to move water through the RoW and keep sediment laden water from within the RoW from entering the feature. Plastic sheeting and filter cloth do not extend the entire length of the crossing which allows sediment laden Project water to drain into the feature at the upper and lower extent of the flume. Additionally, outlet hose from pump with filter bag attached observed on the ground less than 2 m from top of stream bank. Pump not running during inspection, however, chance for sediment laden discharge from filter bag to reach stream feature during pump use due to proximity of bag to feature.

Photo 14. KP281+200. Water from RoW flowing into feature around the flume both upstream and downstream of the measure.

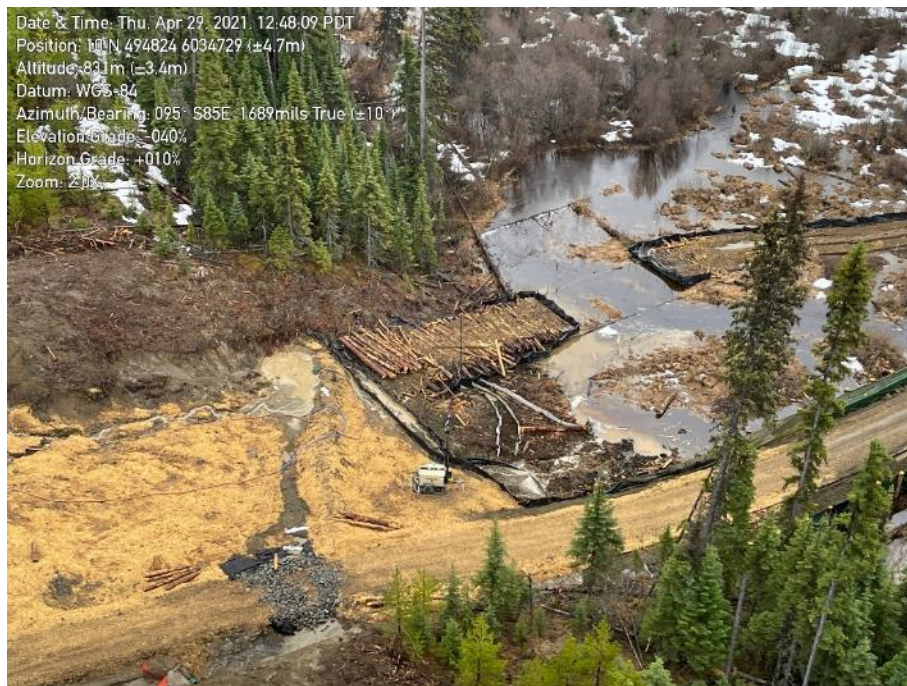
- KP244+510, watercourse WC272 (S3). Sediment laden Project water observed to be overwhelming a sump, leaving the RoW and entering the stream channel.
- KP 277+187 (approximate), watercourse 295-834 (S3). On the high chain approach to this crossing (roughly KP 277+400) sediment laden water from the Project was observed to be directed off the RoW and into a previously existing roadside ditch. Tracking the water in the ditch downstream, it flows through a culvert beneath the road and continues to drain down the slope towards and into the S3 stream (KP 277+187) upstream of the bridge crossing. Sediment laden Project water observed reaching the S3 stream.

Photo 15. KP 244+510, watercourse WC272 (S3). Water from RoW overwhelming sump and flowing into stream feature.

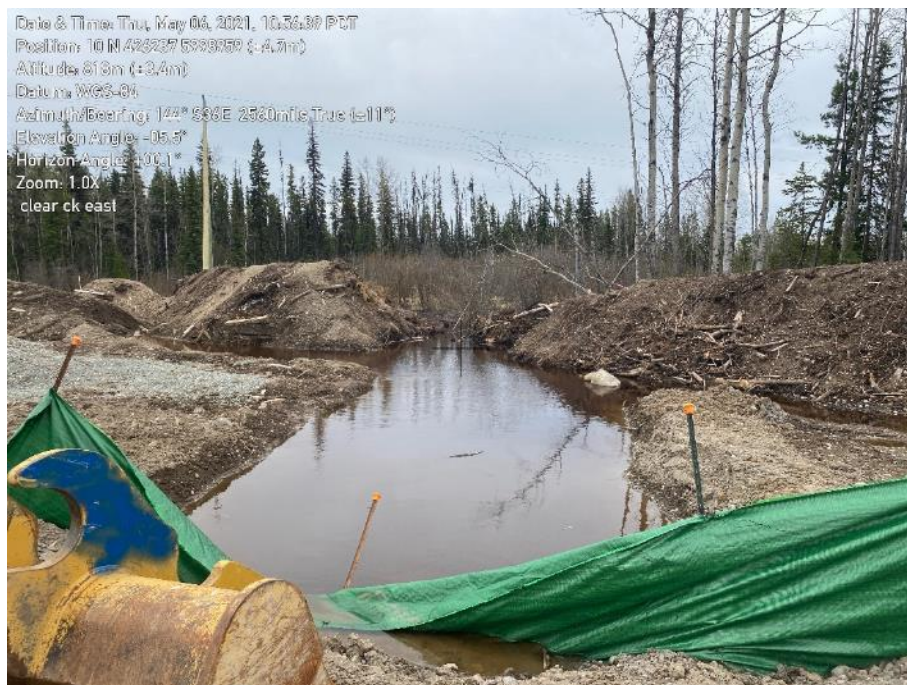
Photo 17. KP 329+282. Looking downstream from culvert outlet on right of way. Stockpiles on right of way with no mitigation measures.

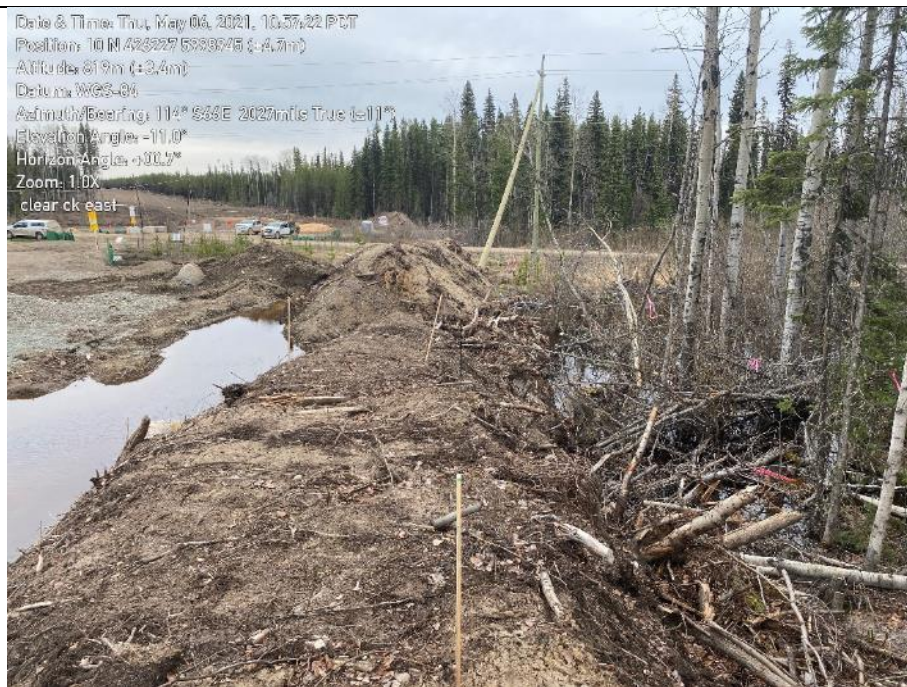
Photo 18. KP 392+282. Stockpiles on right of way within channel.

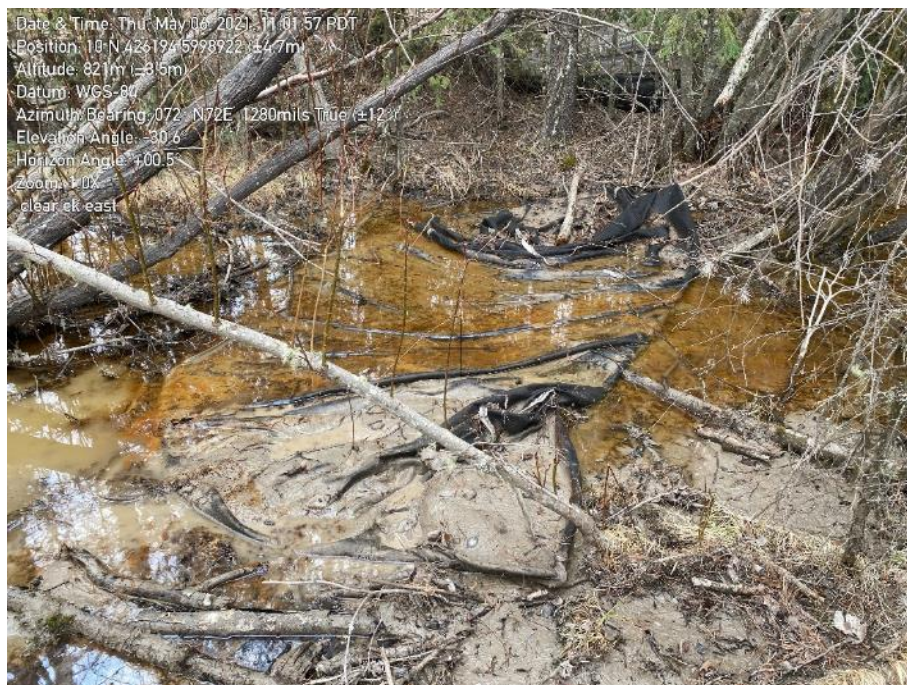
- EAO C&E has moved this finding from Requirement 2 below to Requirement 1. Whether the site is a wetland or a watercourse, Project related sediment was observed mobilizing into this NCD feature which drains directly into Clear Creek. The soil stockpiles were not protected in a manner that controls sediment from transporting off the stockpiles and into the water feature. Additionally, sediment from the filter bags was observed to be mobilized into the water feature as a result of Project pumping activities, including the placement of filter bags directly within the watercourse. The practices carried out at this site during the time of inspection are non-compliant with the requirements of the EAC and EAO Order EN2020-011.

Photo 19. KP392+282. Filter bag potentially placed within WL11248 downstream of right of way. Sediment mobilized into NCD feature with direct connection to Clear Creek.

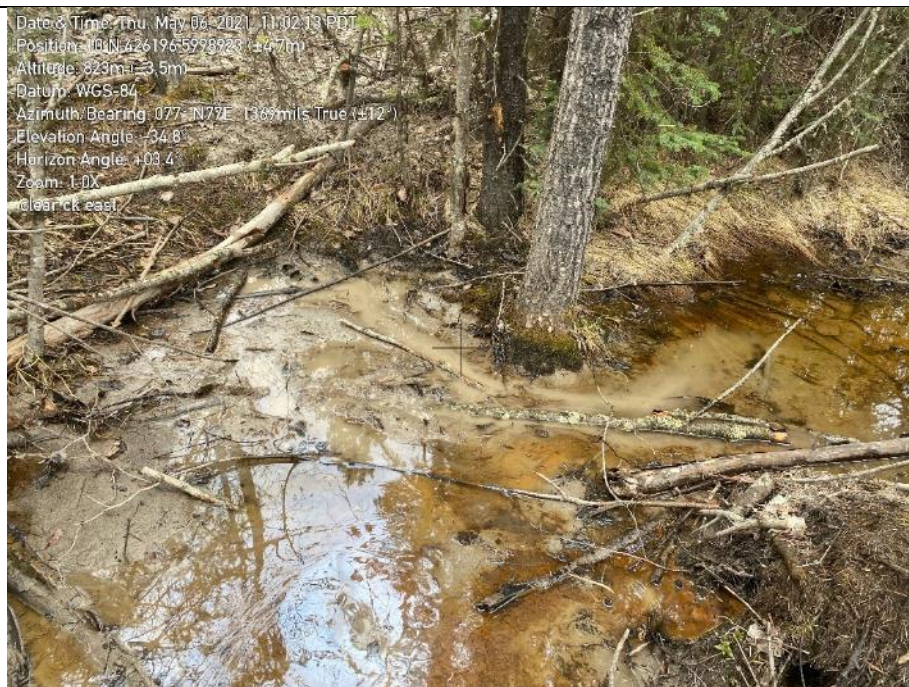
Photo 20. KP 392+282. Sediment from filter bag entering water feature.

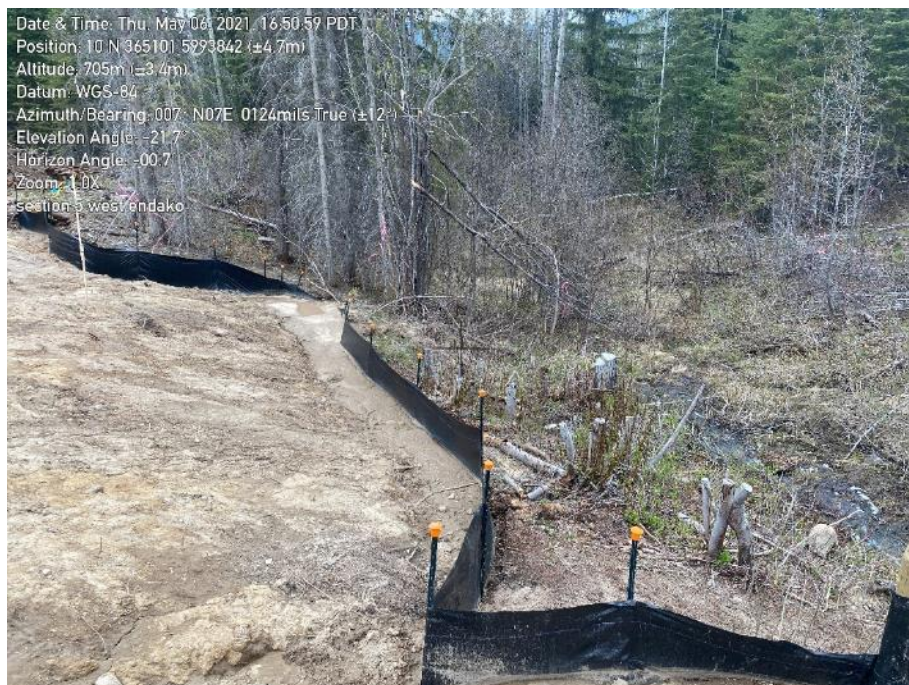
- KP 395+542 (S6), watercourse 408. Sediment from the RoW observed in the vegetation and within the channel at this crossing. ESC measures failed or were overwhelmed/not maintained. Material transported downstream outside of Project onto other stakeholders' tenure (transmission line).

Photo 21. KP 395+542 (S6). Overwhelmed / not maintained ESC measures.

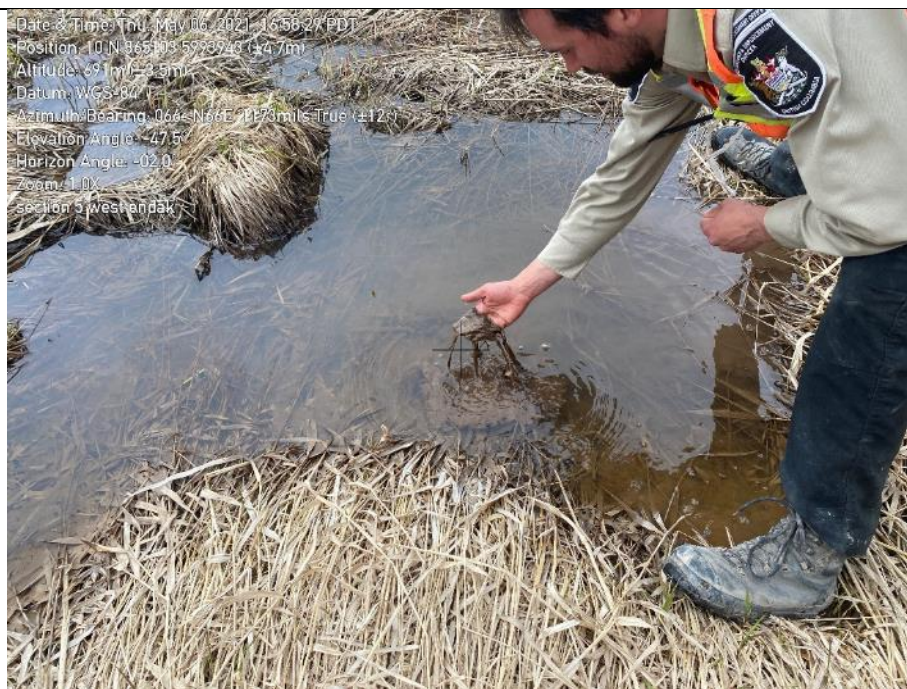
Photo 22. Sediment into feature downstream of crossing at approximately KP 395+550.

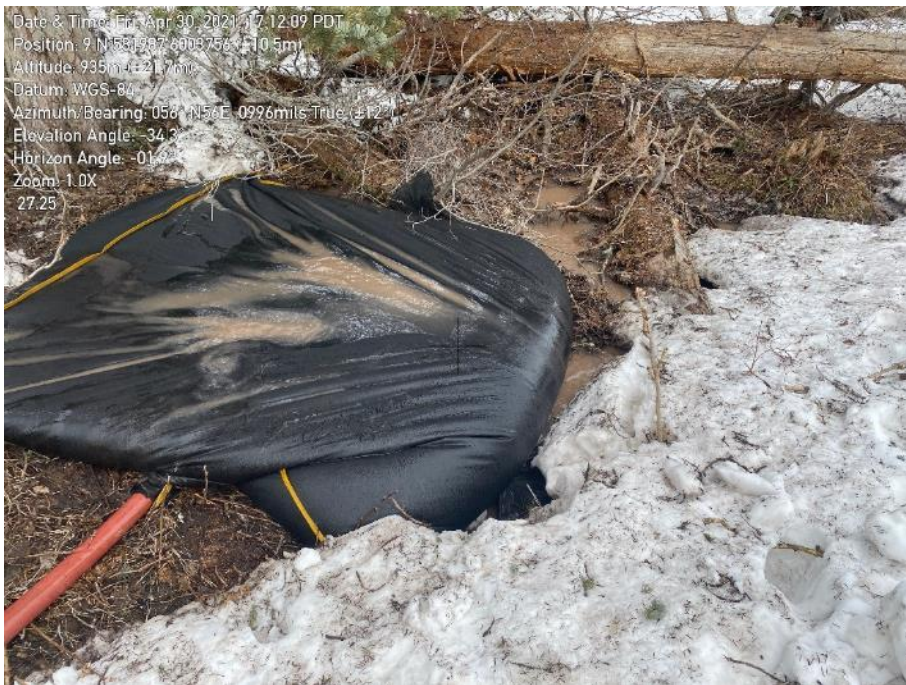
Photo 25. KP 586+800, sediment bag placed within 2 m of channel. Discharge into feature.

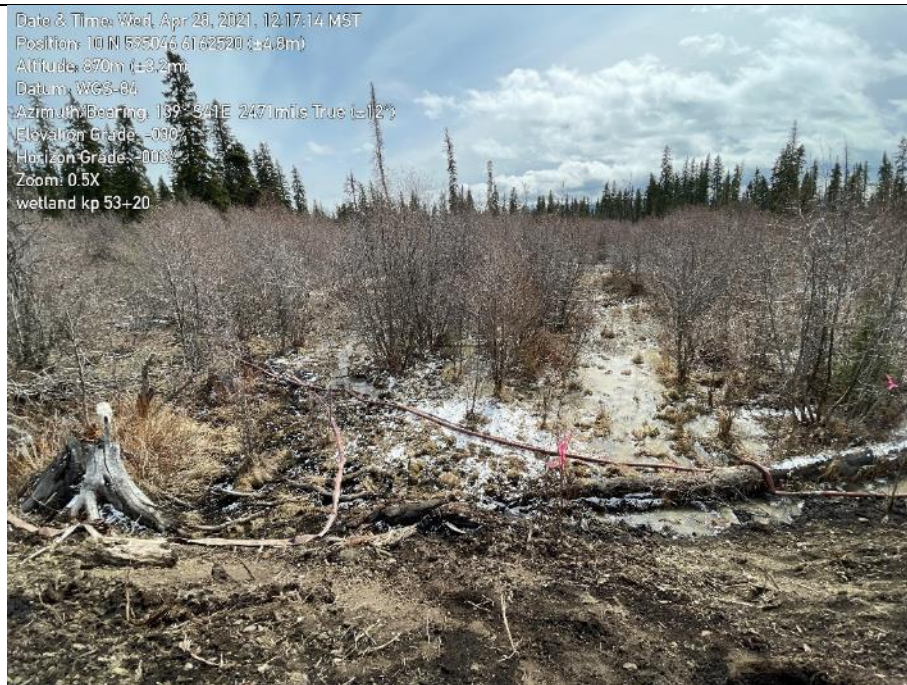
- KP 53+137 (approximate), wetland WL0723 (Environmentally and Socially Important Wetland (ESIW)). Observed active pumping of sediment laden water off the RoW into a filter bag. Filter bag was placed adjacent to WL0723 and sediment laden water from the bag was observed flowing directly into the

Photo 28. WL0723. Sediment laden water from filter bag draining back into wetland outside of RoW.

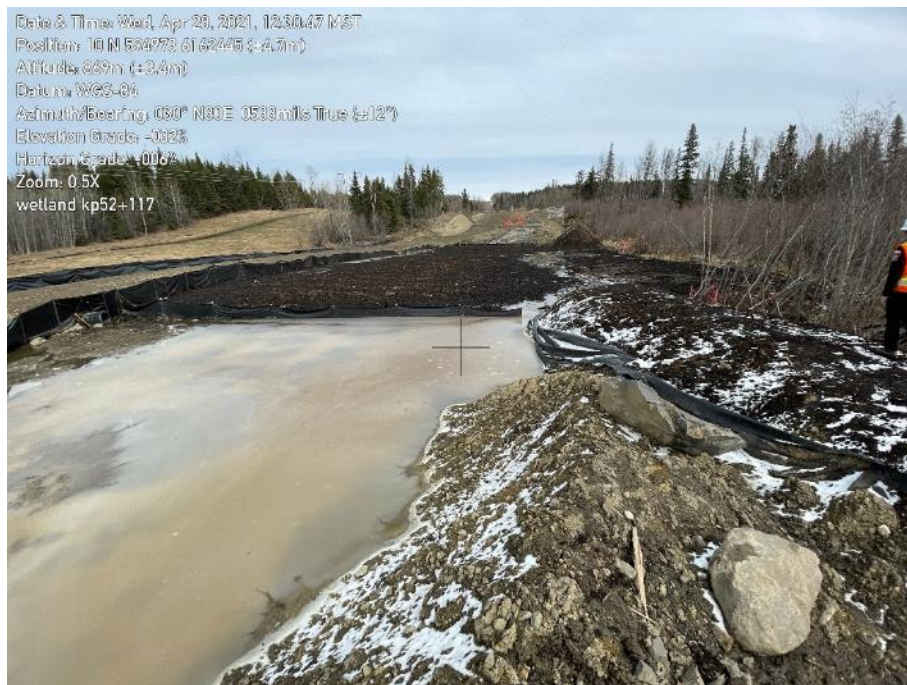
wetland outside of the RoW. Additionally, ESC measures on the RoW were not functioning as intended and sediment laden Project water from the RoW was observed to be flowing into the wetland within the RoW.

Photo 29. WL0723. Sediment laden water from RoW flowing into wetland.

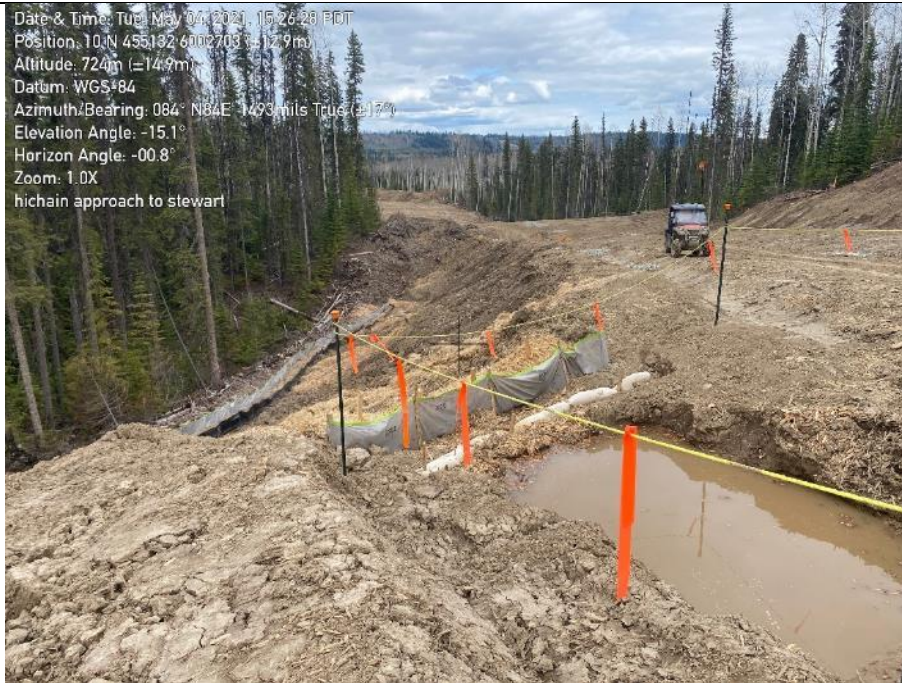
- KP298+700, wetland WL0552 (no signage). Sediment laden Project water was observed leaving the RoW and entering an off-RoW wetland. Sediment laden water was observed to be mixing with the wetlands natural water.
- KP 298+861, wetland WL8113 (ESIW). Sediment laden Project water observed passing the ESC measures and reaching the wetland outside of the RoW.
- KP335+200. Sediment laden Project water observed to be leaving the RoW and settling in a location outside of the RoW.

Photo 32. Wetland with no signage at roughly KP 298+700. Sediment laden water from this location left RoW and reached wetland below (WL0552).

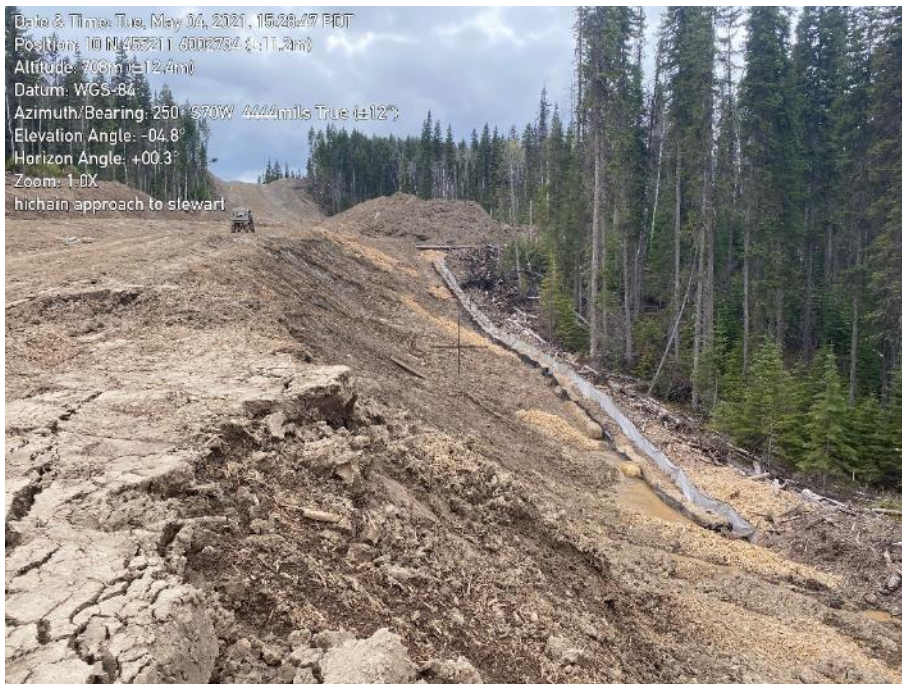
Photo 33. Wetland with no signage at roughly KP 298+700. Sediment laden water from this location left RoW and reached wetland below (WL0552).

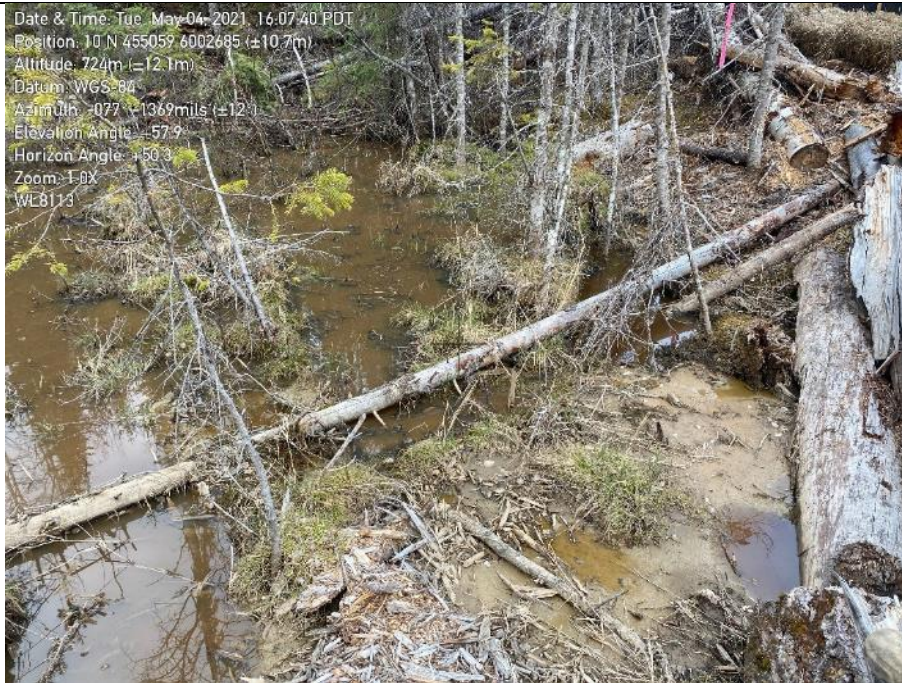
Photo 36.WL8113 at approximately KP 298+861. Sediment depositing into wetland feature.

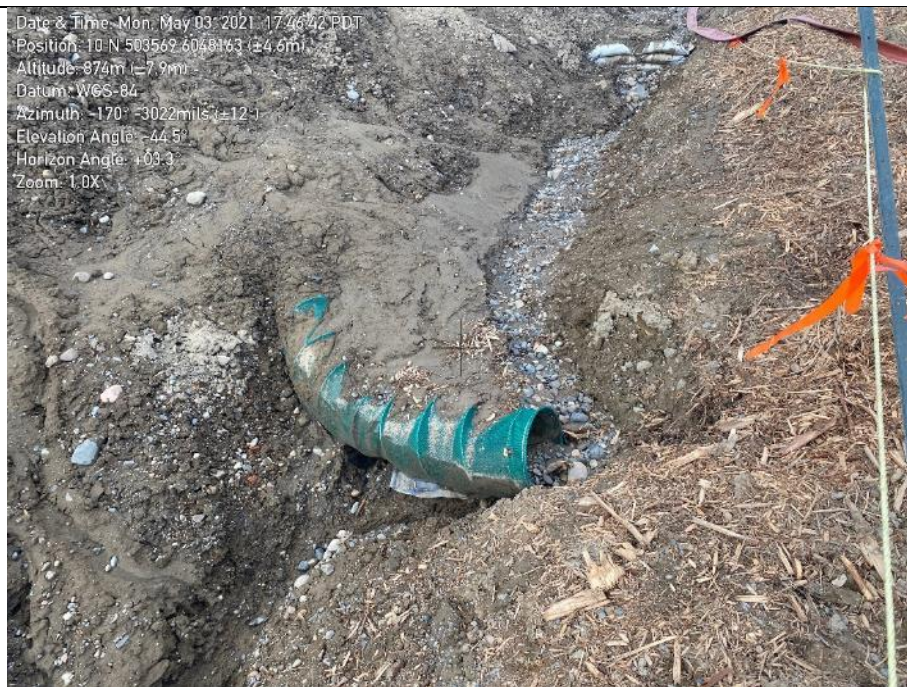
Photo 38. Example of non maintained ESC measure seen near KP 227+800.

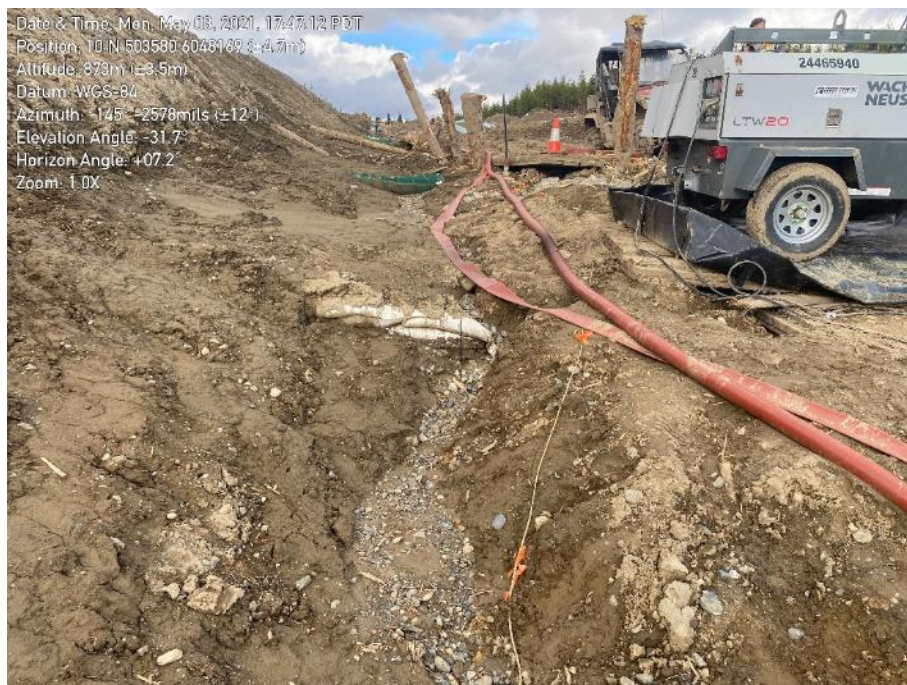
Photo 39. Example of non maintained ESC measure seen near KP 227+800.

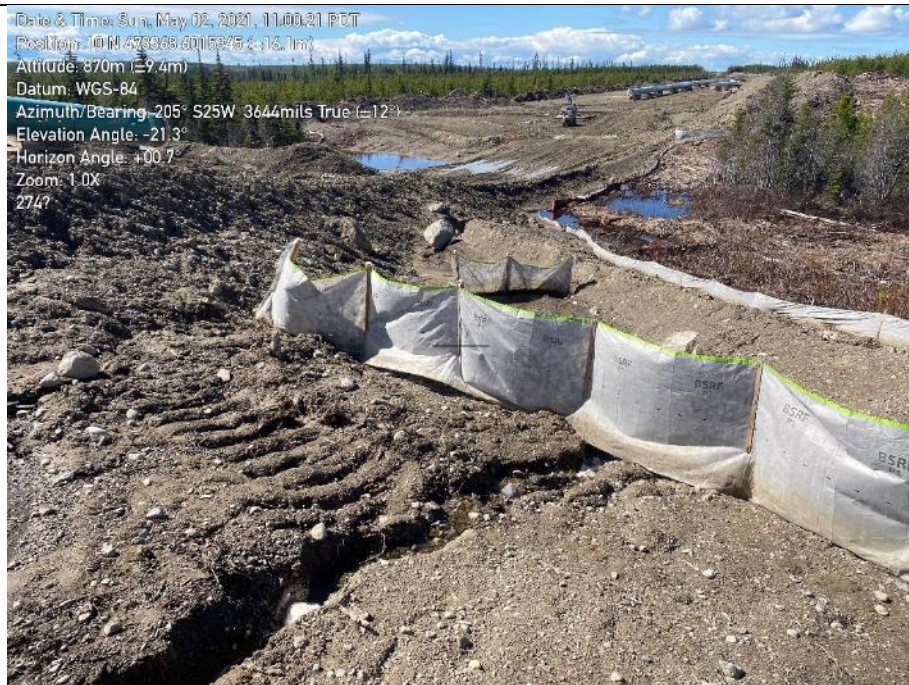
Photo 40. Non maintained ESC measure near KP 274+300. Erosion taking place beneath the measure.

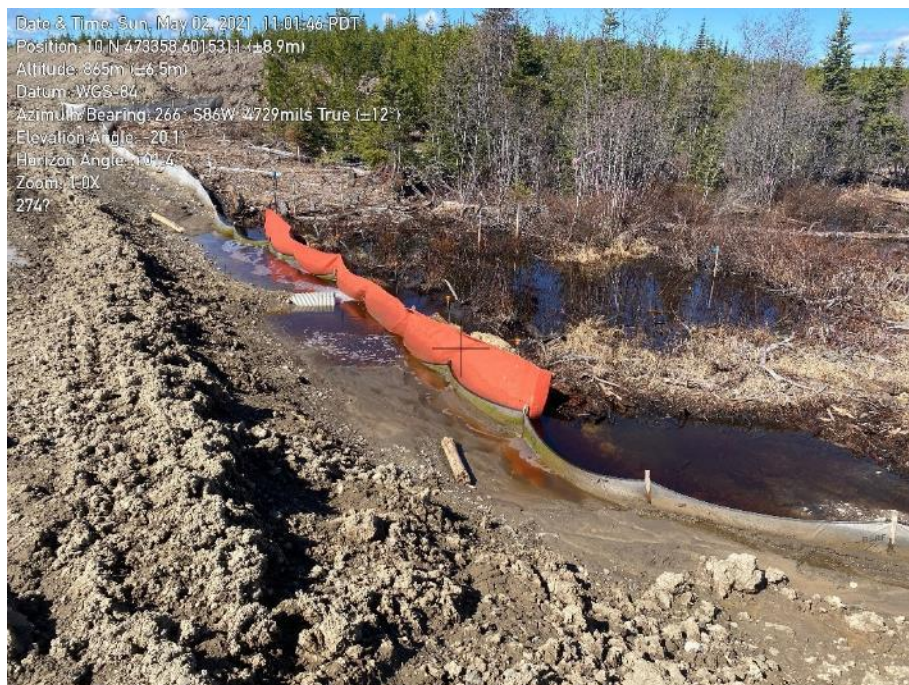
Photo 41. Non maintained ESC measure near KP 274+300.

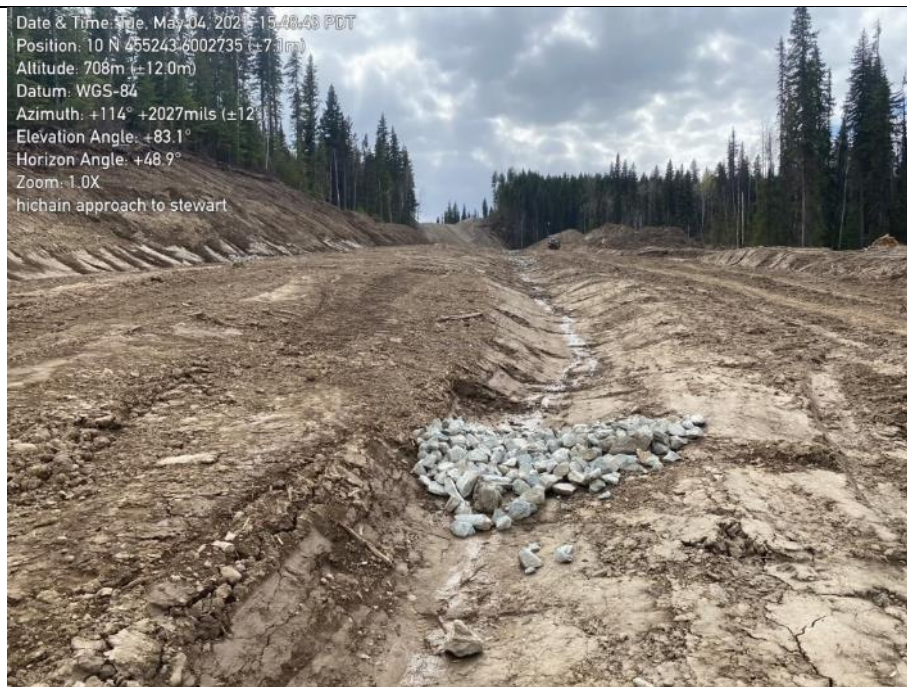
Photo 42. KP 299+100. Coarse material used for check dam construction. Flow beneath the check dam. Large spacing between check dams.

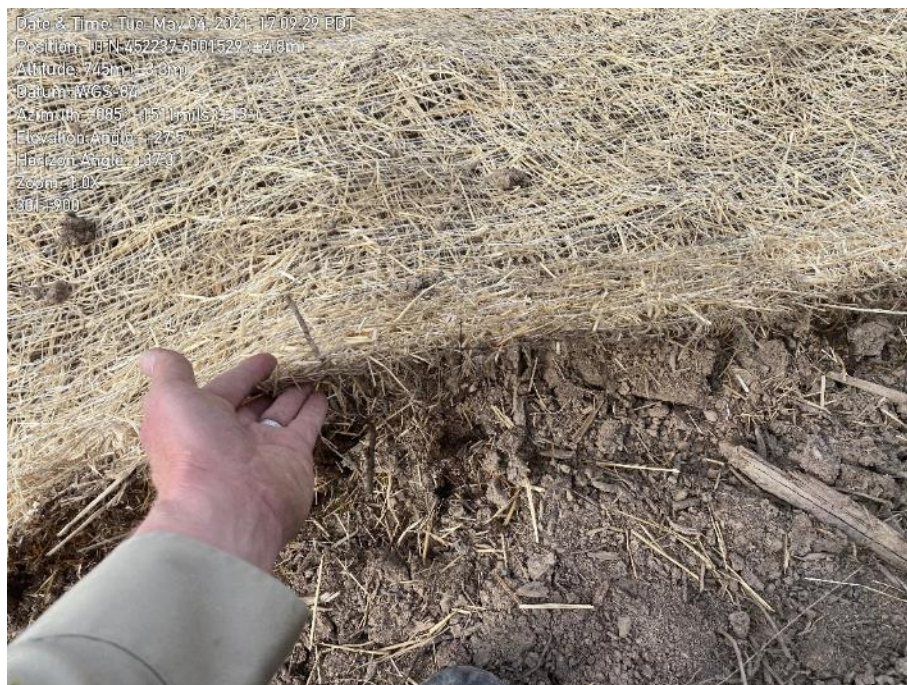
Photo 43. KP 301+900, loose erosion control blanket with limit staples/stakes.

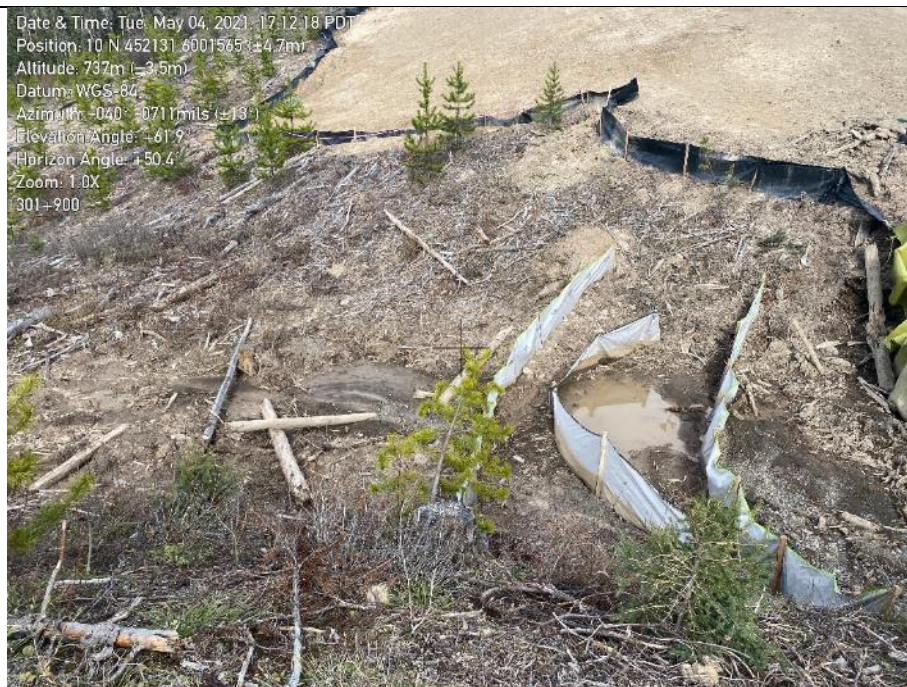
Photo 44. KP 302+045. ESC measures installed across channel. Measures full and require maintenance.

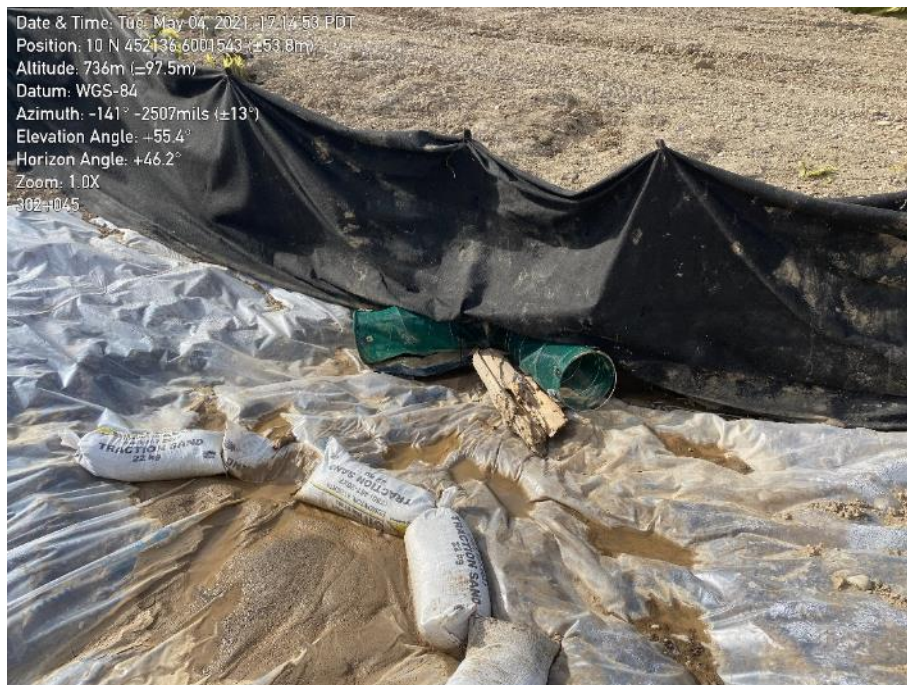
Photo 45. KP 302+045. ESC measures installed in front of culvert inlet. Measures observed to require maintenance.

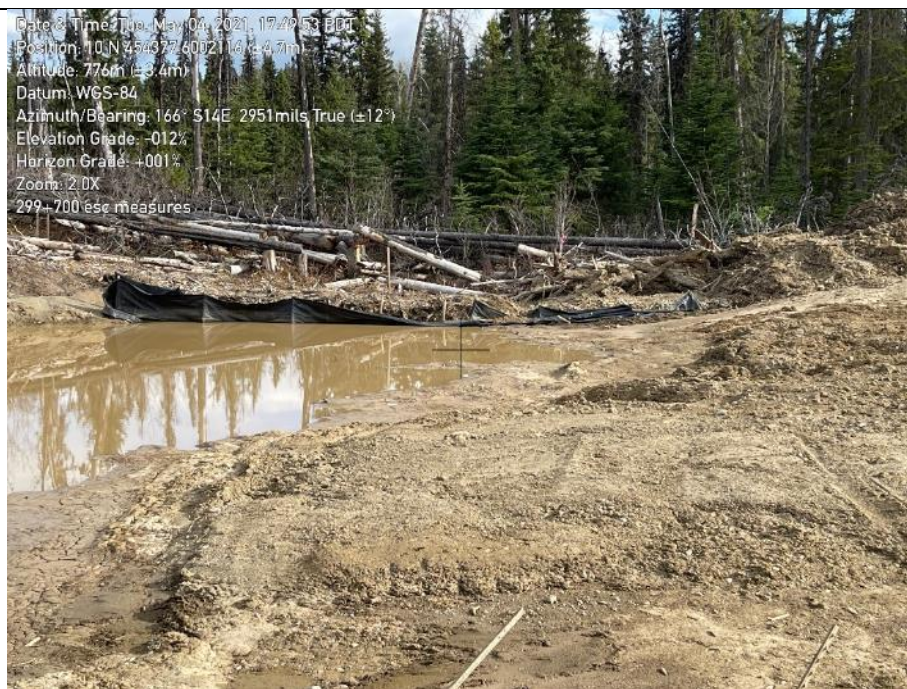
Photo 46. Approximately KP 299+700. ESC measure collapsed.
