<b>Project Name</b>	COASTAL GASLINK PIPELINE Project	<b>Inspection Status</b>	Final
<b>EA Certificate #</b>	E14-03	<b>Inspection No.</b>	IR2021-014
<b>Project Status</b>	Certified	<b>Inspection Start</b>	2021-04-27
<b>Sector</b>	Energy	<b>UTM</b>	10U 533697 E 6071620 N
<b>Trigger</b>	Planned Inspection	<b>Inspection Type</b>	Field
<b>Project Description</b>	The Coastal GasLink Pipeline Project (Project) is an approximately 650 kilometer (km) long natural gas pipeline connecting facilities in northeast British Columbia (BC) to the LNG Canada facility near Kitimat.		
<b>Location Description</b>	The Project is near Groundbirch (40 km west of Dawson Creek) in northeast BC to the LNG Canada facility near Kitimat. This inspection covered portions of focused on work being carried out in Sections 1, 3, 4, 5, 6, 7 and 8 of the Project.		
<b>Inspection Summary</b>	<p>From April 27 to May 6, 2021 Environmental Assessment Office (EAO) Director of Compliance and Enforcement Chris PARKS and Senior Compliance and Enforcement Officer Clayton SMITH (collectively EAO C&amp;E) inspected the Coastal GasLink Pipeline Project (Project) against requirements of the Environmental Assessment Certificate (EA

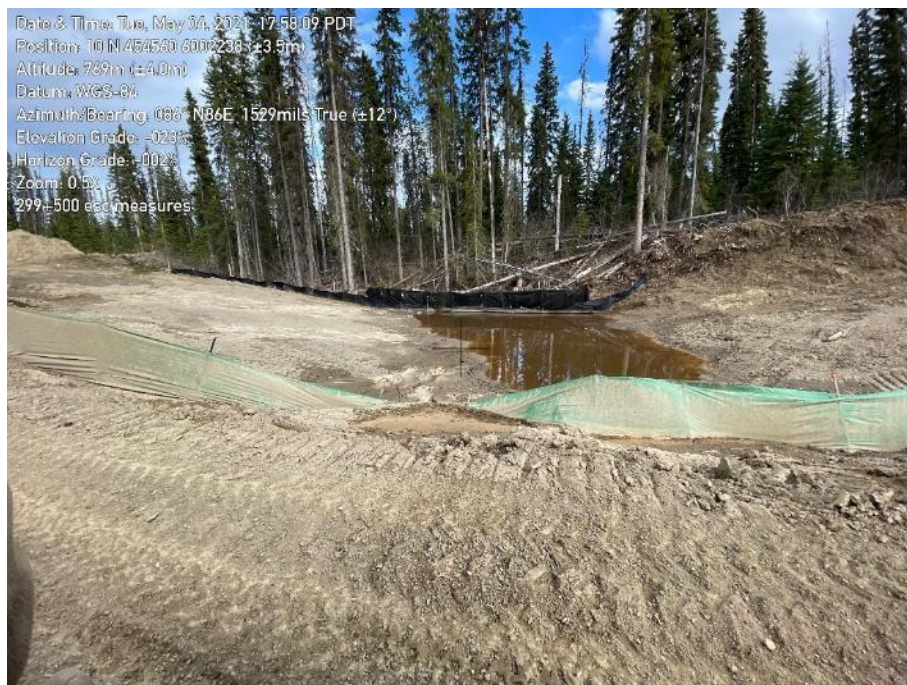
Photo 47. Approximately KP 299+500. ESC measure overwhelmed and collapsed.

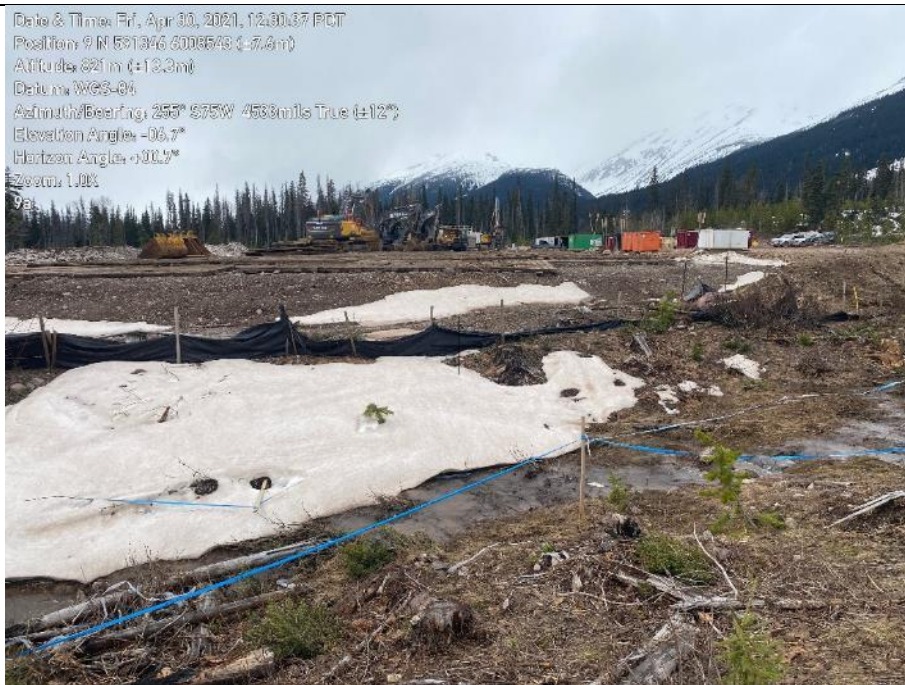
Photo 48. Failing sediment fence at Camp 9A.

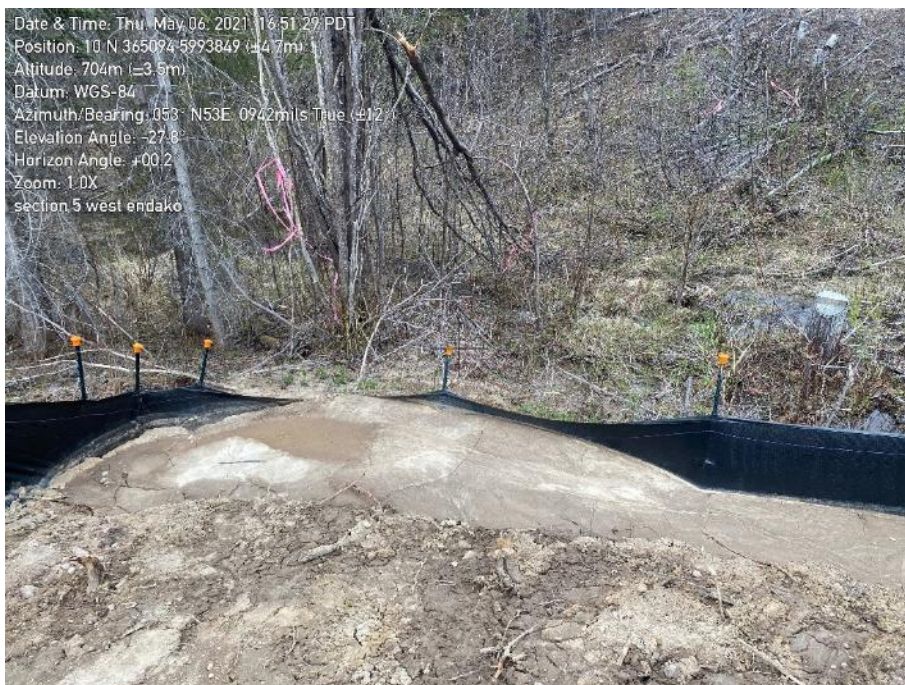
Photo 49. Failing ESC measure at approximately KP 395+550. Lead to sediment discharging into stream feature.

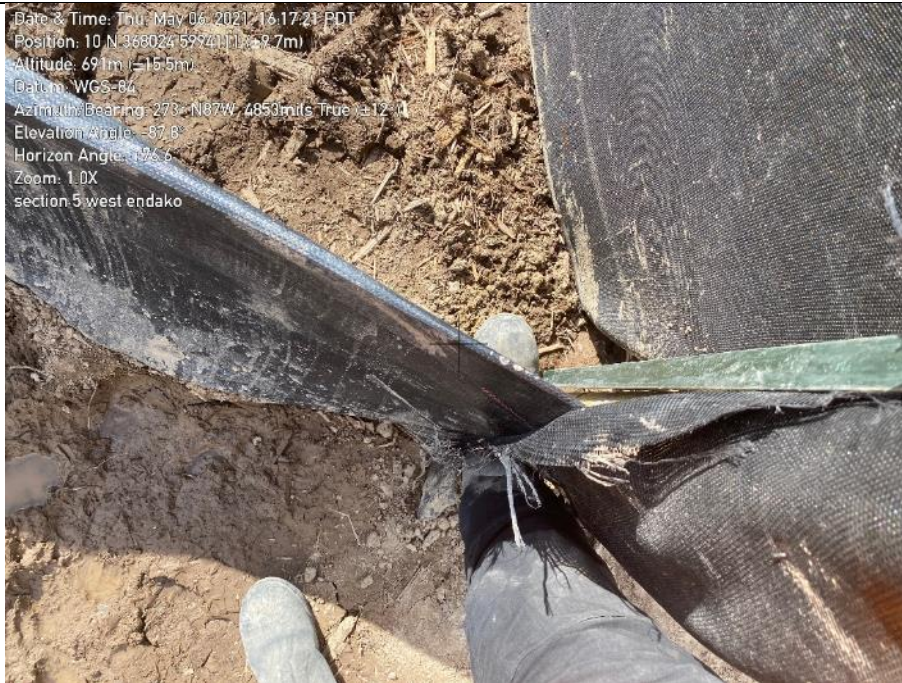
Photo 50. Approximately KP 392+400. Gap beneath sediment fence where two sections meet. Adjacent to stream crossing.

- *KP 392+400: Field personnel have confirmed that the sump located at this location was designed to overtop its banks and was operating as designed at the time of the inspection. Coastal GasLink therefore suggests that this location is in alignment with the requirements of the EAC and EAO Order EN2020-011.*
- During EAO C&E's time on site, sediment laden water was observed to be discharging from this sump towards a watercourse. The sump was not large enough to capture and settle out the suspended material, water was observed to continuously flow through the sump without treating the visibly turbid water. The sump was either not functioning as designed or required maintenance as it was a source of sediment input into a watercourse.

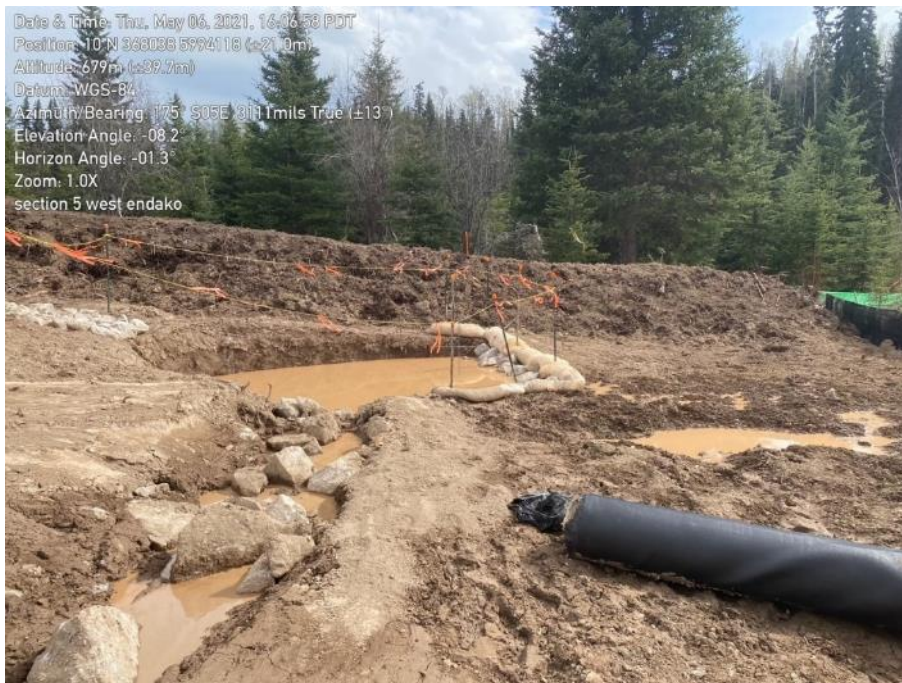
Photo 51. Example of a full sump with sediment laden water overtopping banks.

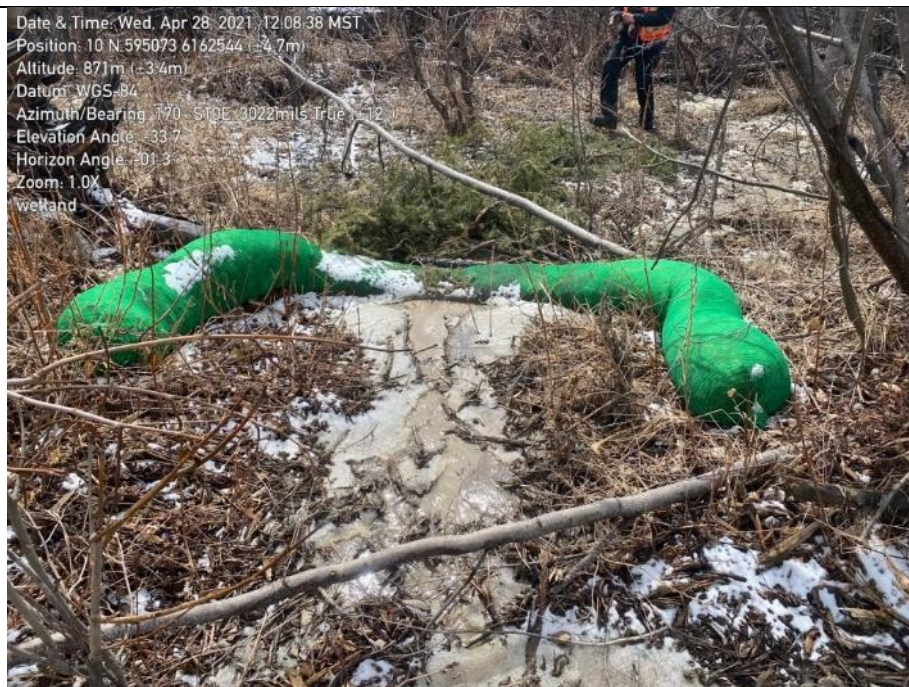
Photo 52. Erosion and flow beneath ESC measure.

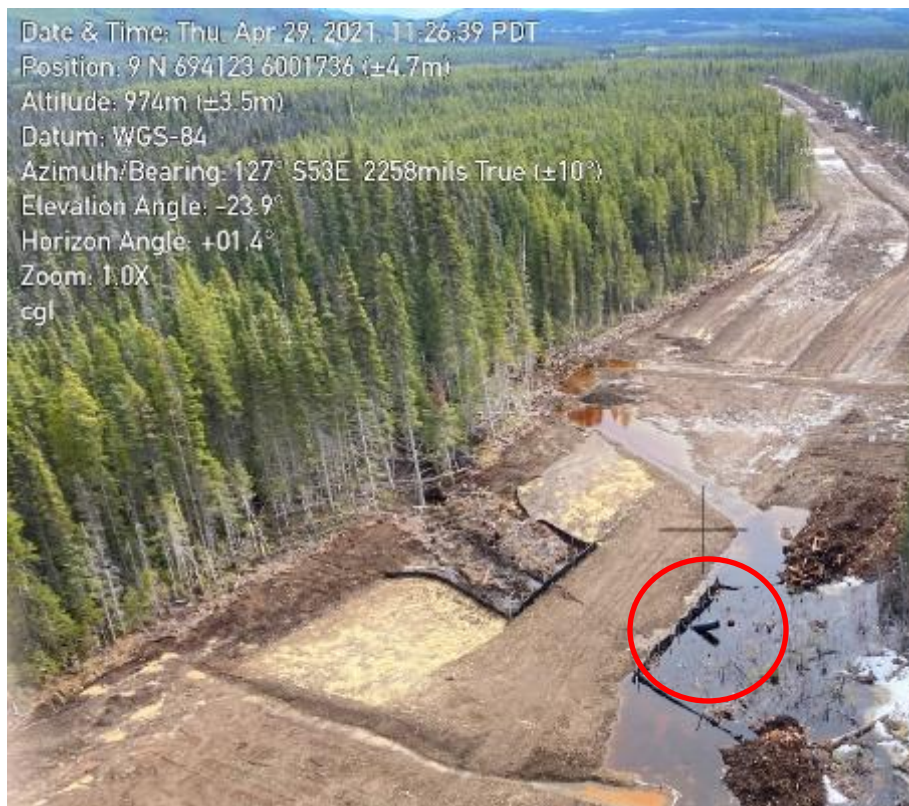
Photo 53. Damaged culvert.

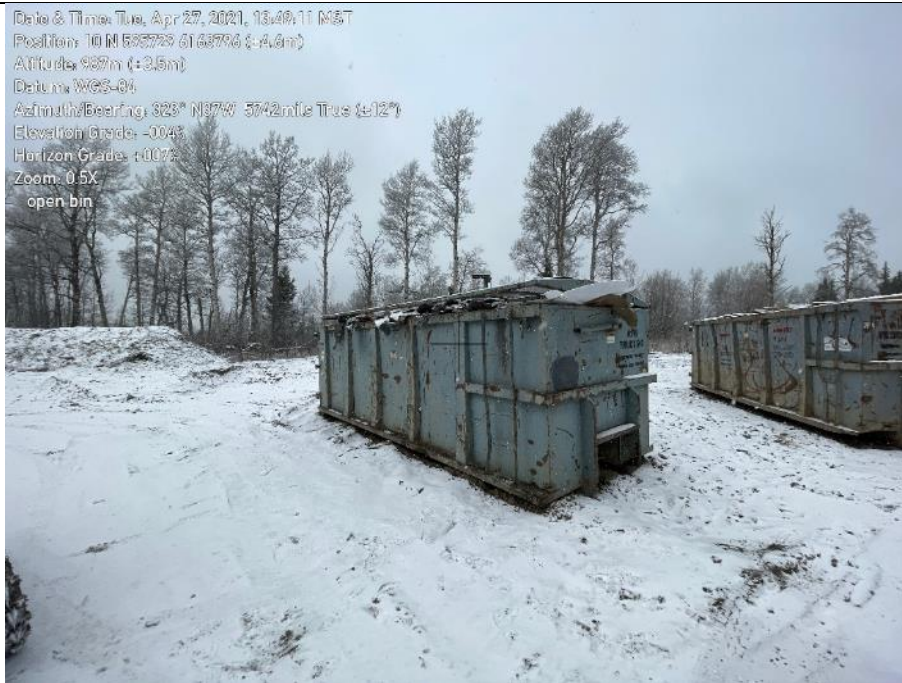
While EAO C&E was on the Project right of way, accessed off the Lone Prairie Road, a waste bin containing anthropogenic food waste was observed to be left open and unattended. Food waste was observed within the bin. This same finding was observed at this location during EAO C&E's inspection of the Project on October 21, 2020.

Photo 54. Waste bin with lid observed to be left open.

*Coastal GasLink agrees that the waste bins located off the Lone Prairie Road in Section 1 have presented a repeated compliance issue. Since time of this inspection, Coastal GasLink confirms that these bins have been removed from this location. Coastal GasLink is also working with the Prime Contractor responsible for Pipeline Section 1 to confirm that waste is stored in locations where they can be closely monitored. Likewise, Coastal GasLink is working with the Prime contractor in Section 4 where the two bags of garbage were found to remind them of the importance of this requirement.*

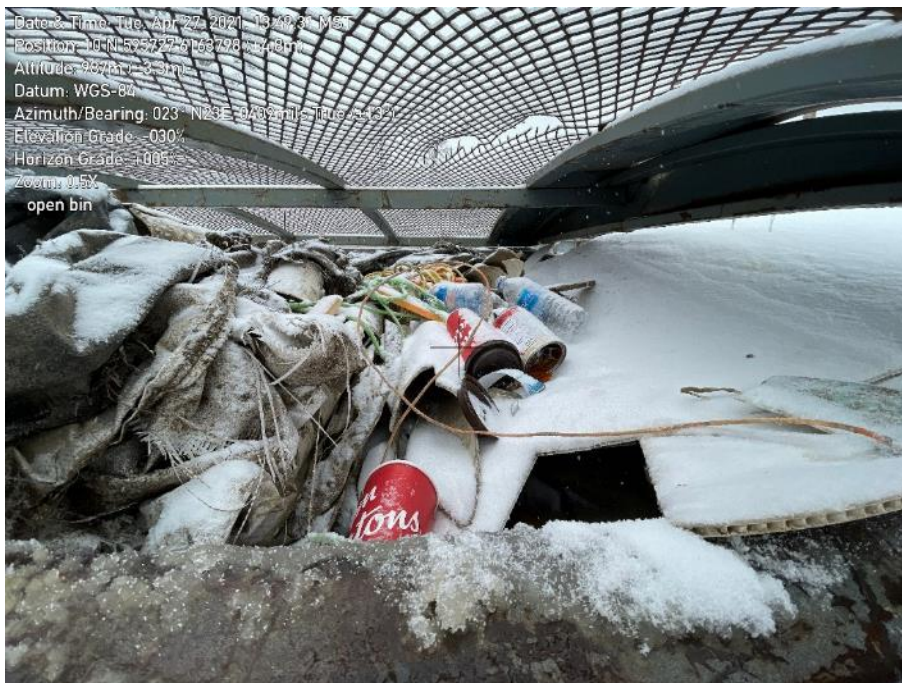
Photo 55. Example of contents within bin shown in above photo.

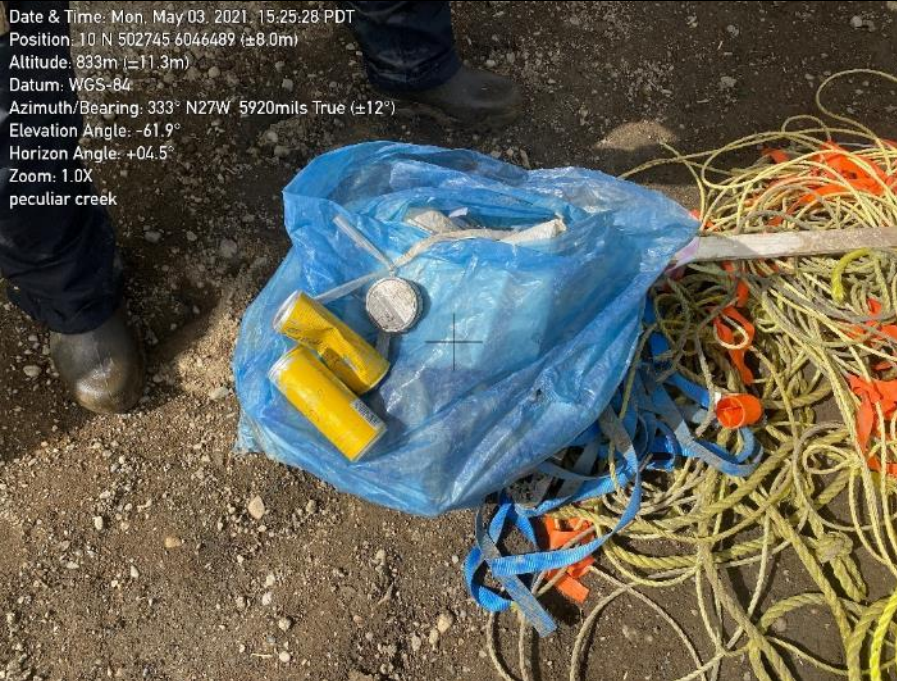
Two unattended bags of food waste were observed to be on the ground near KP 299+800. No crews were in the immediate vicinity at the time of observation. See below photos.

Photo 56. Bag 1 containing food waste on ground at approximately KP 299+800.

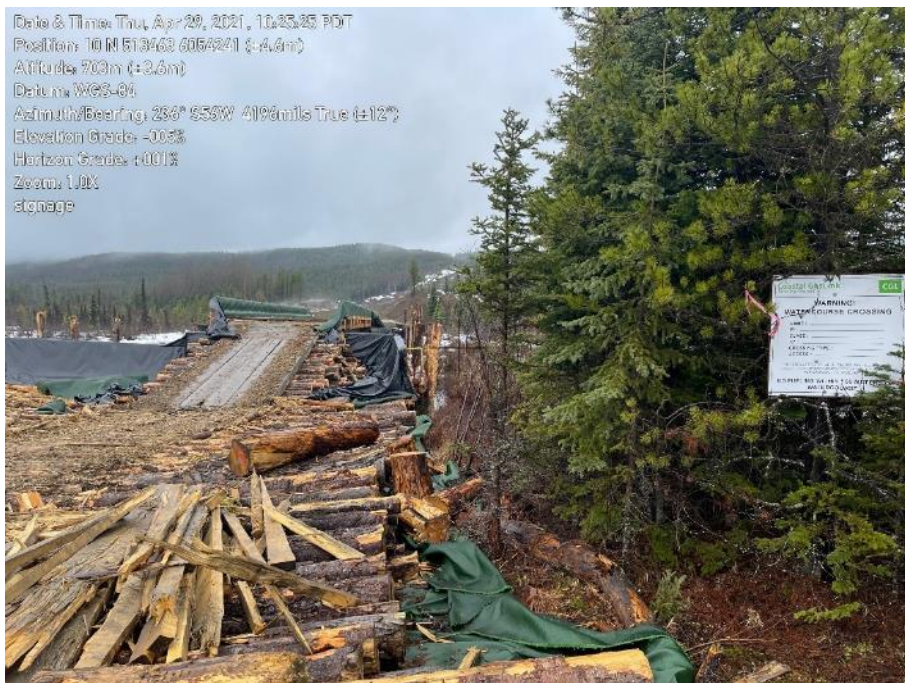
Photo 60. Blank signage. KP 214 range.

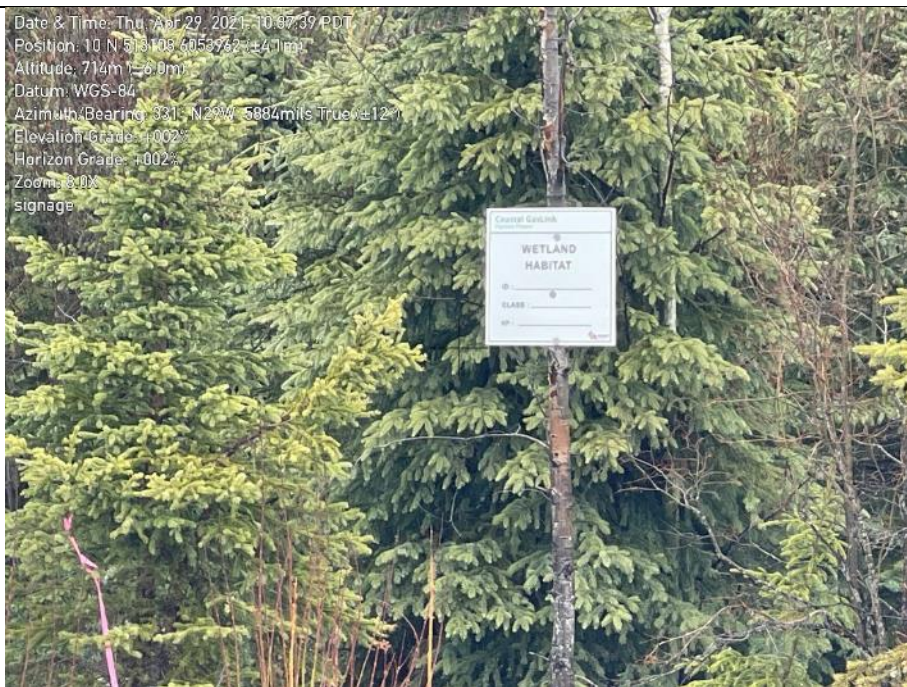
Photo 61. Second example of blank signage near KP 214.

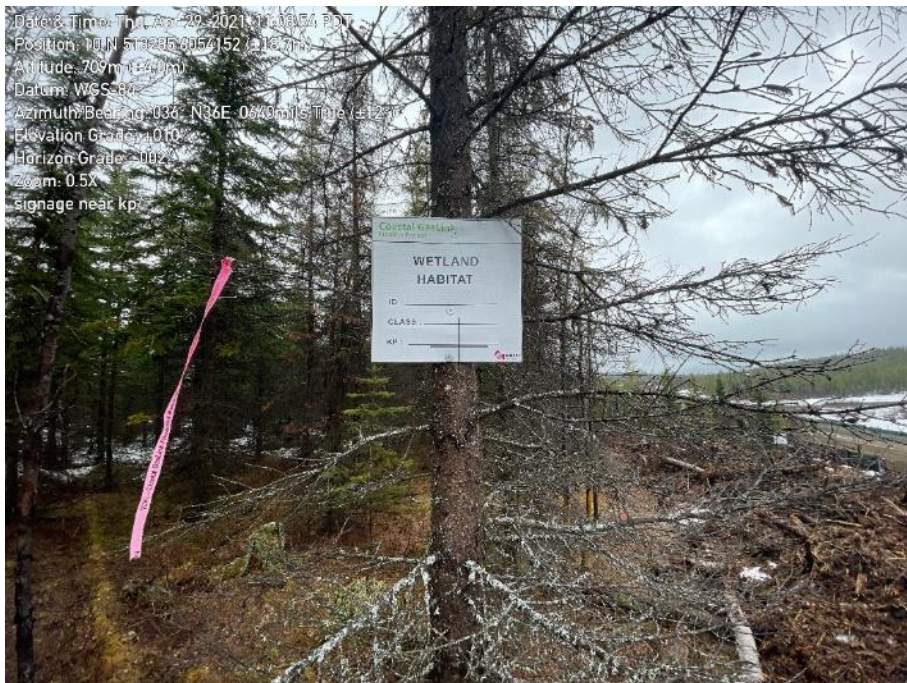
Photo 62. Blank signage near KP 215+780.

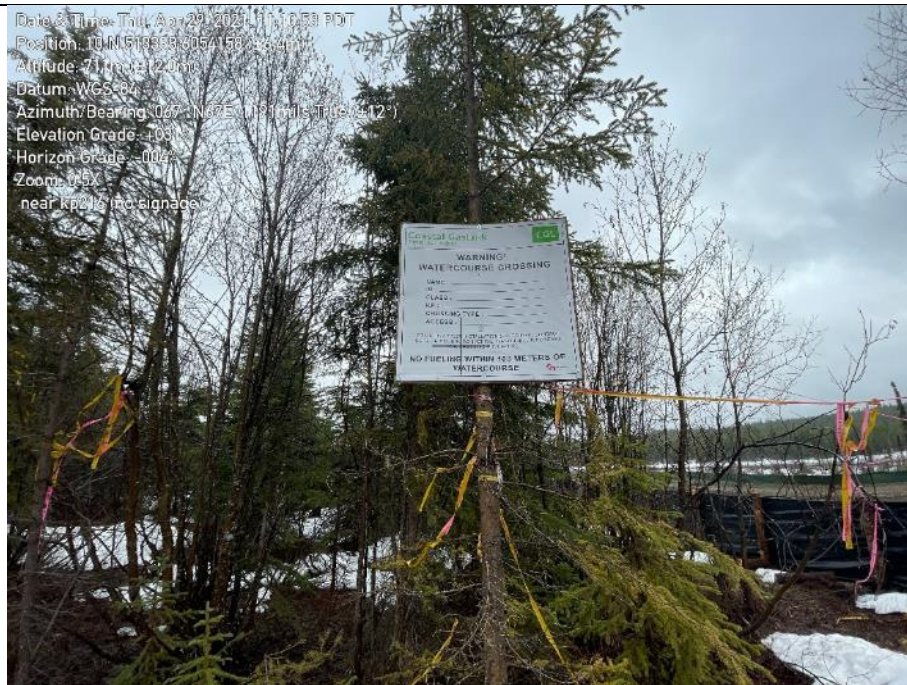
Photo 63. Faded / blank signage near KP 215+700.

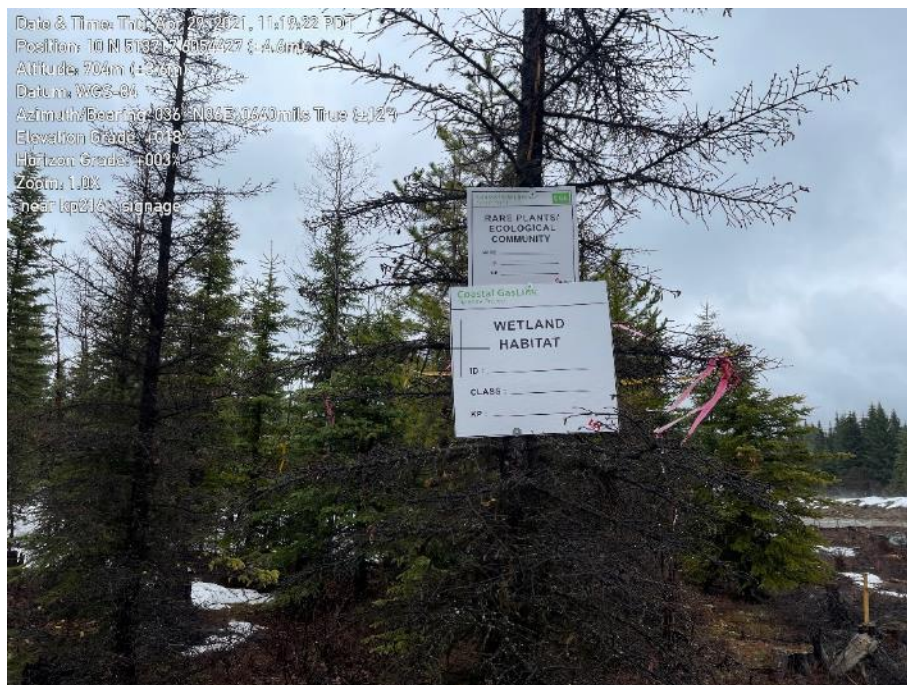
Photo 64. Blank signage near KP 215+280.

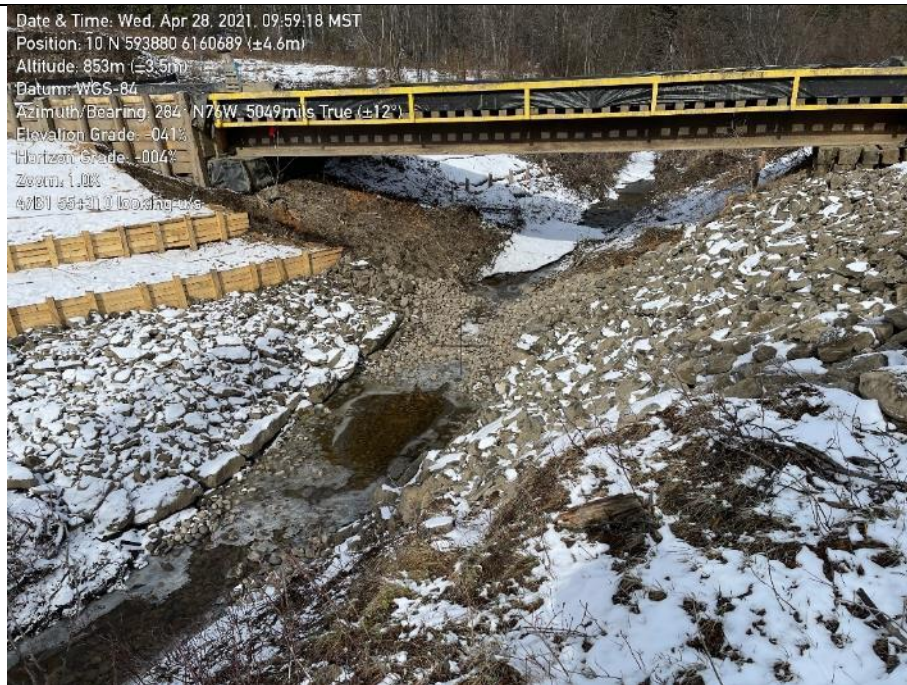
Photo 71: Watercourse 47B1, S3. Shallow flow through reconstructed channel. Potential barrier to fish passage.

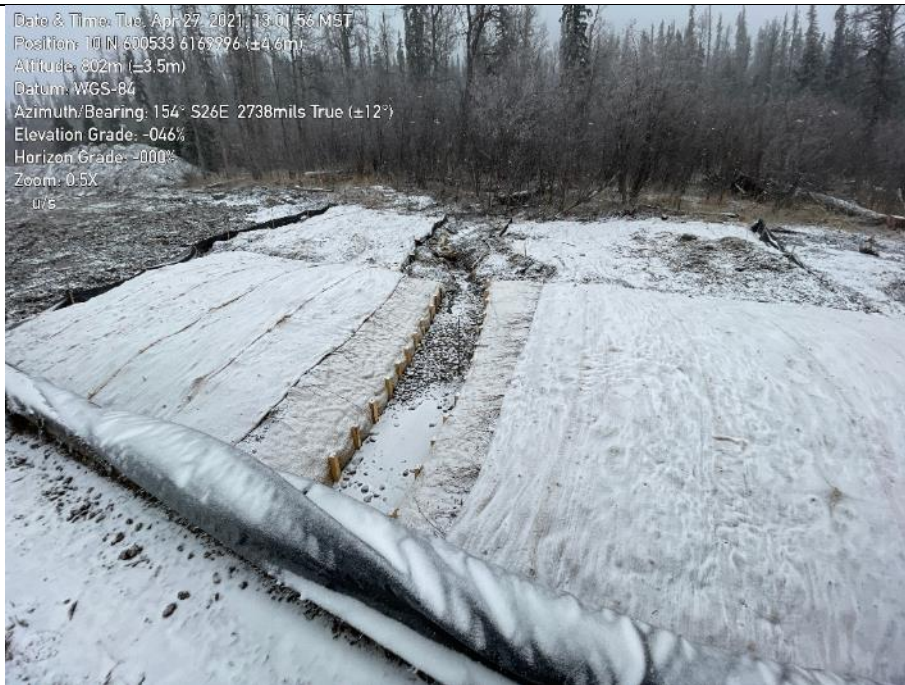
Photo 75. Watercourse UN41-29, S4. Lack of channel profile through crossing. Potential barrier to fish passage.

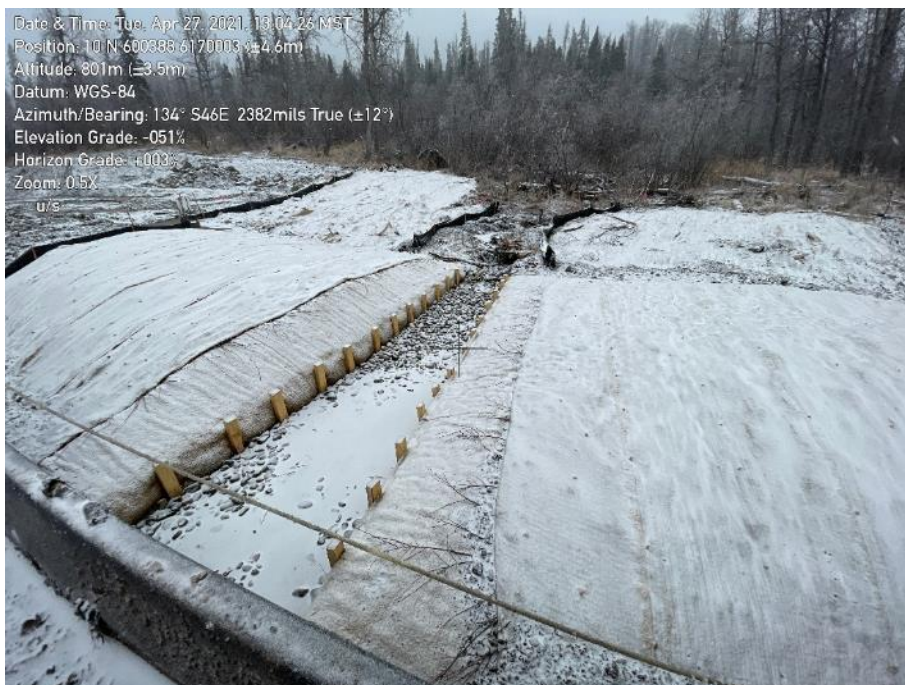
Photo 76. Watercourse UN41-28, S4. Lack of channel profile through crossing. Potential barrier to fish passage.

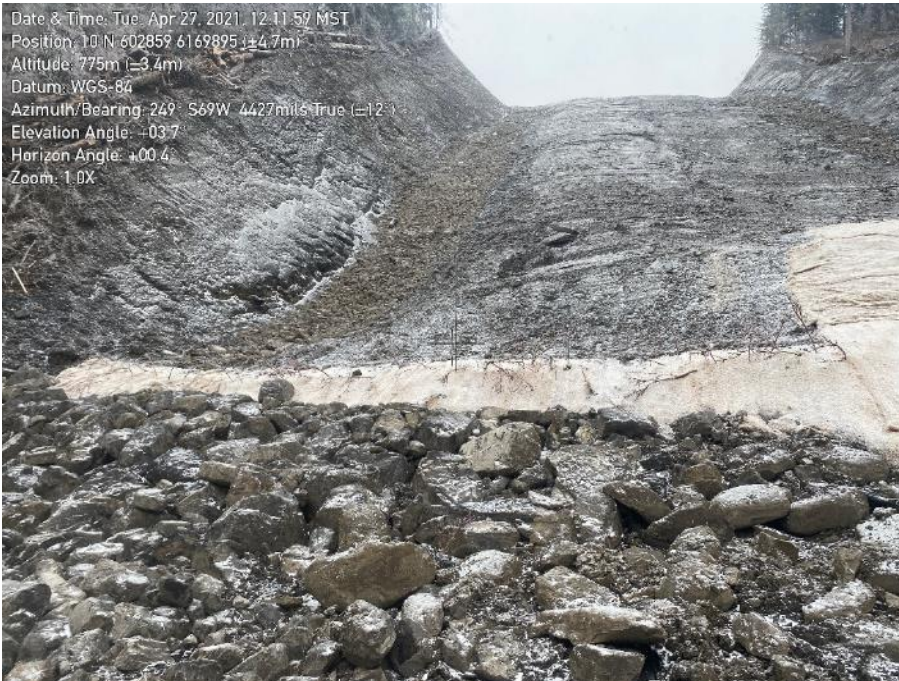
Additionally, the willow stakes had more than 25 cm left exposed and the planting rate of 1 stem per 15 cm was often not met. See photos below for examples.

Photo 79. KP 41. Willow stake density less than one stem per 15 cm.

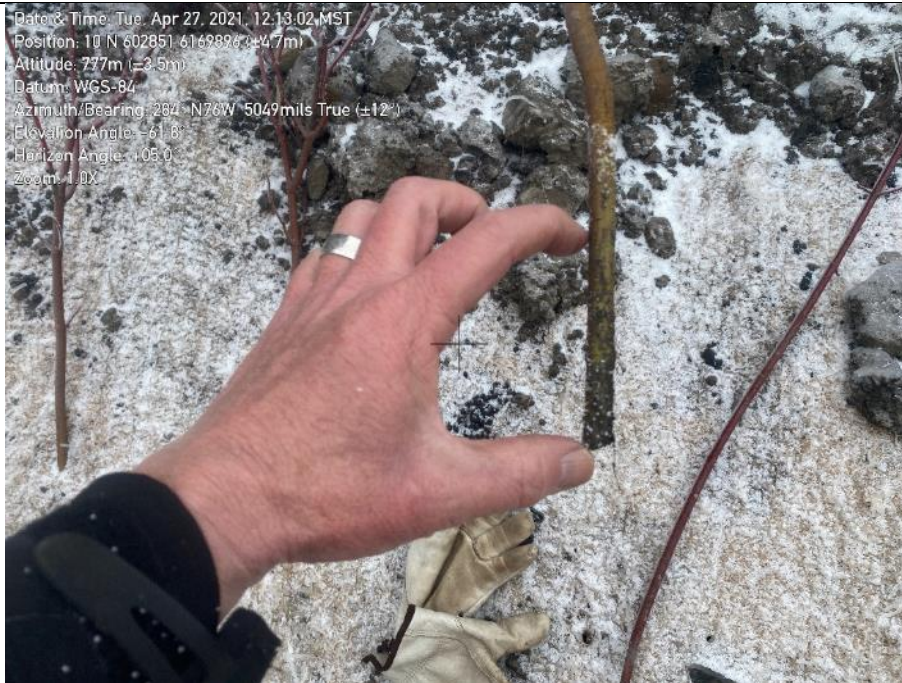
Photo 81. KP 41. Example of the observed planted depth of willow stakes. More than 25 cm left exposed after planting.

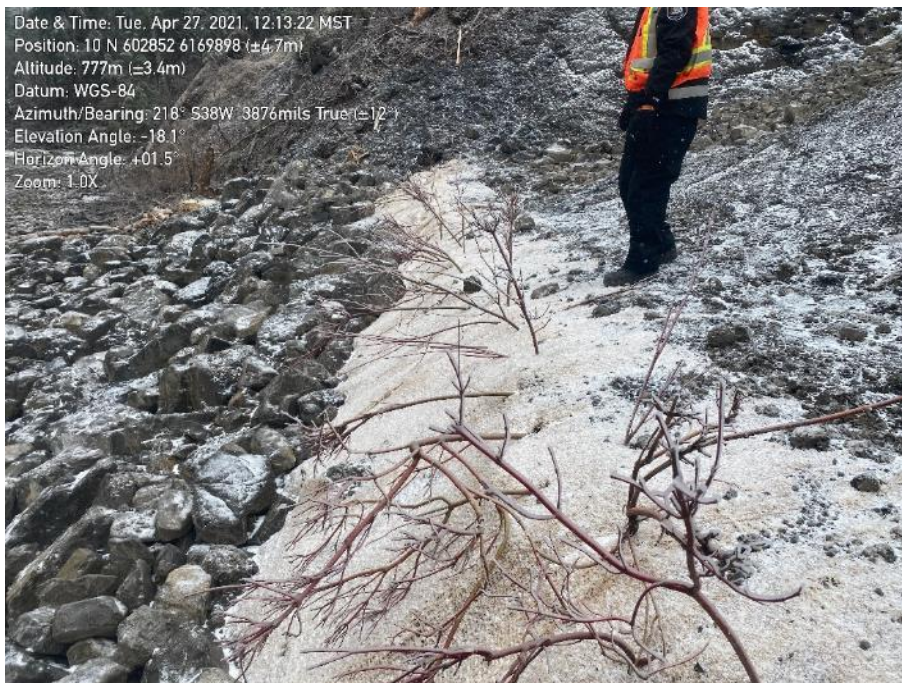
Photo 82. KP 41. Overview of planting at site. Willows not planted to depth, do not reach diameter requirement, not spaced to specification and are less than 2 – 3 m long.

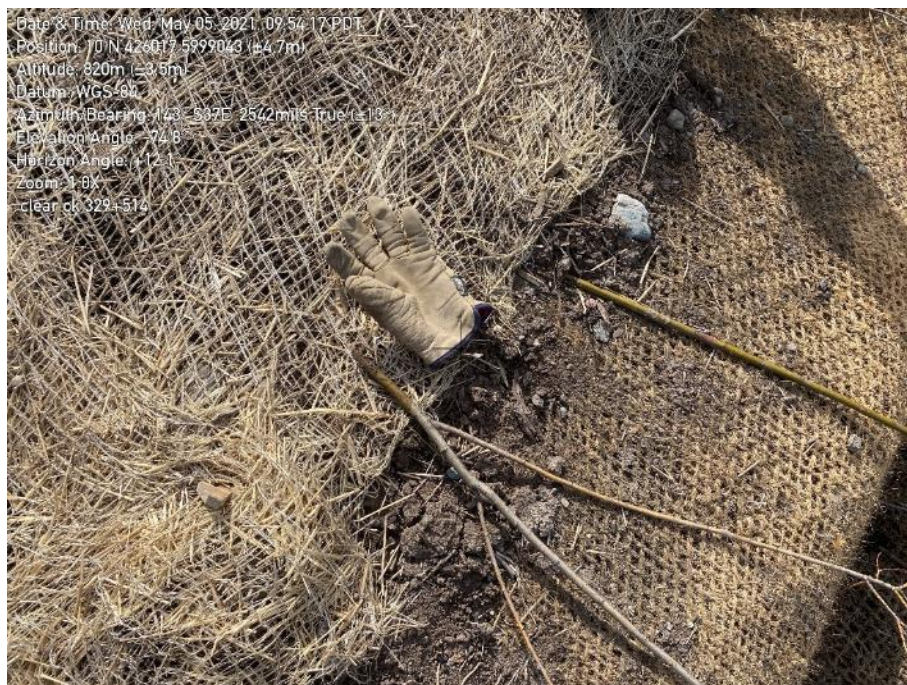
Photo 87. KP 329+300, Clear Creek. Willows not planted at one stem per 15 cm.

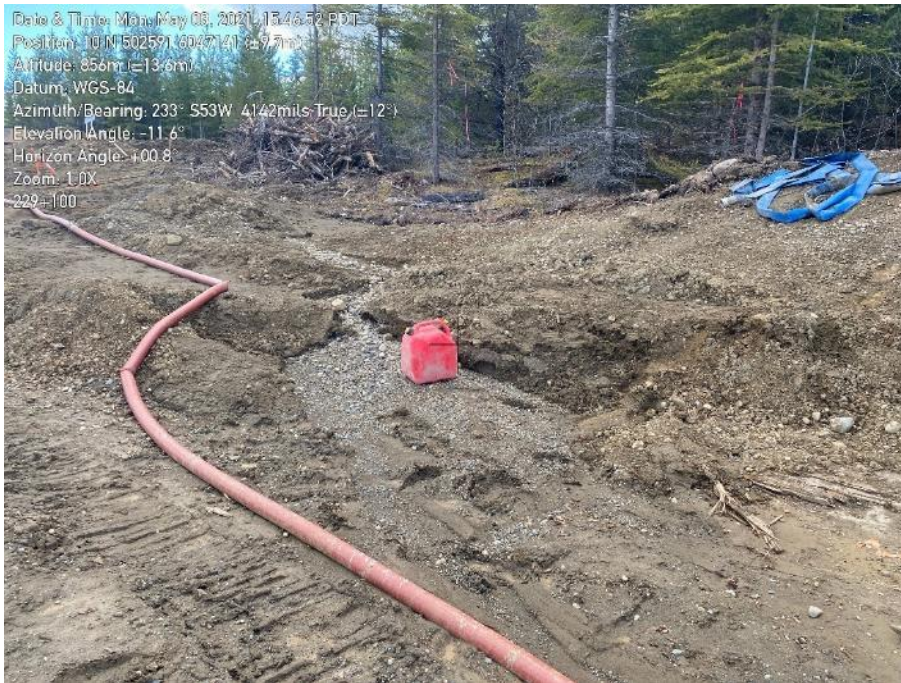
Photo 88. Approximately KP 229+100. Canister of gasoline left unattended on the right of way. Note eroded channel beneath the canister indicating flowing water recently occurred at this location.

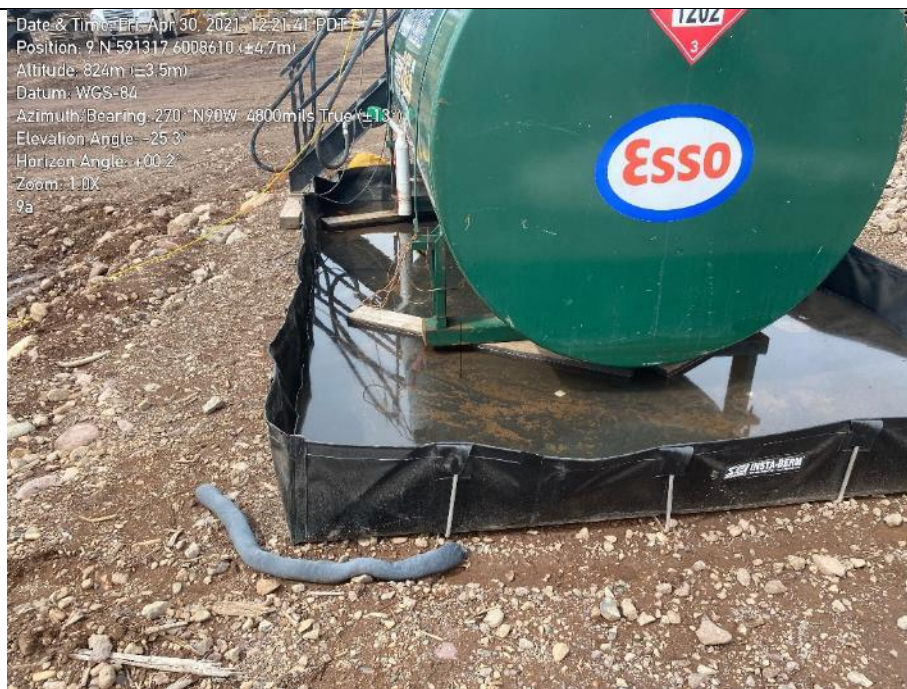
Photo 92. Secondary containment full and water leaving containment - Camp 9A.

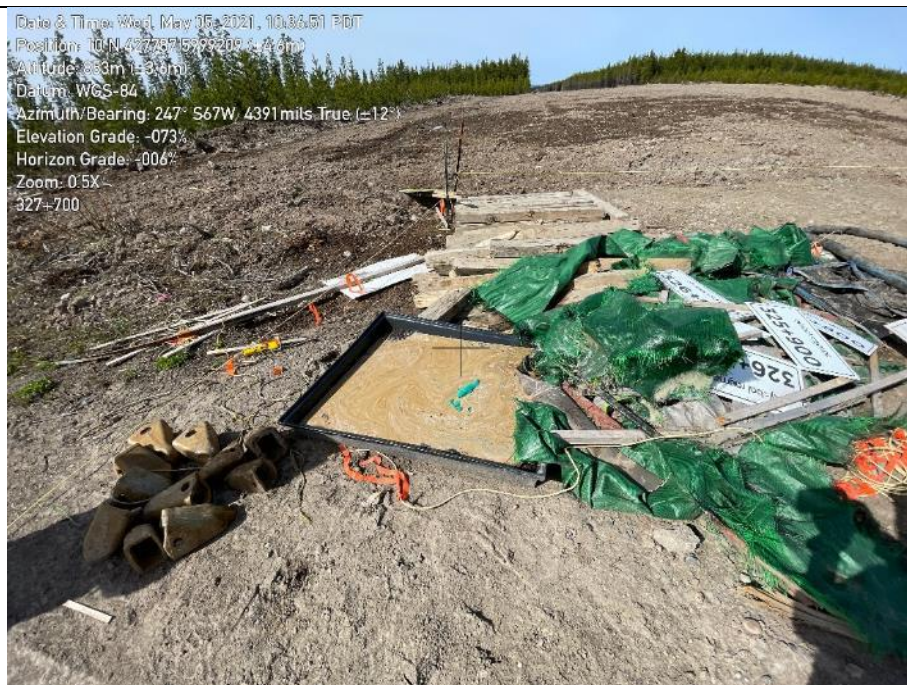
Photo 95. Secondary containment near capacity with oily sheen observed at KP327+700.
