ENVIRONMENTAL ASSESSMENT OFFICE: ADMINISTRATIVE
PENALTY ASSESSMENT FORM

EAC NO: E14-03

PROJECT NAME: Coastal GasLink Pipeline Project

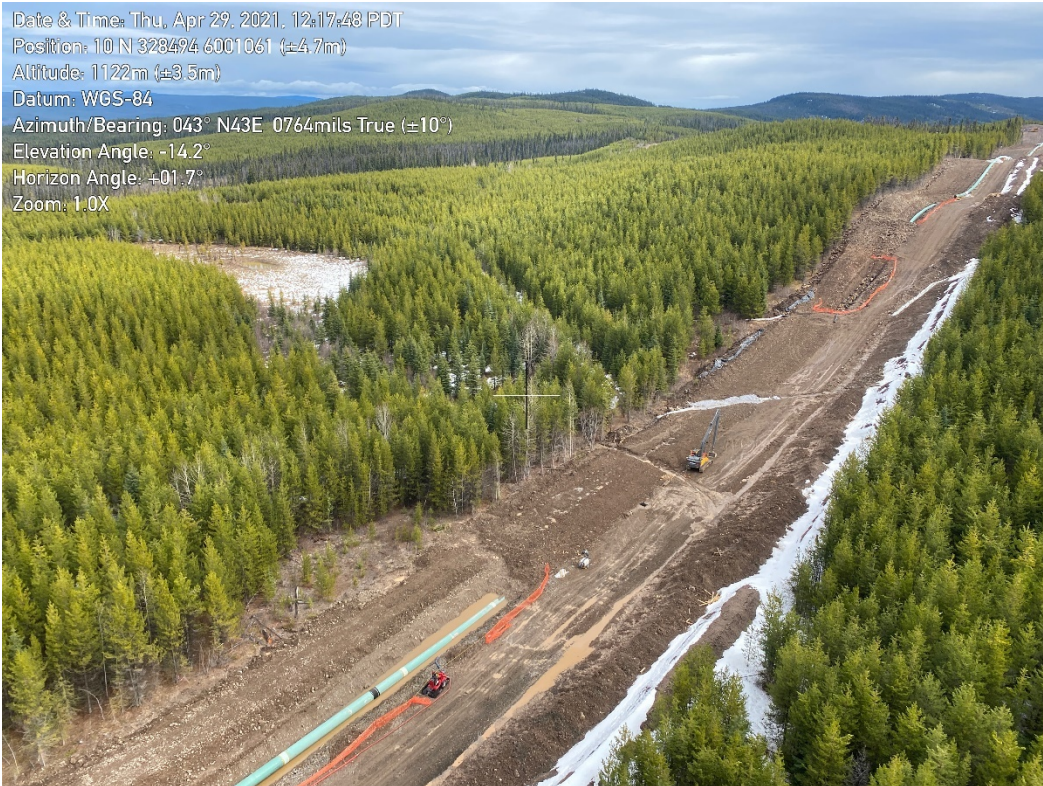
Photo 1: CGL pipeline under construction April 29, 2021.
