<b>Project Name</b>	Coastal GasLink Pipeline Project	<b>Inspection Status</b>	Final
<b>EA Certificate #</b>	E14-03	<b>Inspection No.</b>	20230030_IR001
<b>Project Status</b>	Certified	<b>Inspection Start</b>	2023-04-24
<b>Sector</b>	Energy	<b>UTM</b>	10U 540701.61 m E 6079245.08 m N
<b>Trigger</b>	Planned Inspection	<b>Inspection Type</b>	Field
<b>Project Description</b>	The Coastal GasLink Pipeline Project (Project) is an approximately 650 kilometre (km) long natural gas pipeline connecting facilities in northeast British Columbia (B.C.) to the LNG Canada facility near Kitimat.		
<b>Location Description</b>	The Project is near Groundbirch (40 km west of Dawson Creek) in northeast B.C. to the LNG Canada facility near Kitimat. This inspection covered work being carried out in Sections 3 and 4. The UTM referenced above is approximately in the center of the sections of where the inspection took place.

## INSPECTION DETAILS

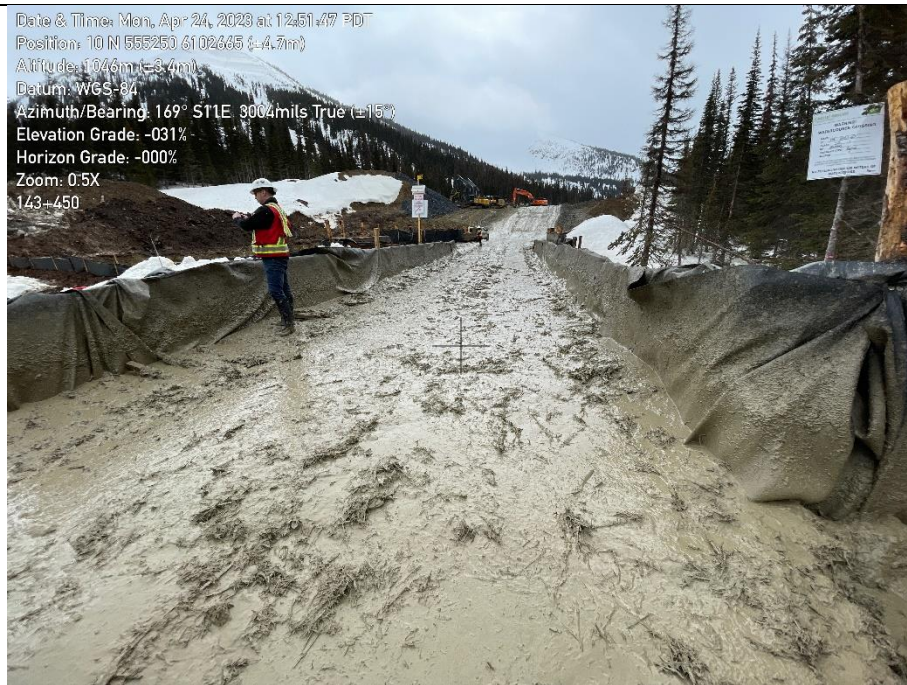
Project related sediment laden water was observed pooling on bridge decks and/or bypassing measures and entering the watercourses below. See the below photos for examples.

Photo 1. S2 watercourse crossing at KP 143+450. Pooling water on bridge deck.

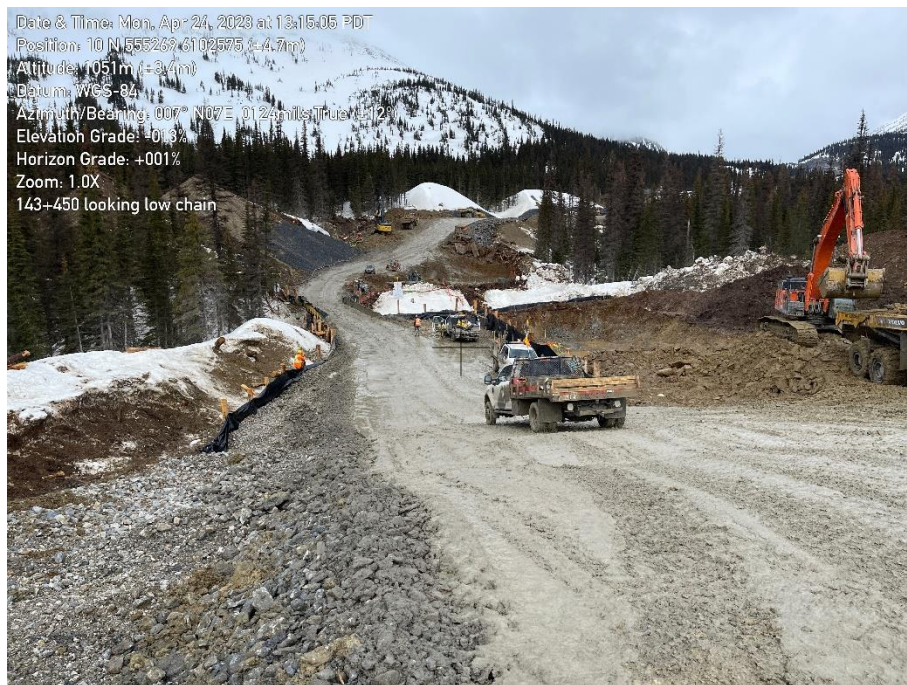
Photo 2. High chain approach to the bridge crossing at KP 143+450. Material from the travel lane flowing towards and onto the bridge deck.

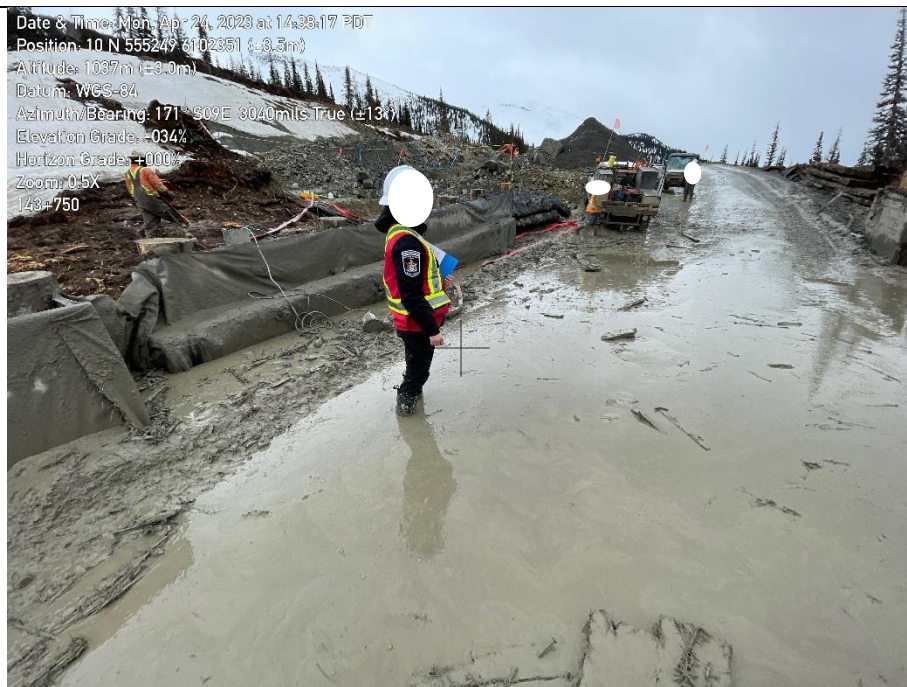
Photo 3. S4 watercourse crossing at KP 143+750. Pooling water on bridge deck.

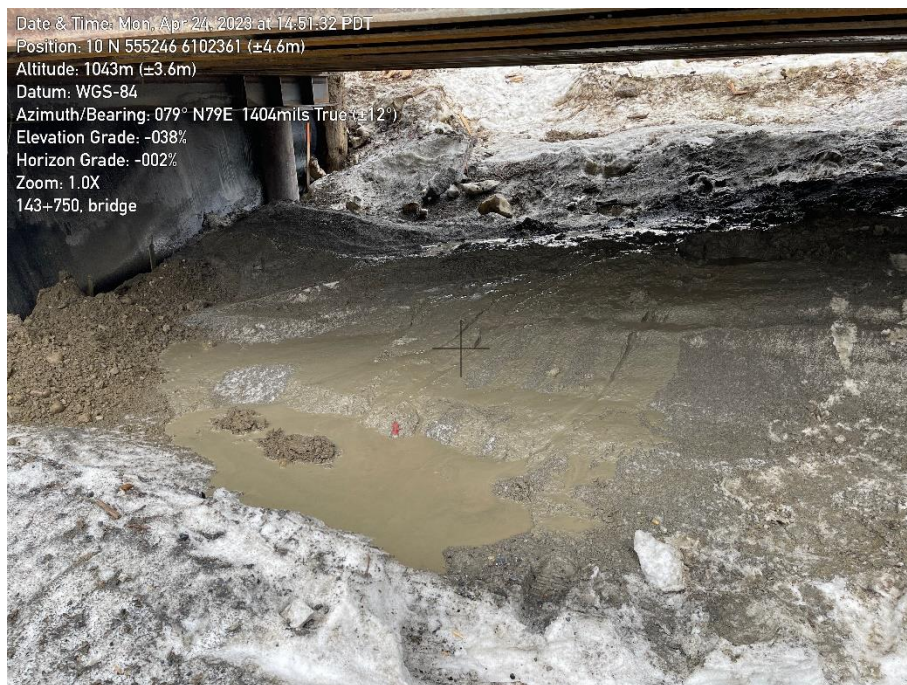
Photo 4. S4 watercourse crossing at KP 143+750 beneath bridge.

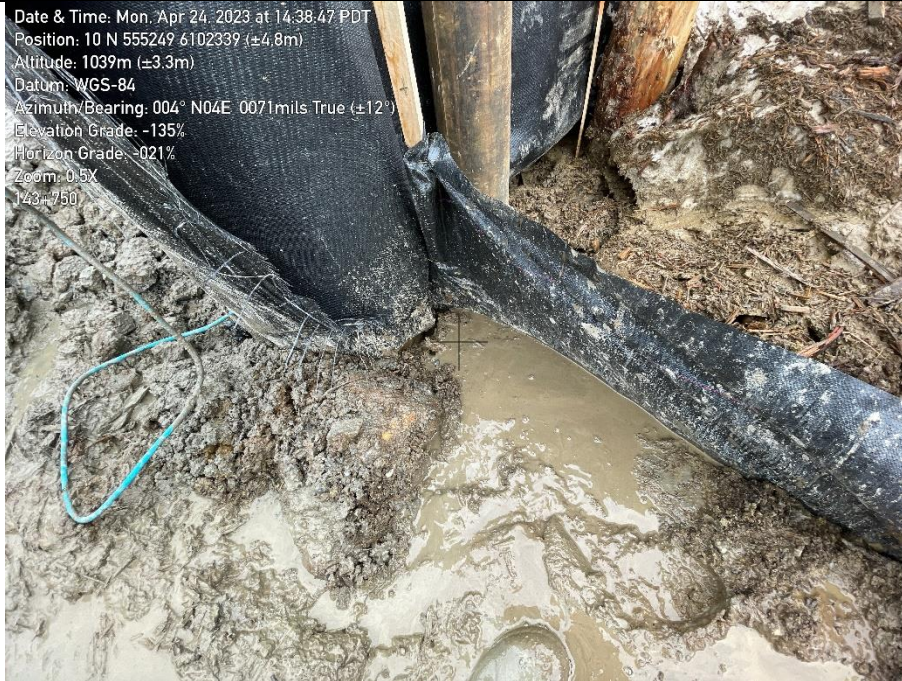
Photo 5. Sediment laden flow through measures and into watercourse at KP143+750.

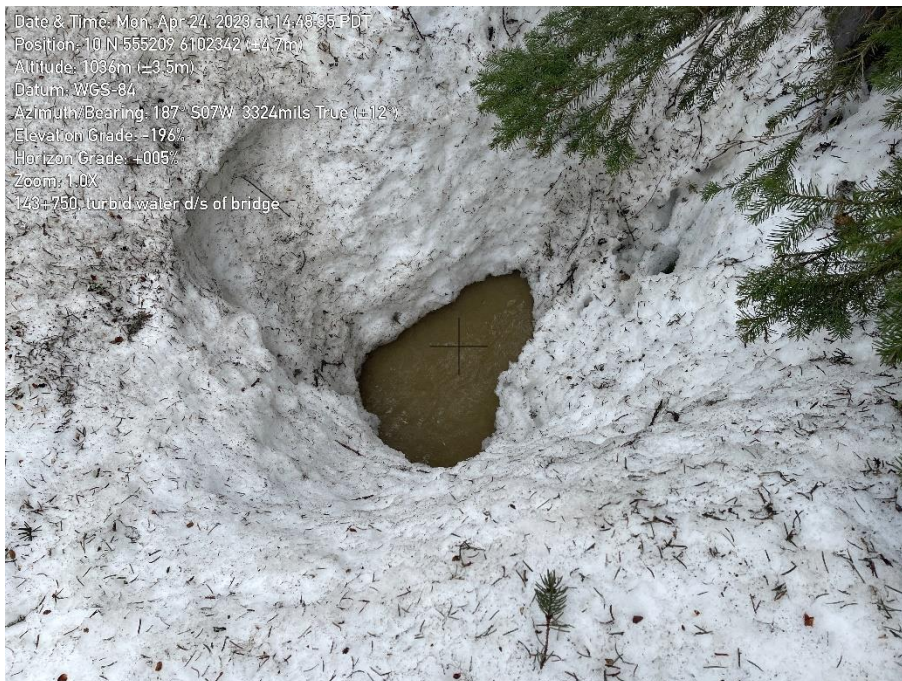
Photo 6. Sediment laden flows in the channel downstream of the bridge crossing at KP143+750.

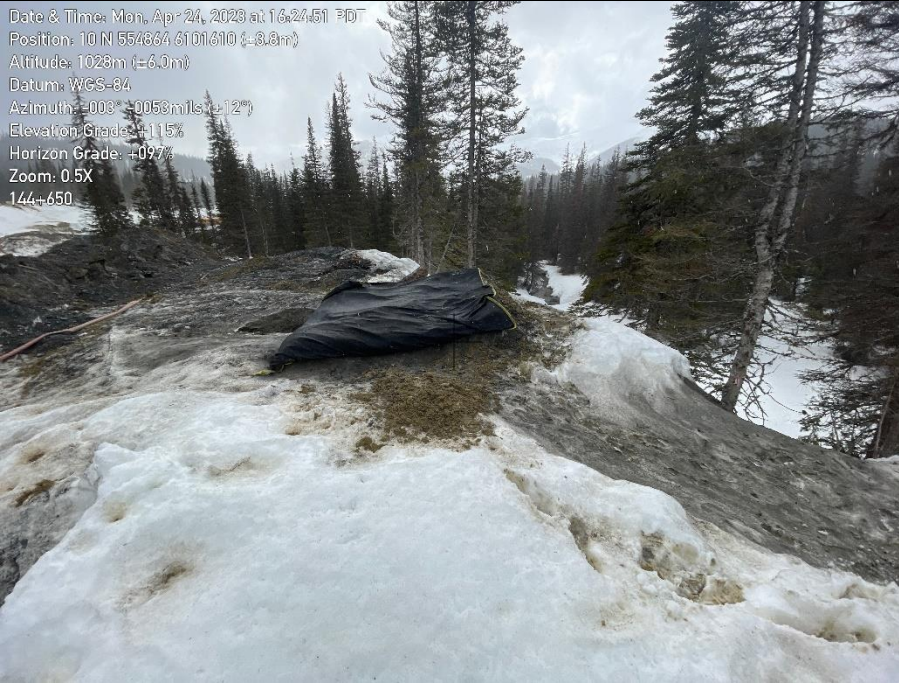
During the helicopter flight on April 24, 2023, EAO CEB observed a filter bag placed adjacent to the right of way (ROW) and at the top of a slope above a fish-bearing watercourse (watershed code: 236-313100-60100-43600). Evidence of sediment laden discharge from the filter bag into the fish-bearing watercourse was observed. Upon further inspection on the ground and cross referencing the WEP, it was confirmed that the filter bag was not installed in an approved pumping area.

Photo 7. Filter bag at roughly KP 144+650 placed immediately above Environmentally Sensitive Receptor.

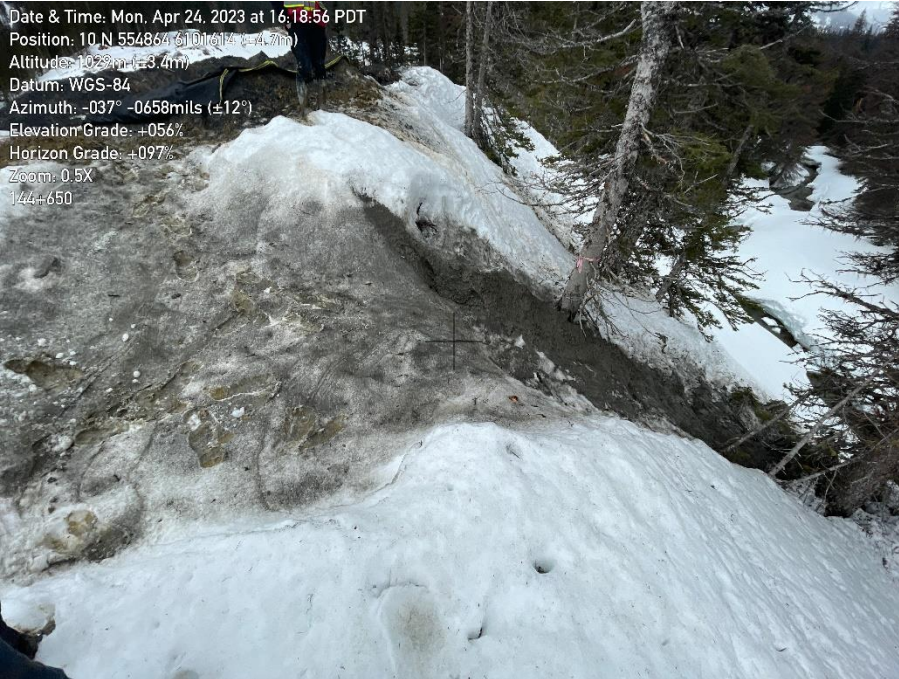
Photo 8. Deposited material from filter bag discharge at approximately KP 144+650.

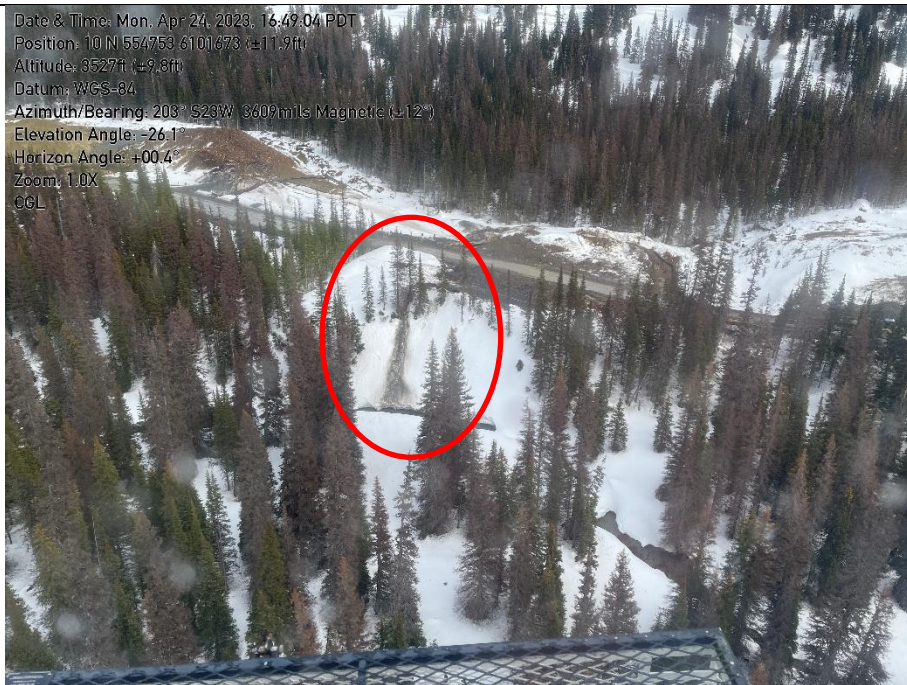
Photo 9. KP 144+650 evidence of filter bag discharge reaching Environmentally Sensitive Receptor (watercourse).

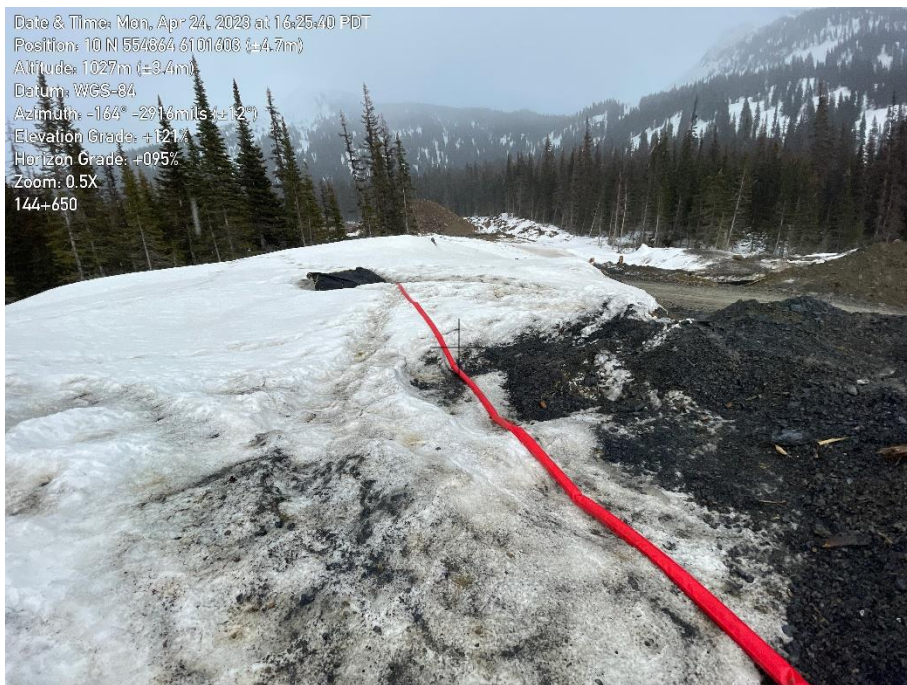
At the time of the inspection, the bag was disconnected from the hoses and not being used. No water was actively being pumped to the filter bag. However, a second, newer filter bag was also installed within 10 metres of the first filter bag. This second filter bag was connected to hoses and the lines of the hoses were primed. These hoses were traced back to a sump on the ROW containing sediment laden water. The pump was not actively running while EAO CEB was onsite.

Photo 10. Second filter bag with hose primed for use.

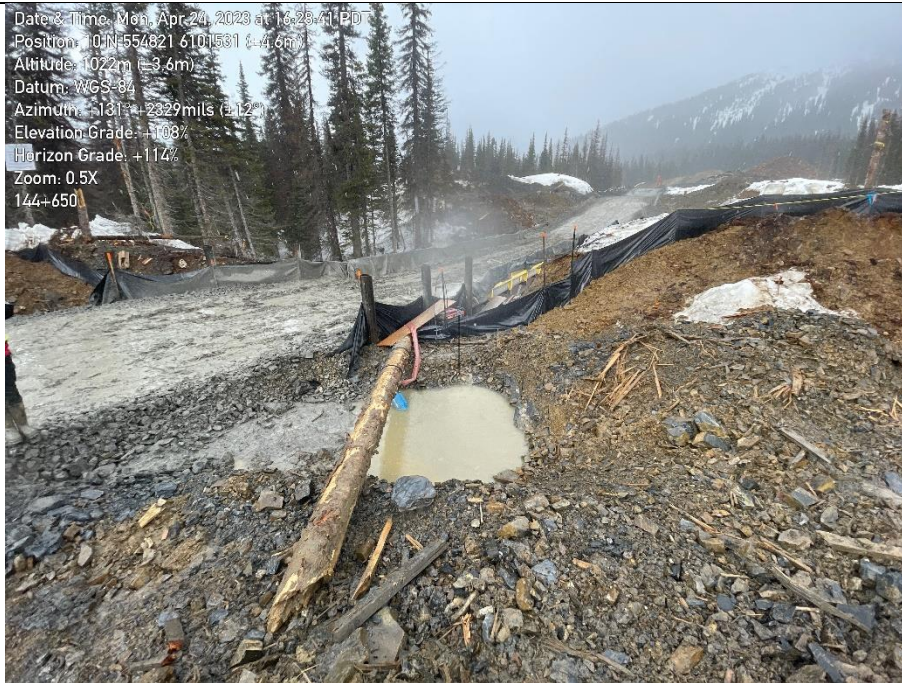
Photo 11. Sump where water is pumped into the second filter bag.

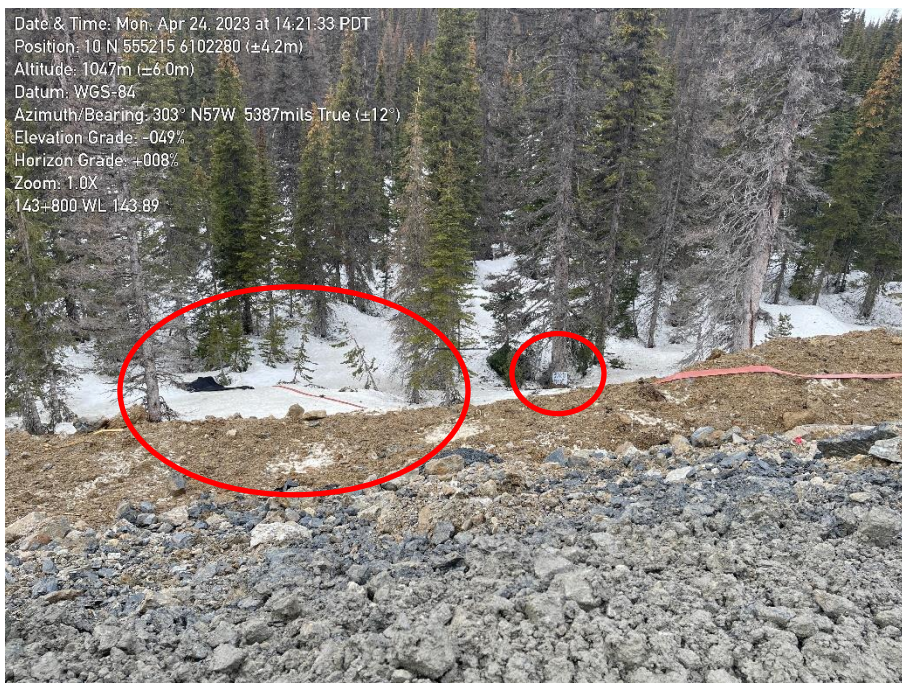
Approximately adjacent to KP143+800 wetland number WL-143.89 is located. During the inspection, a filter bag connected to discharge hose from a pumping location was observed within wetland KP-143.89. The filter bag at approximately KP143+800 was not installed within an approved pumping location or pumping area as required in the WEP. See the below photos for more details.

Photo 12. Filter bag set up within wetland WL-143.89. Red arrows indicate wetland identification sign and filter bag.

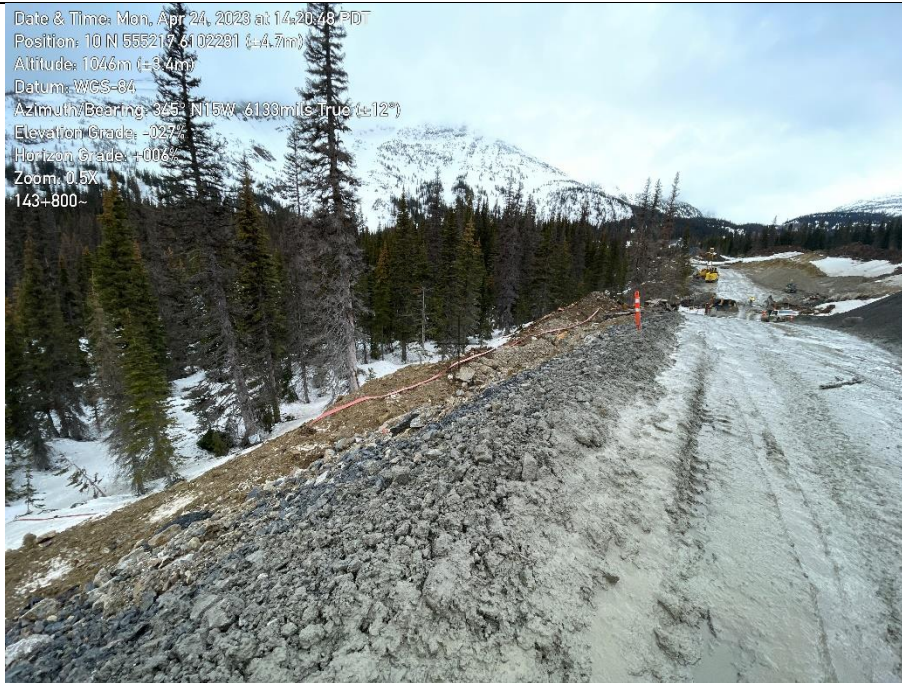
Photo 13. Discharge hose from pumping location connected to filter bag within wetland WL-143.89.
