Project Name	Woodfibre LNG	Inspection Status	Final
EA Certificate #	E15-02	Inspection No.	20260014_IR001
Project Status	Construction	Inspection Start	2026-04-22
Inspection Type	Field and Administrative	Initiation	Planned inspection
UTM	10U 481915E 5501445N		
Project Description	Woodfibre LNG General Partner Inc. is developing Woodfibre LNG, a liquefied natural gas export facility located approximately 7 kilometres southwest of Squamish, B.C. The project is to be supplied by the Woodfibre-Eagle Mountain pipeline and is anticipated to produce up to 2.1 million tonnes per year of natural gas that will be exported to oversea markets. It will also include land-based natural gas processing and liquefaction facility, condensate storage, floating storage tanks to store up to 250,000 cubic metres, and offloading unit with an associated jetty, proposed floating accommodations for workers, and the construction of supporting buildings.

INSPECTION DETAILS

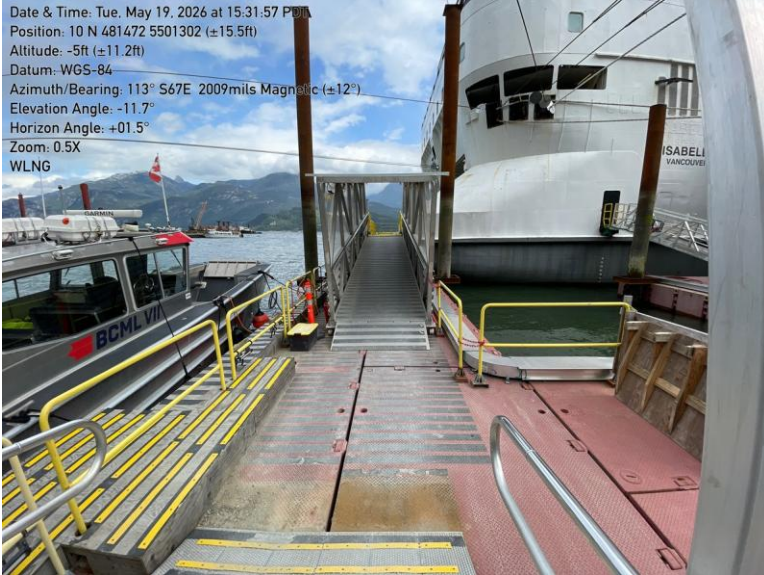
On May 19, 2026, the Officer conducted an inspection of the project's ramps and gangway surfaces to assess the use of grating and other light-permeable materials. During the inspection, it was observed that two gangways were constructed of solid aluminum. This design restricts the penetration of light to the benthic communities located beneath these structures (Photo 1 and Photo 2).

The observations made at the time of inspection provide evidence of non-compliance with requirements for the use of light-permeable materials in overwater structures.

Photo 1. Solid aluminum gangway to Floatel 1.

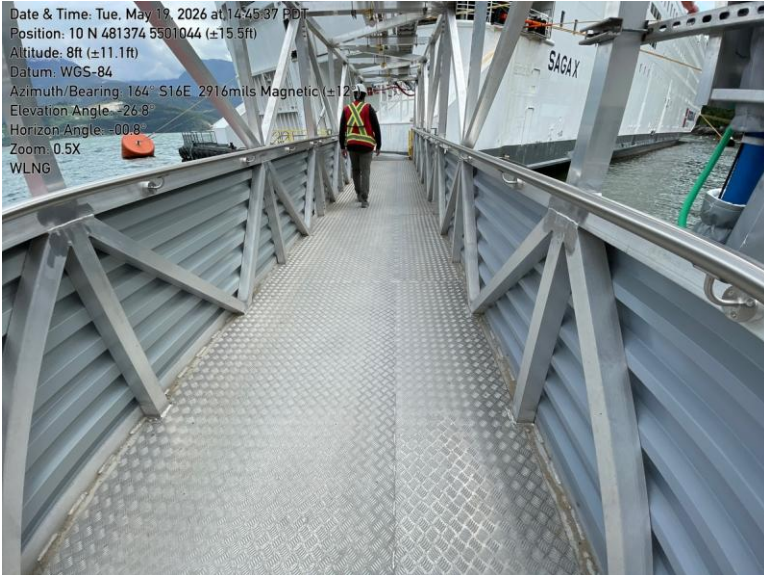
Photo 2. Solid aluminum gangway to Floatel 2.

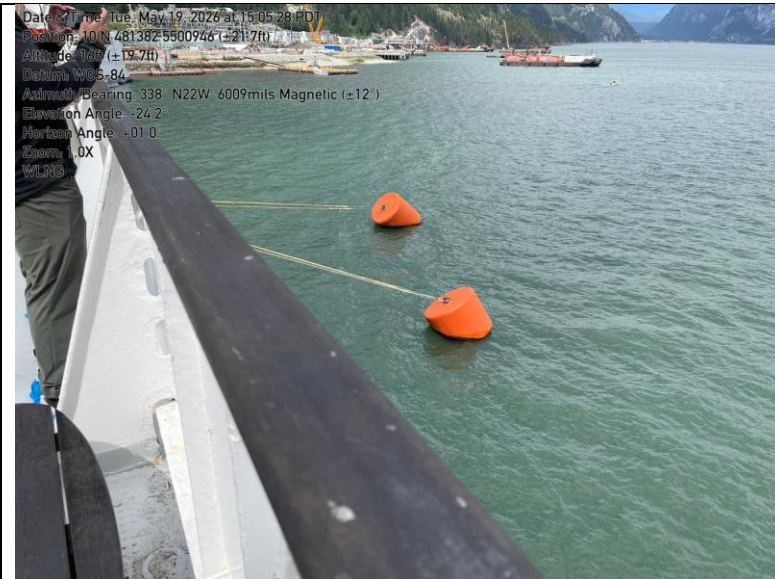
During the field inspection on May 19, 2026, the Officer confirmed that six anchor points had been installed off the vessel, two on the stern and four on the bow (Photo 3 and Photo 4).

Photo 3. Two anchor points installed off stern of vessel.

An underwater survey to evaluate the effectiveness of measures to avoid disturbance to glass sponges in the vicinity of the Floatel #2 moorings will be conducted at a later date.

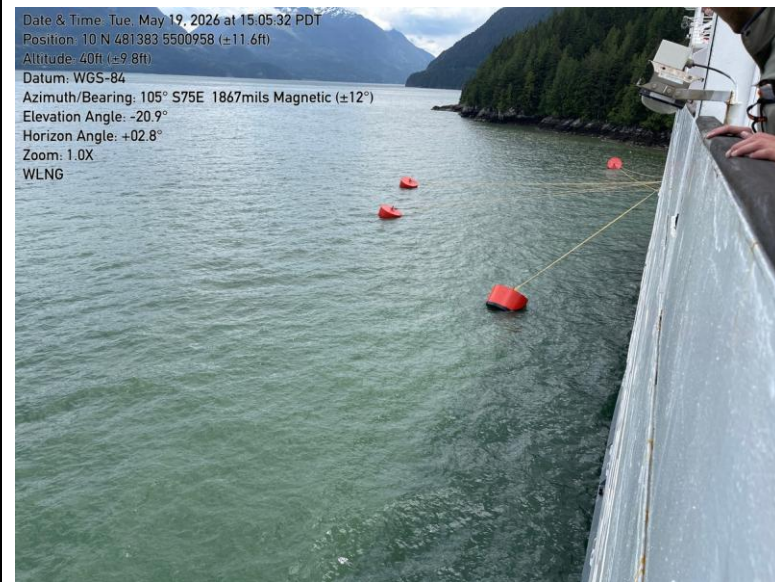
Photo 4. Four anchor points installed off of the vessels bow.

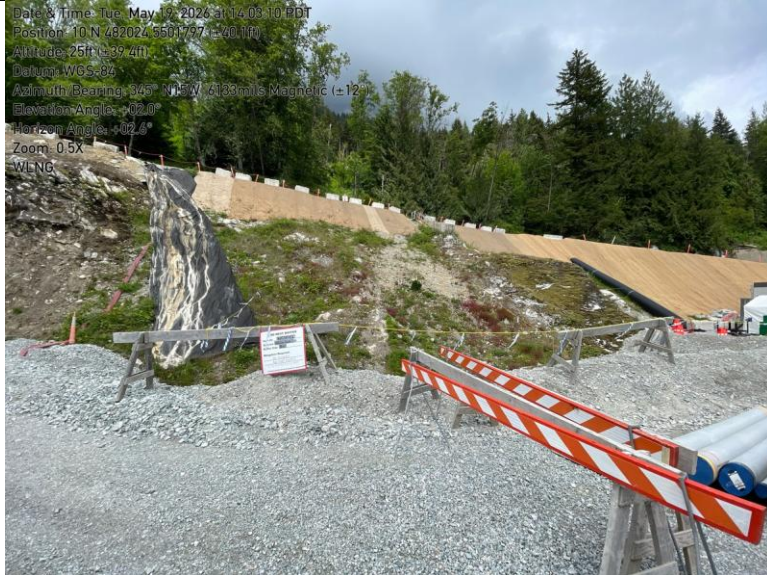
The White-crowned Sparrow nests were clearly identified with signage and delineated using fencing and/or yellow rope and flagging. The signage included the nest identification number, species, buffer distance, and applicable mitigation measures (Photo 5 and Photo 6).

Photo 5. White-crowned Sparrow bird nesting buffer.

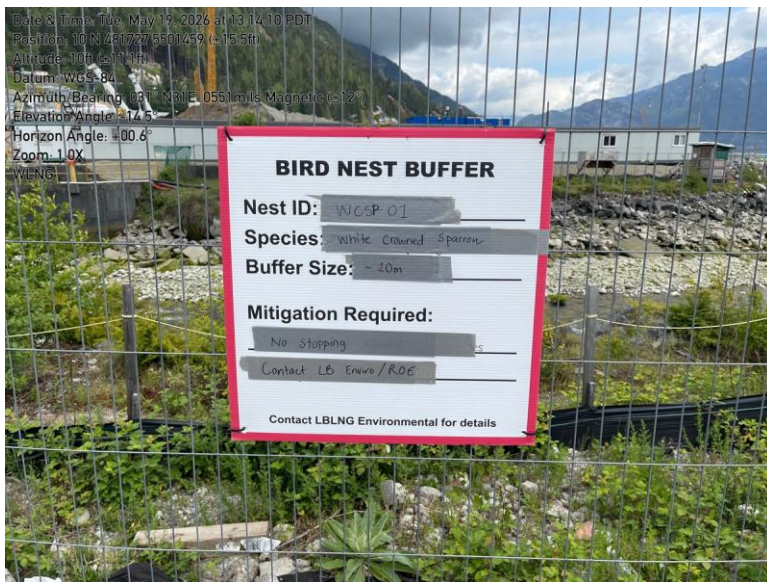
Photo 6. White-crowned Sparrow bird nest buffer signage.

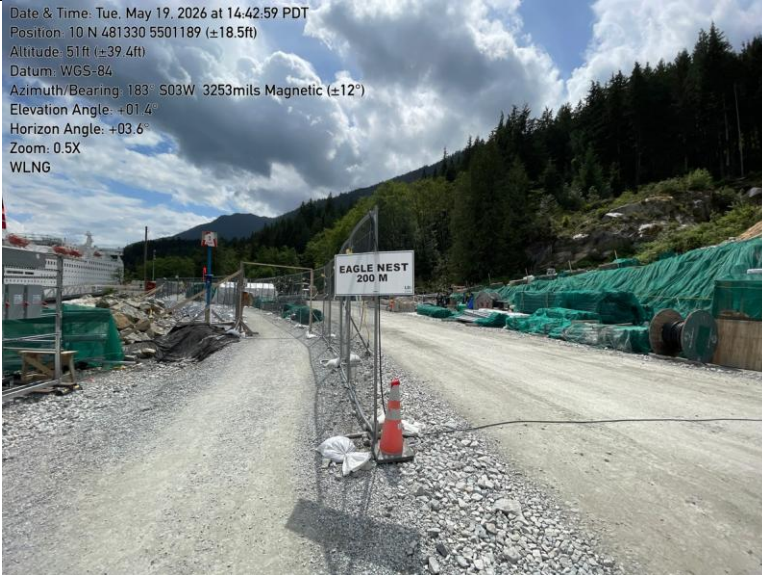
The Bald Eagle nest is located off the projects active construction footprint and therefore 200-meter buffer signs are located near active construction areas for construction personal awareness (Photo 7).

Photo 7. Bald Eagle nest signage.

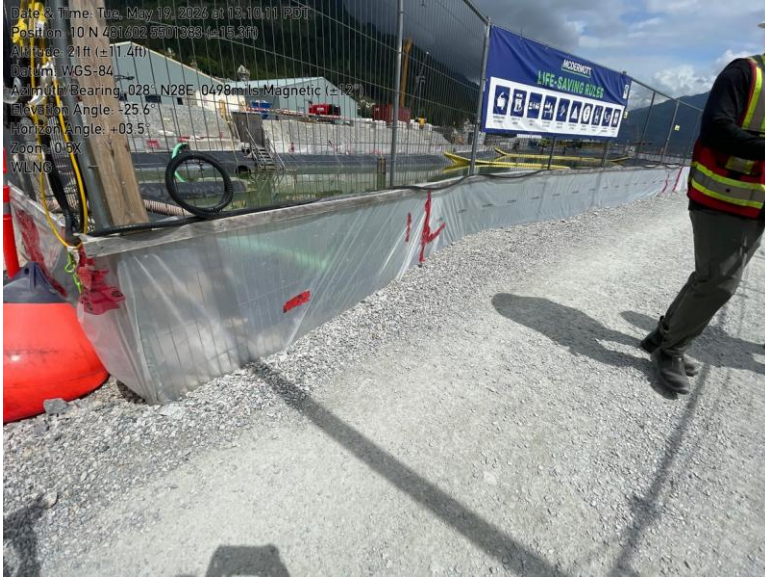
During the site inspection on May 19, 2026, the Officer assessed the installation and condition of amphibian exclusion fencing surrounding active work areas. It was observed that the water treatment ponds were enclosed with two-foot-high polyethylene (poly) sheeting securely affixed to metal fencing, effectively preventing amphibian access to the ponds. No holes or deficiencies were observed, and the fencing appeared to be in good working condition at the time of inspection (Photo 8).

Photo 8. Poly exclusion fencing secured to metal fencing around perimeter of water treatment ponds.

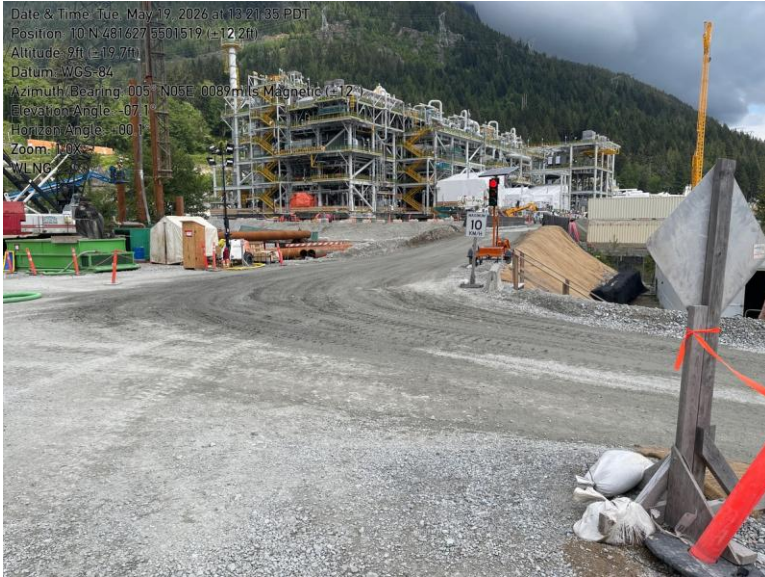
During the site inspection on May 19, 2026, the Officer observed that access roads were saturated and free of dust (Photo 9). Two water trucks were actively applying water to the roadways at the time of inspection (Photo 10).

Photo 9. Saturated access road.

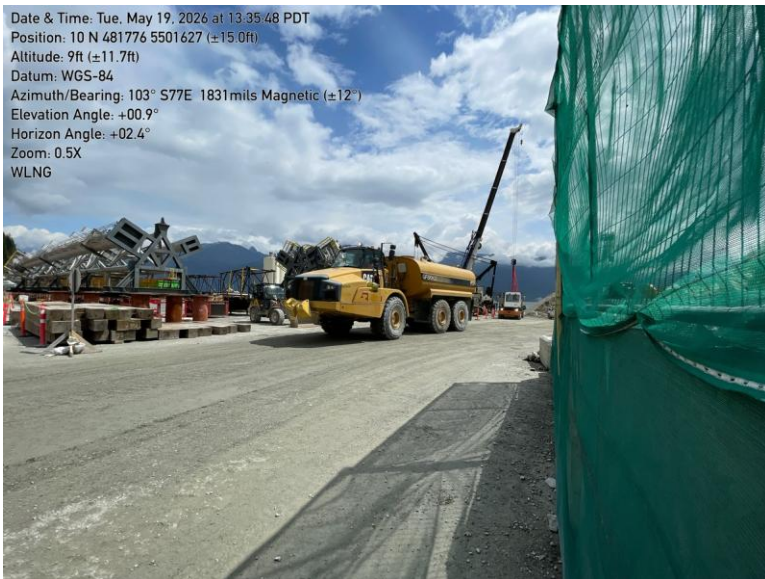
Photo 10. One of two water trucks observed actively operating.

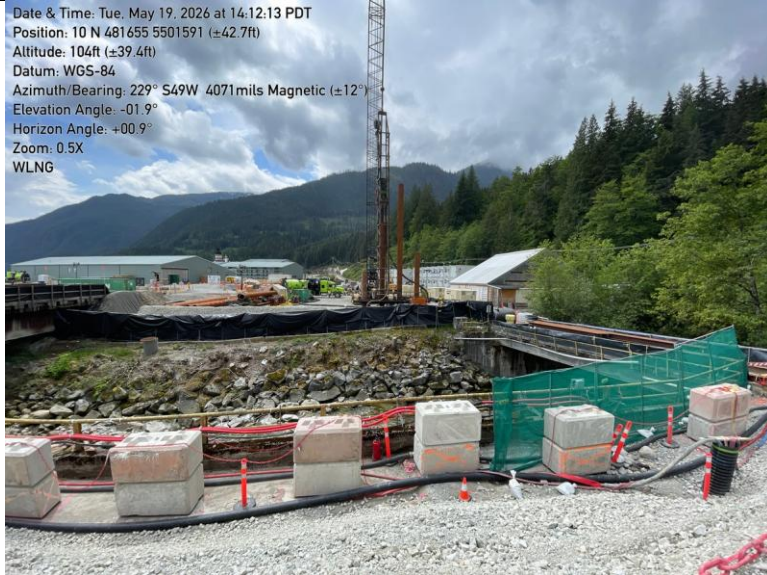
Vegetation along the slope leading to Mill Creek remained intact and showed no signs of recent disturbance. A large sediment fence had been properly installed adjacent to a rock berm in the area of the pile driving equipment, providing an additional erosion and sediment control measure (Photo 11).

No turbidity was observed in Mill Creek during the pile driving operations.

Photo 11. Erosion and sediment controls along side Mill creek pile driving activities.

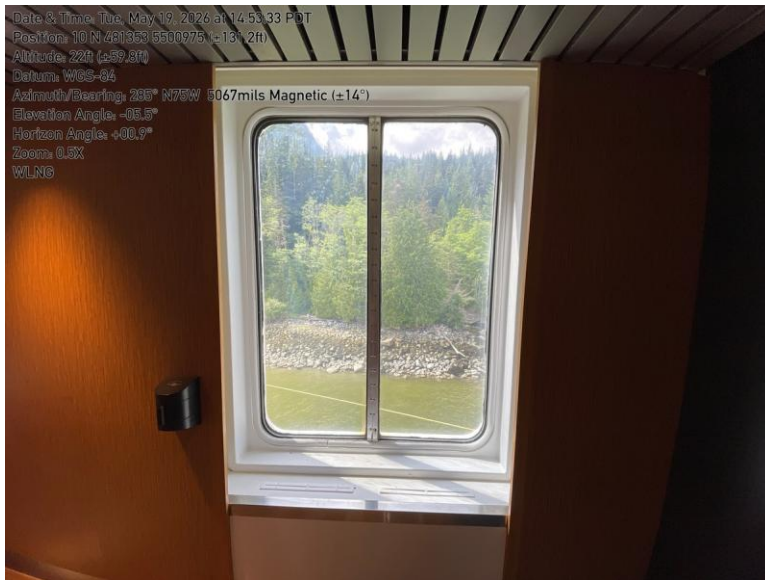
It was observed that none of the windows on the vessel are operable; all are securely shut and locked (Photo 12). The Officer also noted that all exterior doors were equipped with hydraulic self-closing mechanisms and were functioning as intended.

Photo 12. Window on Floatel #2 securely closed.

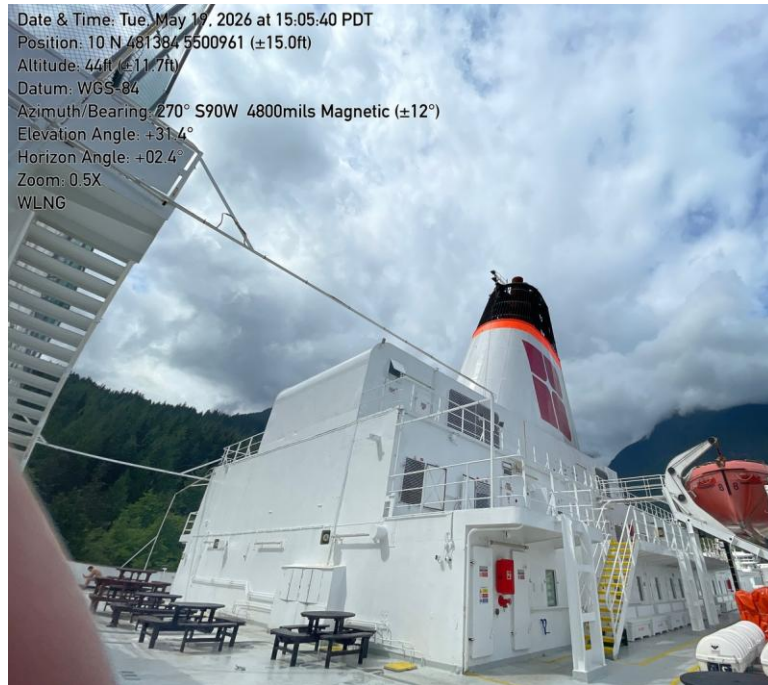
On May 19, 2026, the Officer observed that the exhaust stack was not emitting any visible emissions and further confirmed with project representatives that shore power was currently the sole power source for Floatel 2 (Photo 13).

Photo 13. Exhaust stack from Floatel 2.
