<b>Project Name</b>	Brucejack Mine	<b>Inspection Status</b>	Final
<b>EA Certificate #</b>	M15-01	<b>Inspection No.</b>	IR2022-030
<b>Project Status</b>	Certified	<b>Inspection Start</b>	2022-06-07
<b>Sector</b>	Mines	<b>UTM</b>	9U 428206 N 6258662 N
<b>Trigger</b>	Planned Inspection	<b>Inspection Type</b>	Field and Administrative
<b>Project Description</b>	The Brucejack Mine (Project) is an underground gold and silver mine.		
<b>Location Description</b>	The Project is located approximately 65 kilometres northwest of Stewart, within the Regional District of Kitimat-Stikine.		
<b>Inspection Summary</b>	<p>On June 7, 2022, Environmental Assessment Office (EAO) Senior Compliance and Enforcement Officer Christie Lombardi (Officer Lombardi) inspected the Project against the requirements of Environmental Assessment Certificate (EAC) # M15-01 (Appendix 1).</p> <p>The Project was in Operations at the time of inspection.</p> <p>Project areas inspected include the access road, Wildfire Camp, Bowser West laydown, Knipple Camp and Transfer Area, and the mine site. The inspection included a debrief of observations with Project staff, Tahltan Central Government and Nisga’a Lisims Government repre

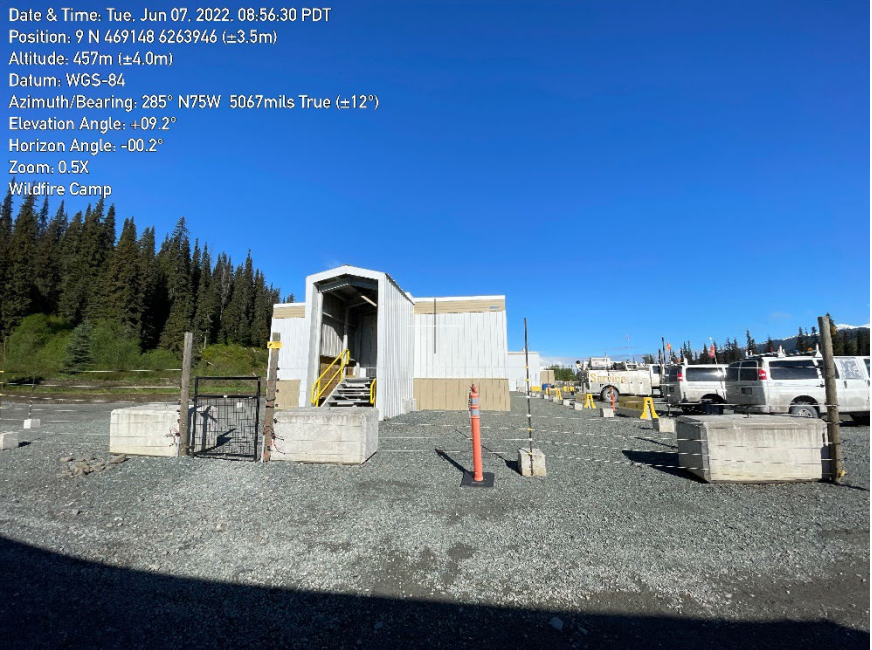
Photo 1. Electric fencing at Wildfire Camp.

During the field inspection on June 7, 2022, Officer Lombardi observed an electrified perimeter fence around the Wildfire Camp (Photo 1). The fence controller indicated an operational voltage of 15,500 volts.

These observations provide evidence of compliance with Amendment 2 and the June 27, 2019 Enforcement Order with respect to electric fencing at Wildfire Camp and Knipple Camp.

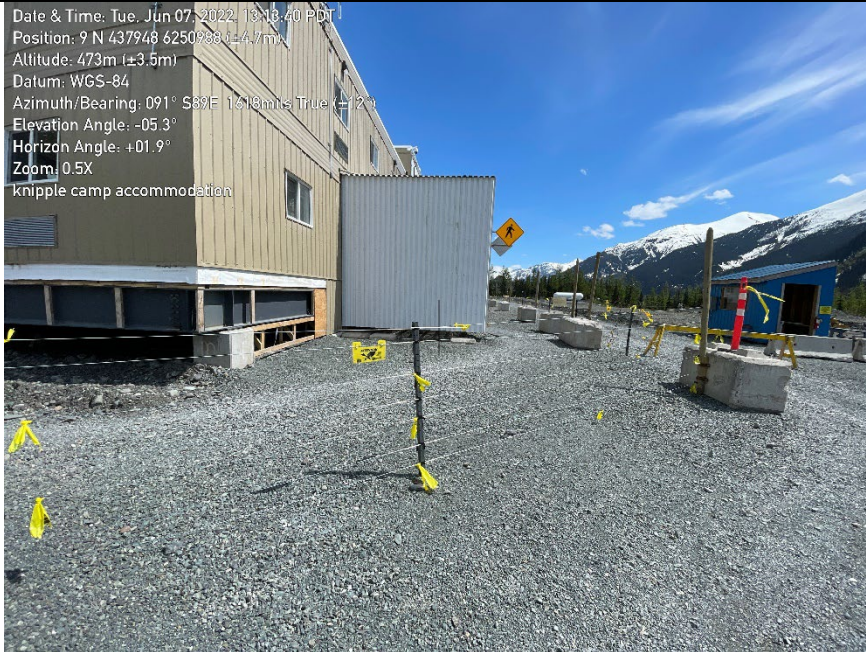
Photo 2. Electric fencing at Knipple Camp.

Officer Lombardi also observed an electric perimeter fence around Knipple Camp with an operational voltage of 18,000 volts (Photo 2).

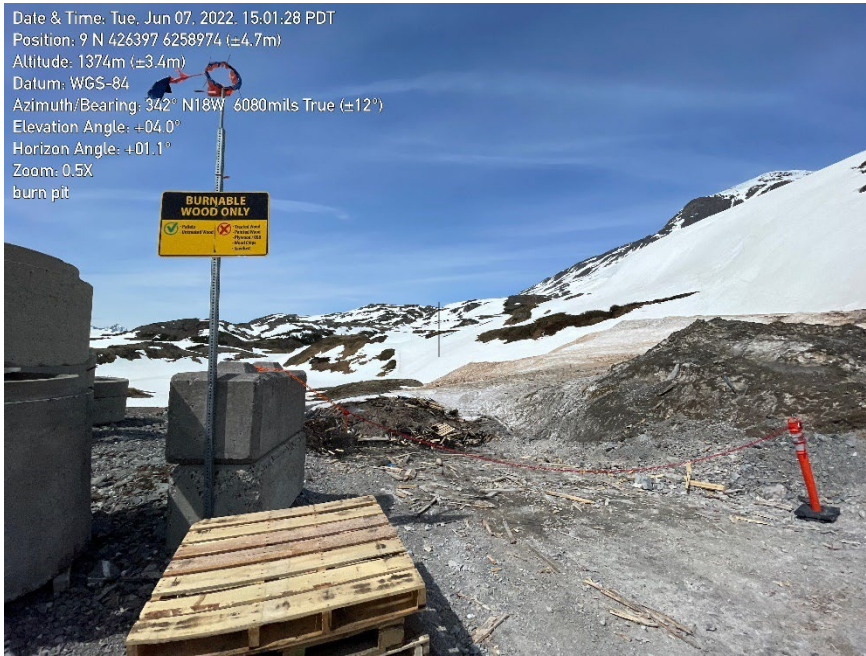
Photo 3. Burn pit at Mine Site.

During the field inspection, Officer Lombardi inspected the burn pit at the Mine Site. Consistent with the signage present, the yet unburned materials in the pit were observed to be pallets and untreated wood (Photo 3).

These observations provide evidence of compliance with Condition 1 with respect to acceptable burn pit materials specified in the Air Quality Management Plan.

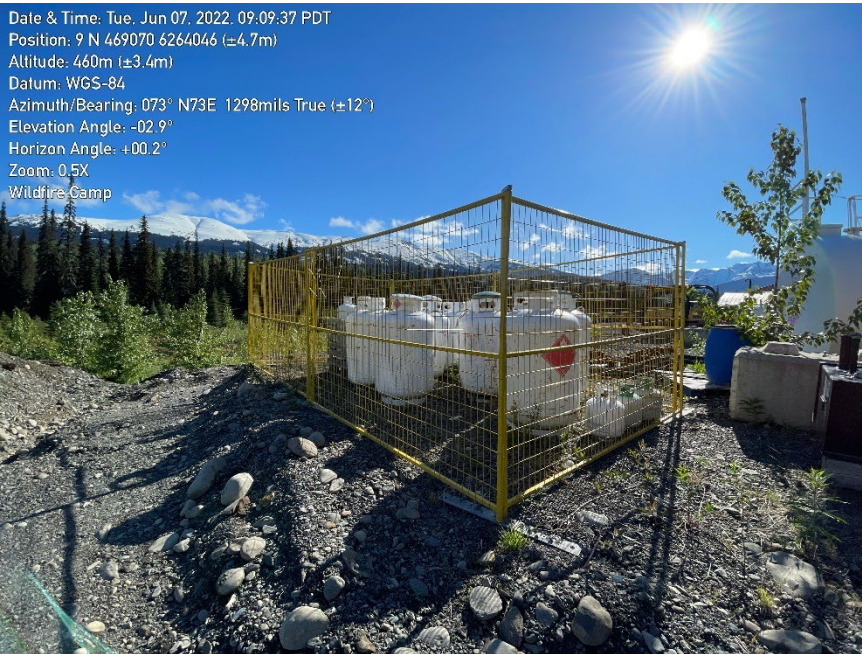
Photo 4. Propane tank storage at Wildfire Camp.

Officer Lombardi observed a propane tank storage area at the Wildfire Camp. The tanks were stored in a fenced enclosure on a gravel surface that was level with the adjacent area (Photo 4).

These observations provide evidence of non-compliance with Condition 1 with respect to outdoor storage requirements for compressed gases in the Chemicals and Materials Storage and Handling Plan.

**Compliance Determination:** Out - Notice of Non-Compliance

<b>Actions Required by Certificate Holder &amp; Additional Comments</b>	
None at this time.	
<b>Enforcement Summary</b>	
<p><b>PRETIUM RESOURCES INC. IS NOTIFIED THAT THE PROJECT IS NOT COMPLIANT WITH CONDITION 1 WITH RESPECT TO OUTDOOR STORAGE OF COMPRESSED GASES AND RECYCLABLE WASTES (REQUIREMENTS 3 AND 8 ABOVE).</b></p> <p><b>SEE APPENDIX 14 FOR WARNING LETTER ISSUED ON DECEMBER 12, 2022 FOR NON-COMPLIANCE WITH CONDITION 1 WITH RESPECT TO SECONDARY CONTAINMENT FOR WASTE OIL (REQUIREMENT 4 ABOVE).</b></p> <p><b>EAO CEB MAY INSPECT TO DETERMINE IF THE BRUCEJACK MINE PROJECT HAS BEEN BROUGHT BACK INTO COMPLIANCE WITH THESE REQUIREMENTS. CONTINUED NON-COMPLIANCE WITH THESE REQUIREMENTS MAY RESULT IN ADDITIONAL ENFORCEMENT UNDER THE ENVIRONMENTAL ASSESSMENT ACT.</b></p>	
<b>Regulatory Considerations</b>	
None at this time.	
<b>Inspection Conducted by</b>

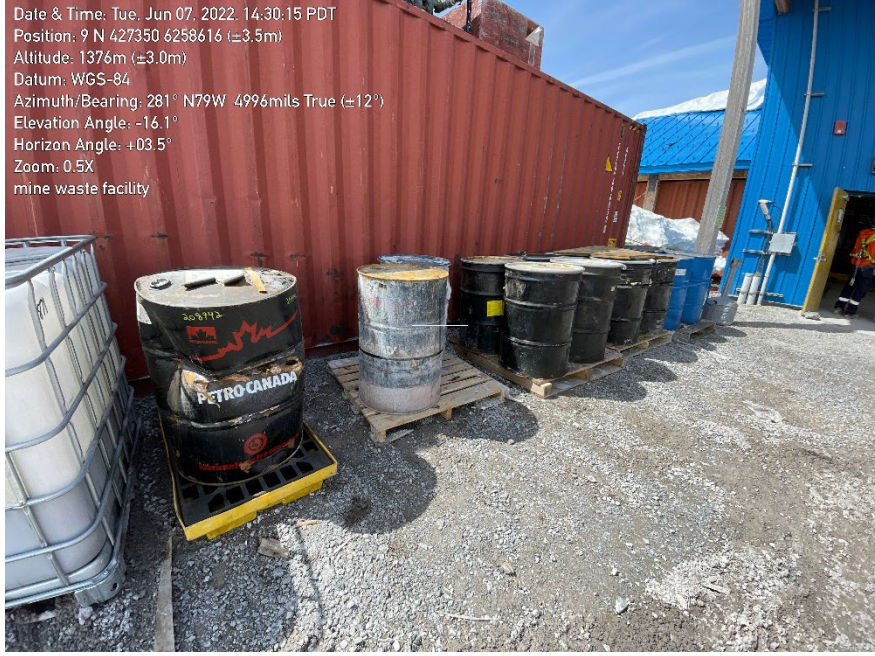
Photo 5. Waste oil stored at Mine Site Waste Transfer Area without secondary containment.

At the Mine Site Waste Transfer Area, Officer Lombardi observed 14 barrels of waste oil stored outside on pallets without secondary containment (Photo 5). The Certificate Holder representative present identified that the drums had been stored there for a few days awaiting transfer to Knipple Camp.

These observations provide evidence of non-compliance with Condition 1 with respect to secondary containment for waste oil required by the Waste Management Plan.

**Compliance Determination:** Out - Warning - Refer to Enforcement Summary

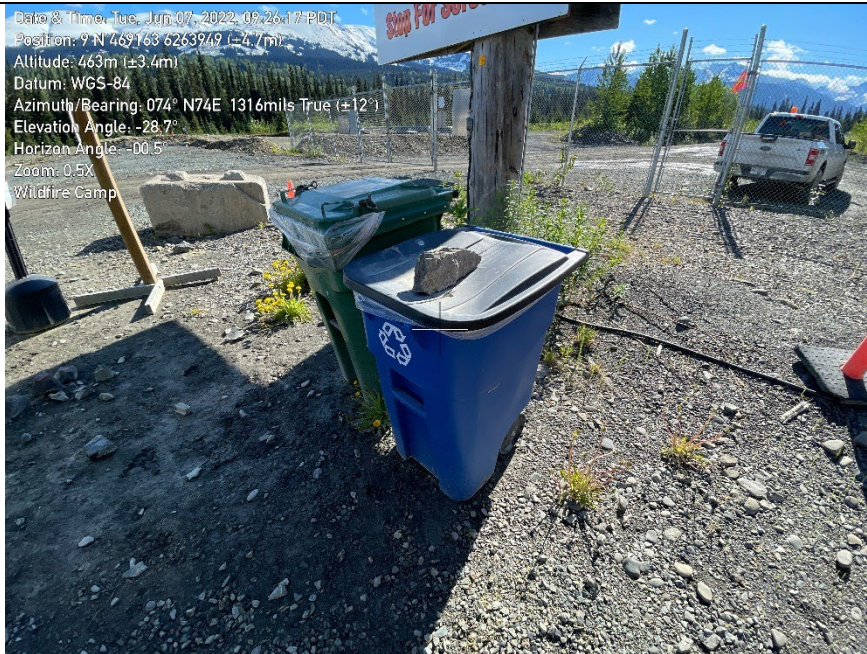
Photo 6. Unsecured recycling bin at Wildfire Camp containing animal attractants.

Over the course of the field inspection, Officer Lombardi inspected multiple project areas and found waste to be generally stored in suitable receptacles to prevent access by wildlife. At Wildfire Camp, however, a plastic recycle bin containing juice boxes was observed to be secured with a rock placed on top of the lid (Photo 6).

These observations provide evidence of non-compliance with Condition 14 and the December 9, 2016 Enforcement Order with respect to storing recyclable wastes in wildlife-proof containers.

**Compliance Determination:** Out - Notice of Non-Compliance

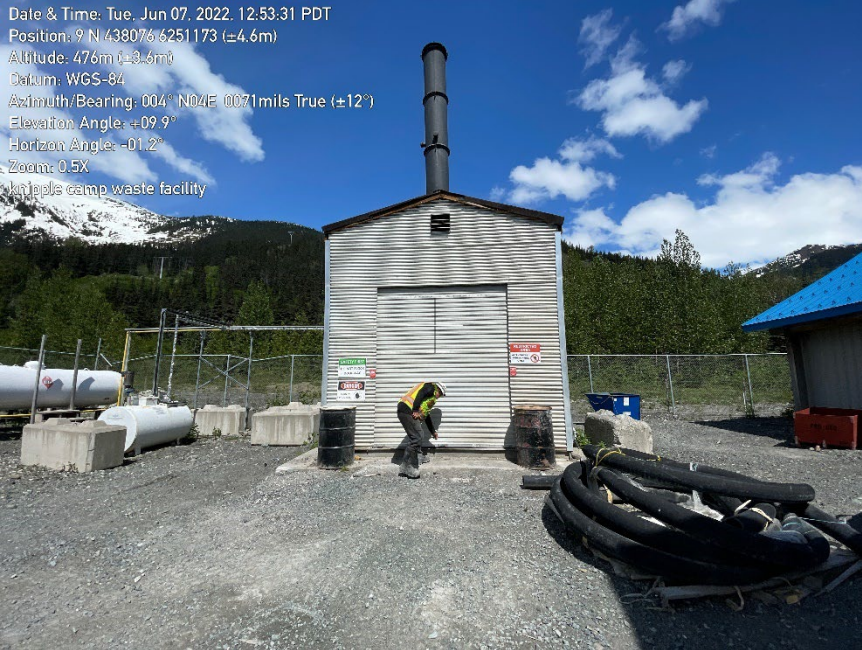
Photo 7. Incinerator at Knipple Camp.

Officer Lombardi inspected Project incinerators at Knipple Camp and the Mine Site. The incinerator at Knipple Camp was in the waste yard, which was surrounded by an approximately nine-foot fence with three strands of barbed wire on top, with an electric fence around approximately three quarters of the yard (Photo 7). The incinerator at the Mine Site was inside the mine waste facility building (Photo 8).

These findings provide evidence of compliance with Condition 14 with respect to excluding wildlife from incinerator facilities.
