<b>Project Name</b>	COASTAL GASLINK PIPELINE Project	<b>Inspection Status</b>	Final
<b>EA Certificate #</b>	E14-03	<b>Inspection No.</b>	IR2021-014
<b>Project Status</b>	Certified	<b>Inspection Start</b>	2021-04-27
<b>Sector</b>	Energy	<b>UTM</b>	10U 533697 E 6071620 N
<b>Trigger</b>	Planned Inspection	<b>Inspection Type</b>	Field
<b>Project Description</b>	The Coastal GasLink Pipeline Project (Project) is an approximately 650 kilometer (km) long natural gas pipeline connecting facilities in northeast British Columbia (BC) to the LNG Canada facility near Kitimat.		
<b>Location Description</b>	The Project is near Groundbirch (40 km west of Dawson Creek) in northeast BC to the LNG Canada facility near Kitimat. This inspection covered portions of focused on work being carried out in Sections 1, 3, 4, 5, 6, 7 and 8 of the Project.		
<b>Inspection Summary</b>	<p>From April 27 to May 6, 2021 Environmental Assessment Office (EAO) Director of Compliance and Enforcement Chris PARKS and Senior Compliance and Enforcement Officer Clayton SMITH (collectively EAO C&amp;E) inspected the Coastal GasLink Pipeline Project (Project) against requirements of the Environmental Assessment Certificate (EA

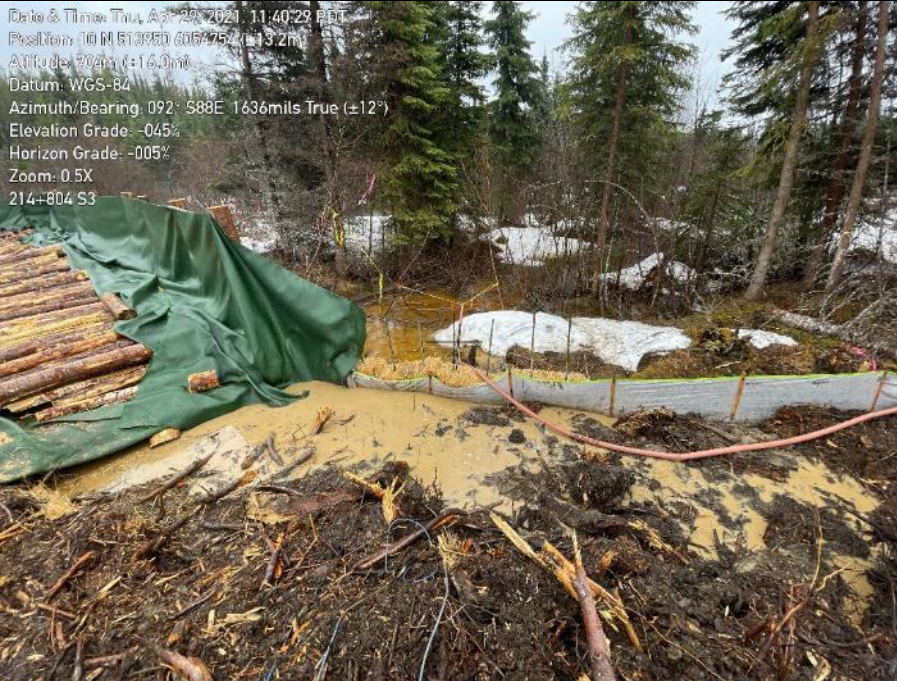
Photo 5: Section 3, Crooked River. High chain approach slopes towards Crooked River. Stripping into naturally occurring flood plain within the Crooked River. Project related exposed surfaces and sediment laden water mixing with Crooked River flows.

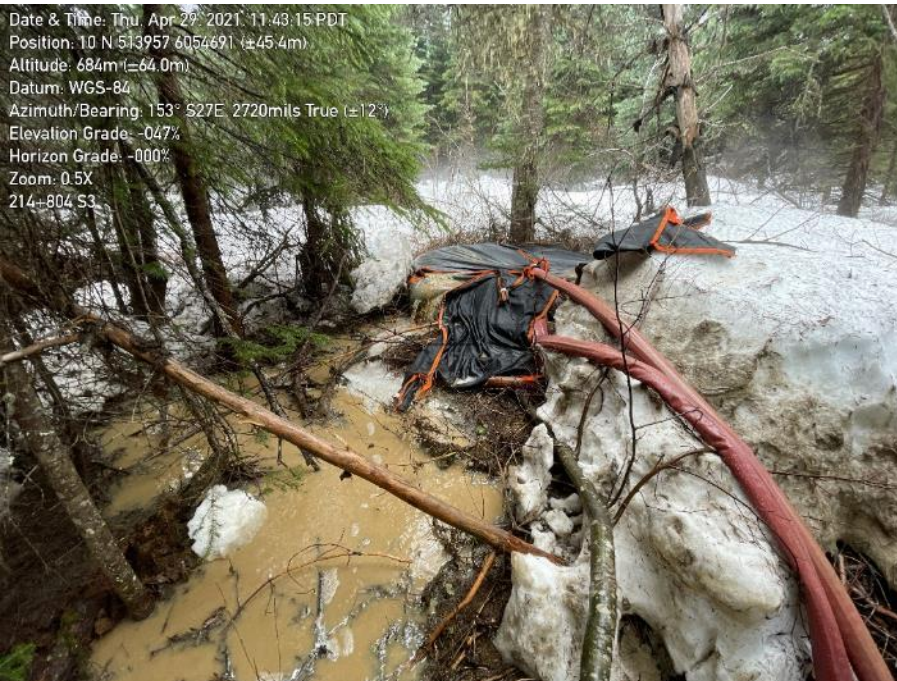
Photo 6. Section 3, approximately KP214+804, S3. Sediment laden water leaving RoW and entering channel.

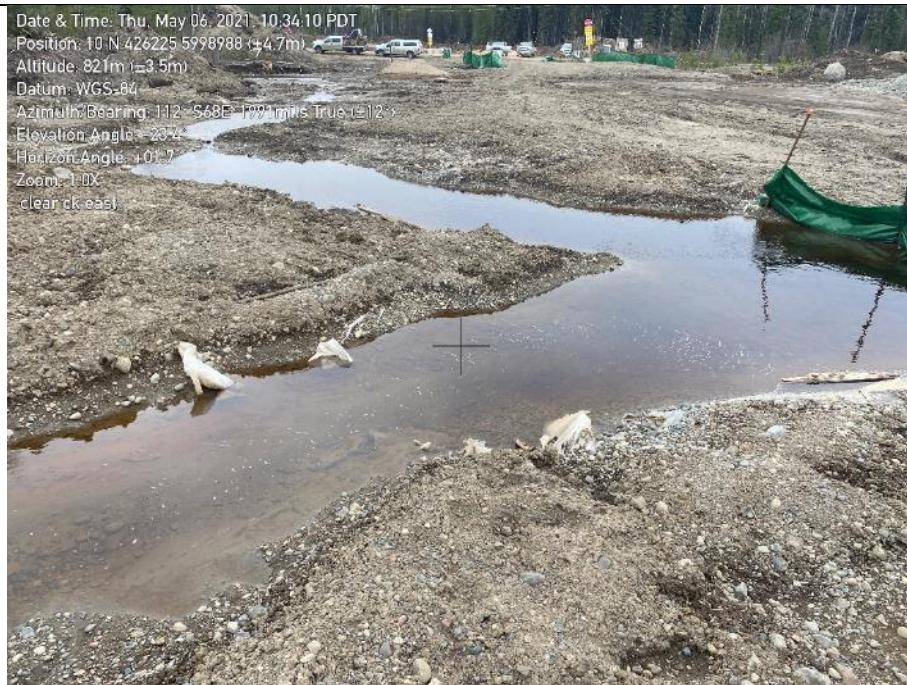
Photo 15. KP 244+510, watercourse WC272 (S3). Water from RoW overwhelming sump and flowing into stream feature.

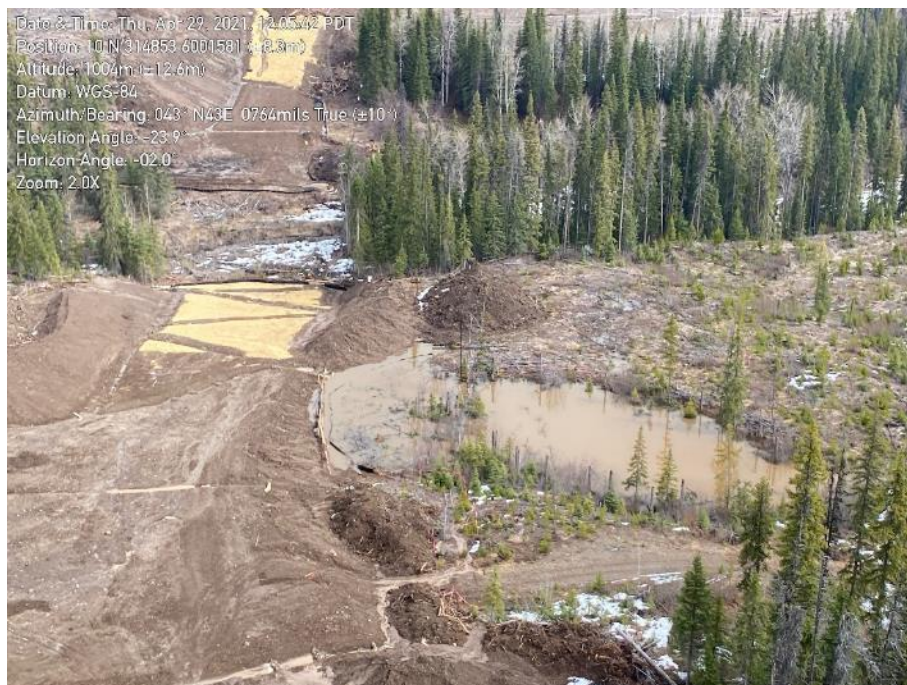
Photo 22. Sediment into feature downstream of crossing at approximately KP 395+550.

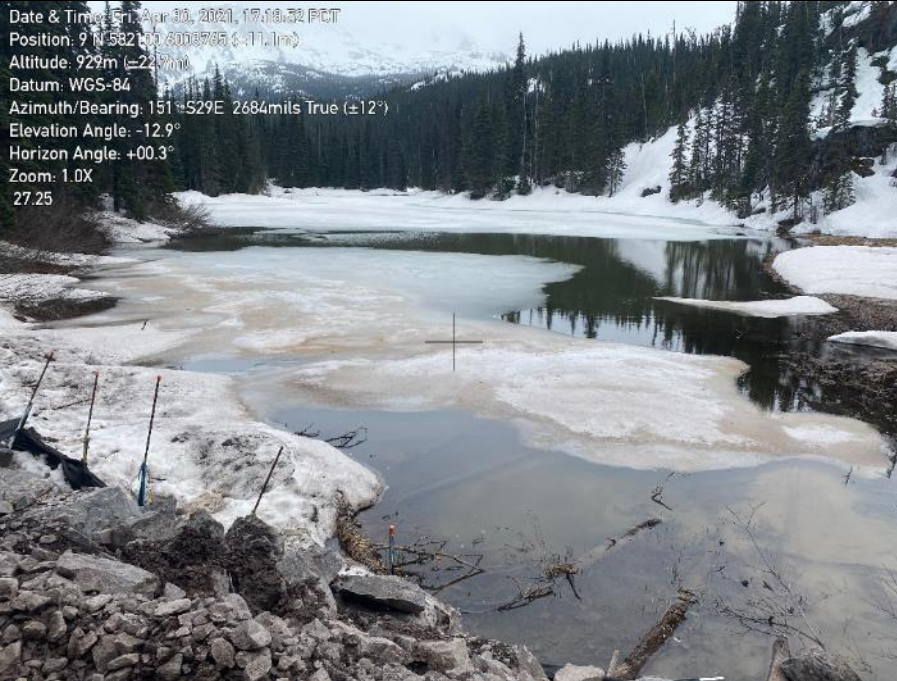
Photo 25. KP 586+800, sediment bag placed within 2 m of channel. Discharge into feature.

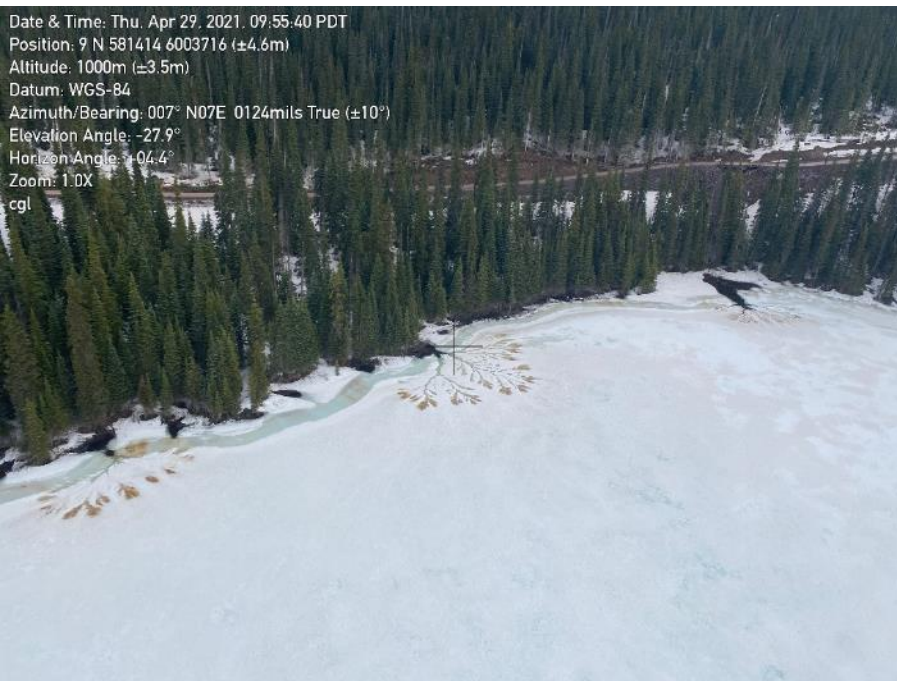
Photo 26. KP 586+700, sediment discharge to lake evident from deposition within lake and on remnant ice

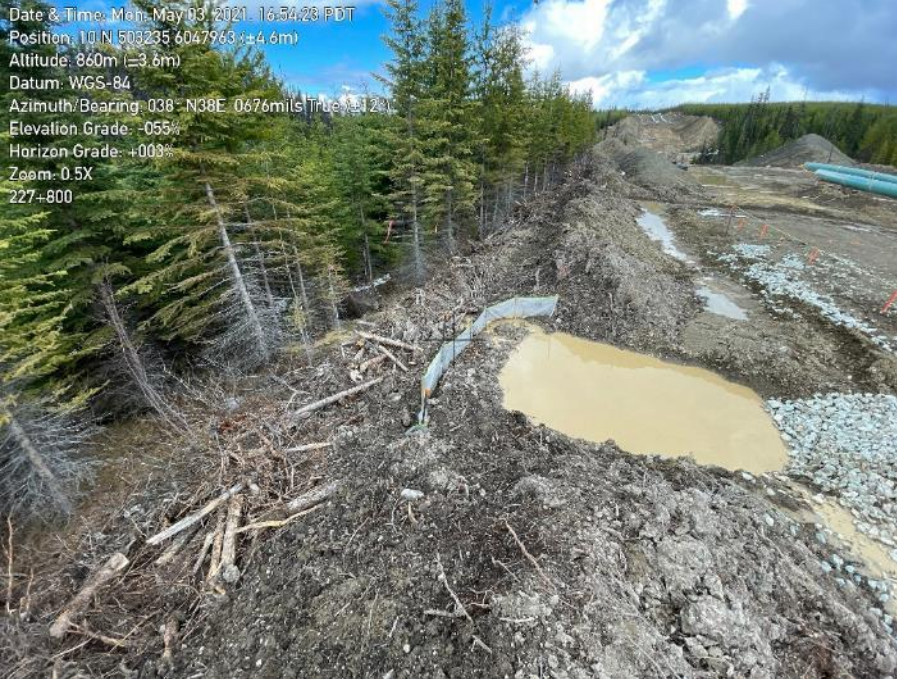
- KP 53+137 (approximate), wetland WL0723 (Environmentally and Socially Important Wetland (ESIW)). Observed active pumping of sediment laden water off the RoW into a filter bag. Filter bag was placed adjacent to WL0723 and sediment laden water from the bag was observed flowing directly into the

wetland outside of the RoW. Additionally, ESC measures on the RoW were not functioning as intended and sediment laden Project water from the RoW was observed to be flowing into the wetland within the RoW.

Photo 29. WL0723. Sediment laden water from RoW flowing into wetland.

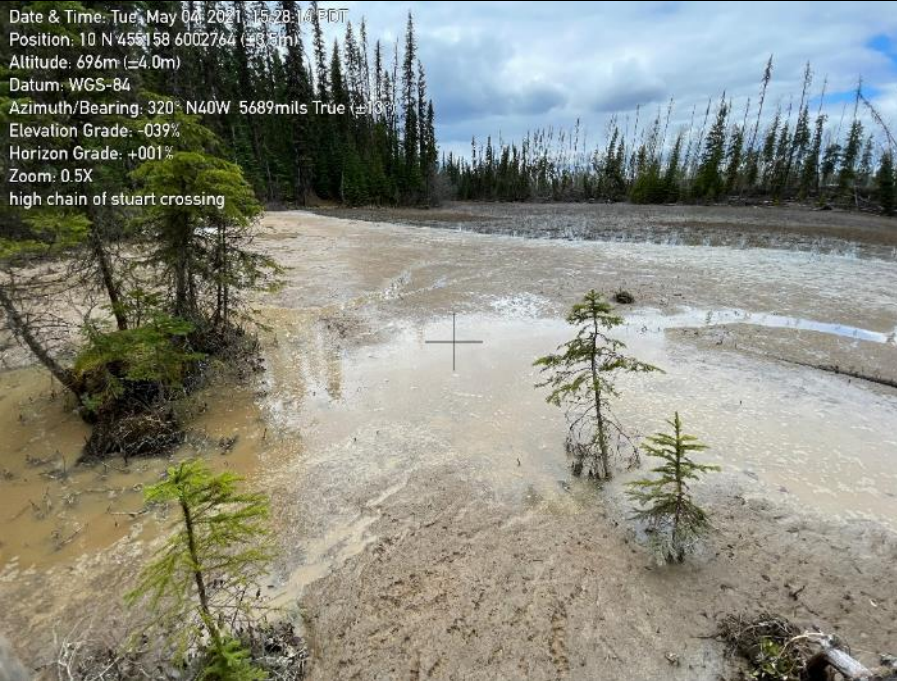
Photo 33. Wetland with no signage at roughly KP 298+700. Sediment laden water from this location left RoW and reached wetland below (WL0552).

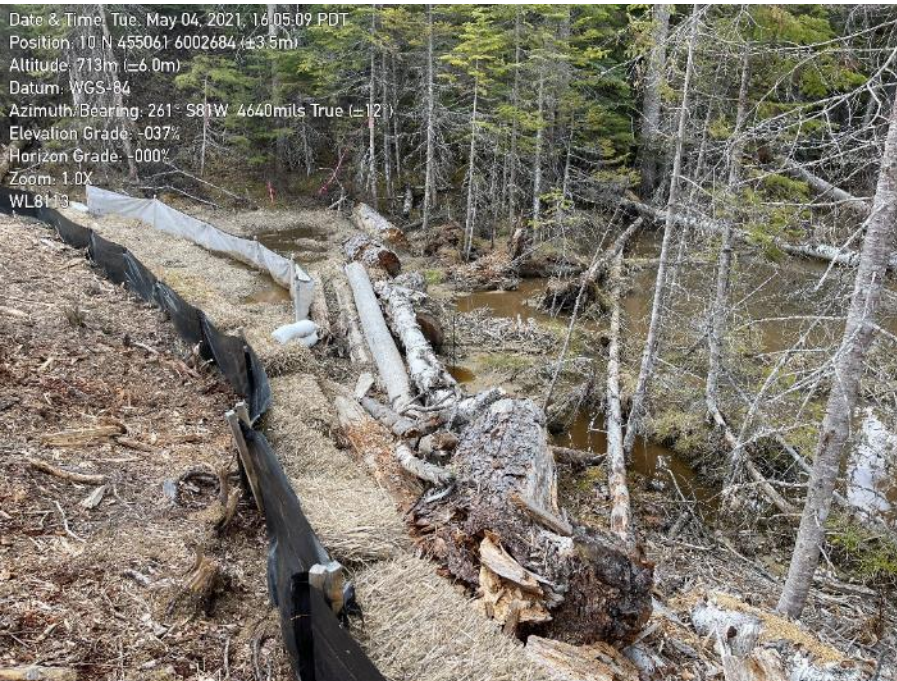
Photo 34. Wetland with no signage at roughly KP 298+700. Sediment laden water and sediment deposited in wetland (WL0552).

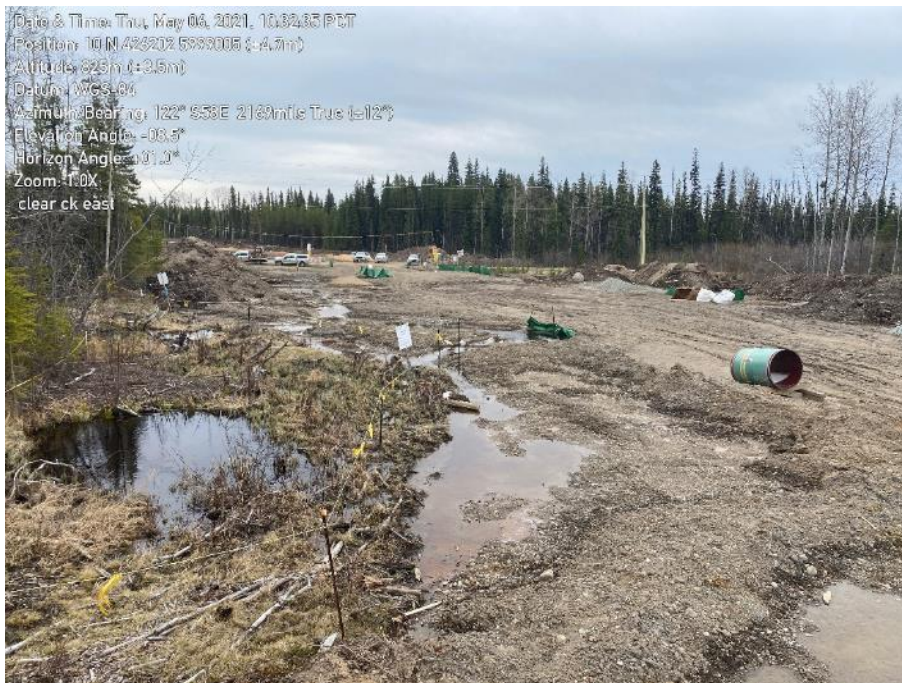
Photo 36.WL8113 at approximately KP 298+861. Sediment depositing into wetland feature.

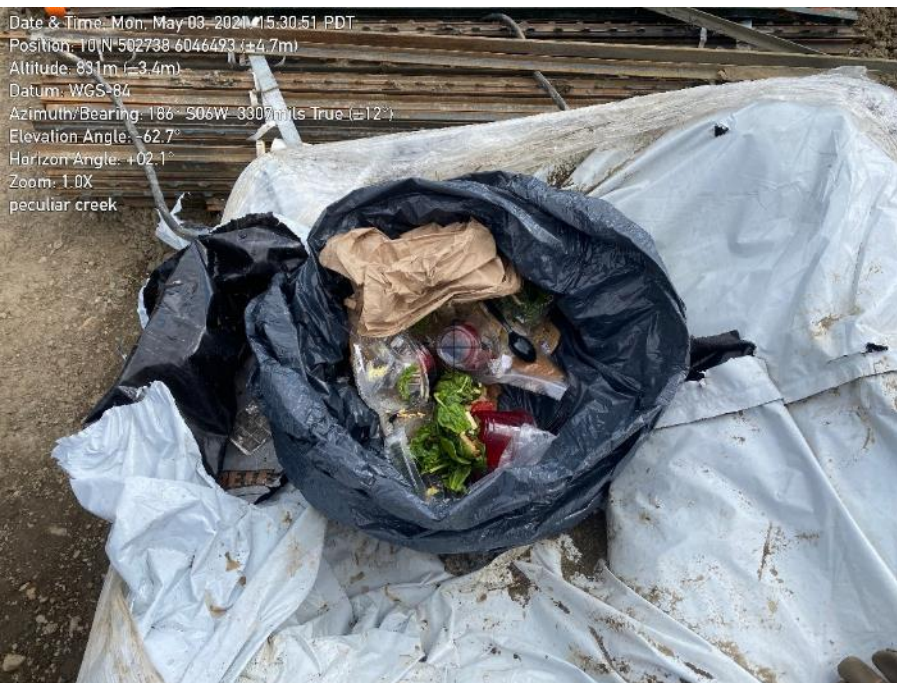
Two unattended bags of food waste were observed to be on the ground near KP 299+800. No crews were in the immediate vicinity at the time of observation. See below photos.

Photo 56. Bag 1 containing food waste on ground at approximately KP 299+800.

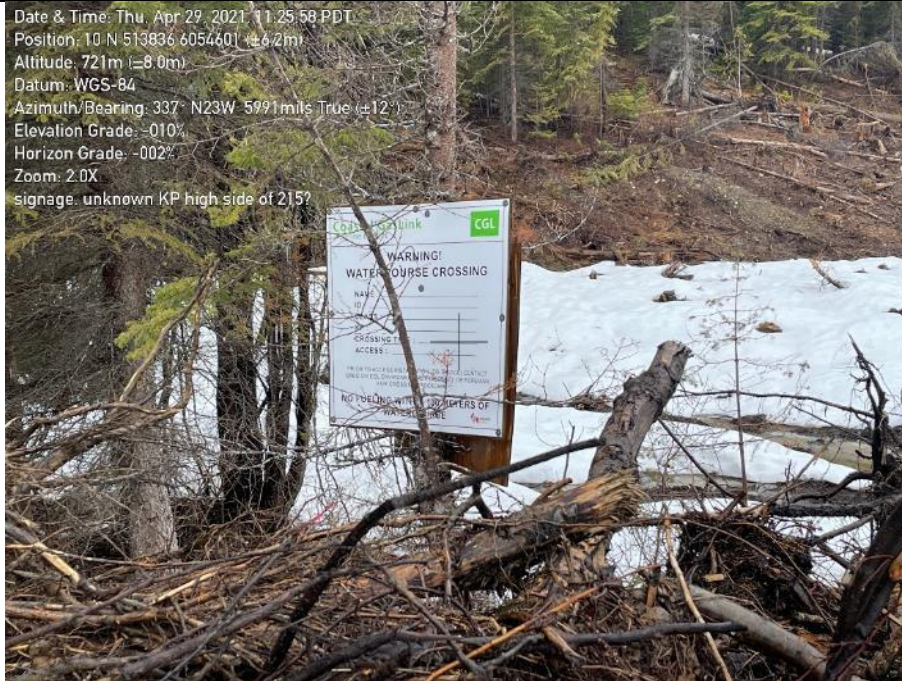
Photo 64. Blank signage near KP 215+280.

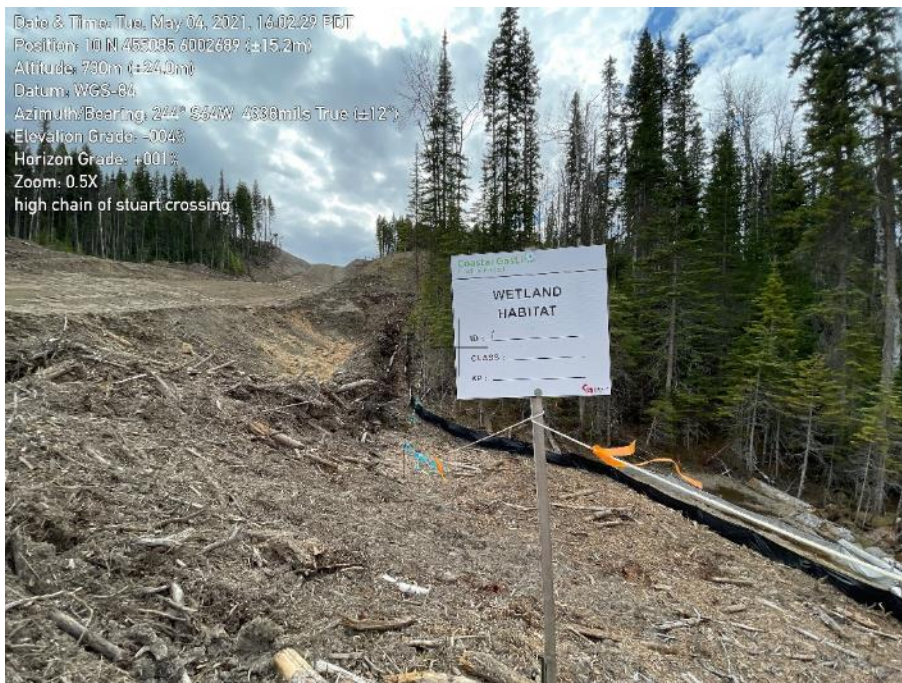
Photo 65. Approximately KP 215+110. Blank signage.

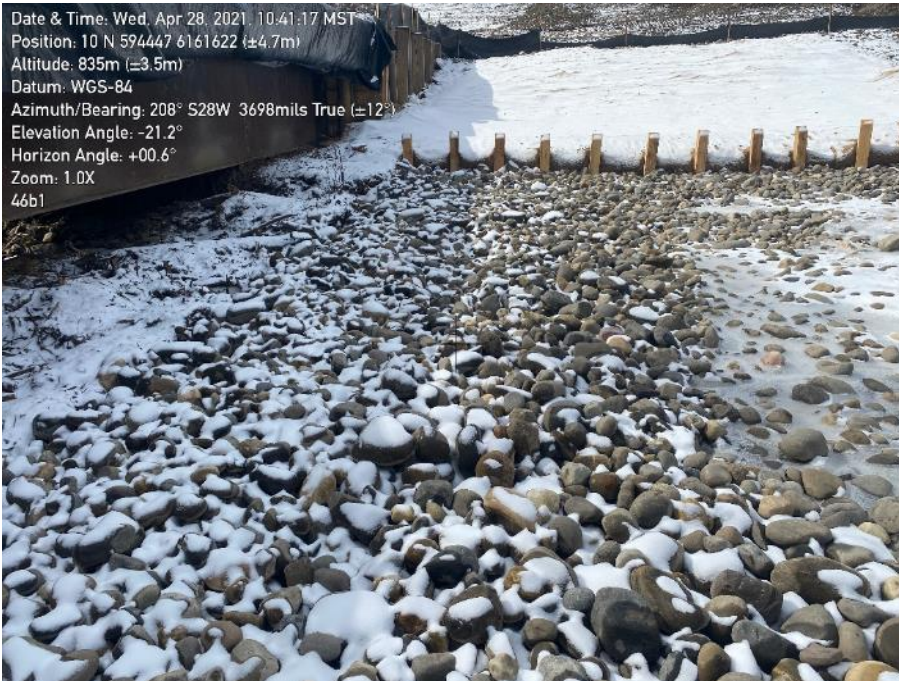
- Watercourse 46B1 (S3). The re-constructed channel, where the pipe has been installed through the crossing, has large substrate consisting primarily of cobble placed in a manner that limits the channels profile. EAO C&E observed sub-surface like flows through the reconstructed portion of the channel. The lack of a defined channel profile may cause fish passage issues as the channel depth is limited. The measured channel width at the crossing was roughly 20 m wide. The feature is classified as an S3, which are defined as fish-bearing streams with a channel width between 1.5-5 m. The width of the stream banks does not align with the upstream and downstream portions of the feature. Under almost all conditions the flow will be subsurface due to large substrate, a wider than average channel width and limited channel profile.

Photo 68: Watercourse 46B1, S3. Channels flow at this location is sub-surface and over a wide area (greater than 5 m).

*Coastal GasLink agrees with the EAO's assessment of the condition of watercourses 43B1, 46B1, 47B1 and UN42-22. Coastal GasLink further notes that as these locations do not meet the regulatory requirements, they would not have passed a final environmental inspection and additional work will be required at these locations in order to meet the required reclamation standard. Coastal GasLink confirms that these watercourses will be subject to further qualified professional (QP) inspection before these sites can be considered complete.*

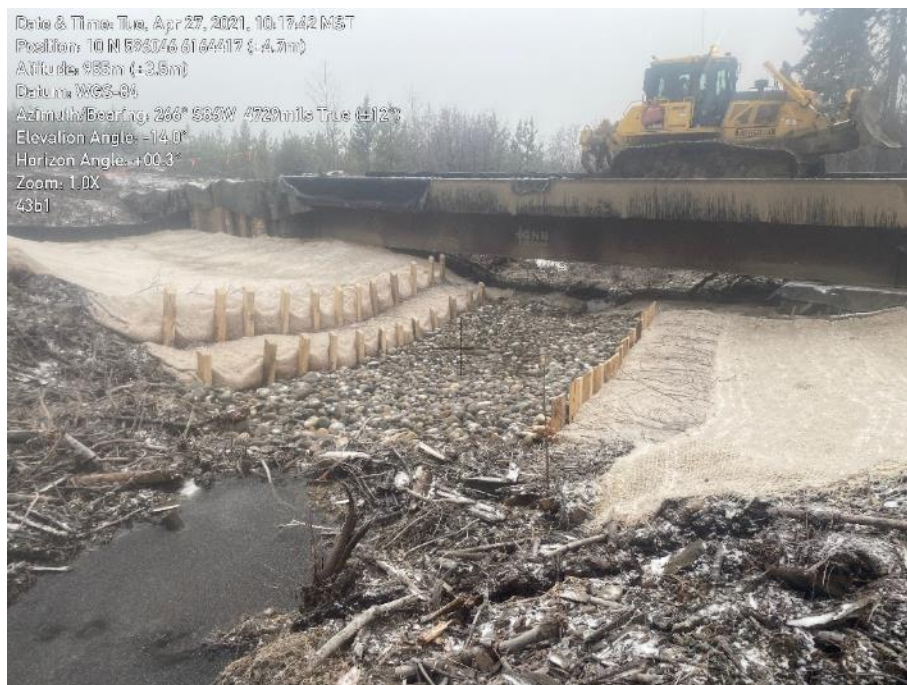
- Watercourse 47B1 (S3). The re-constructed channel, where the pipe has been installed through the crossing, has large substrate consisting primarily of cobble placed in a manner that limits the channels profile. Flow through this area of the channel was observed to be within the spaces between the cobble itself; the lack of a defined channel profile limited the channels depth through this portion of the stream. The lack of a channel profile and channel depth through the re-established portion of the feature may causes fish passage restrictions.

Photo 71: Watercourse 47B1, S3. Shallow flow through reconstructed channel. Potential barrier to fish passage.

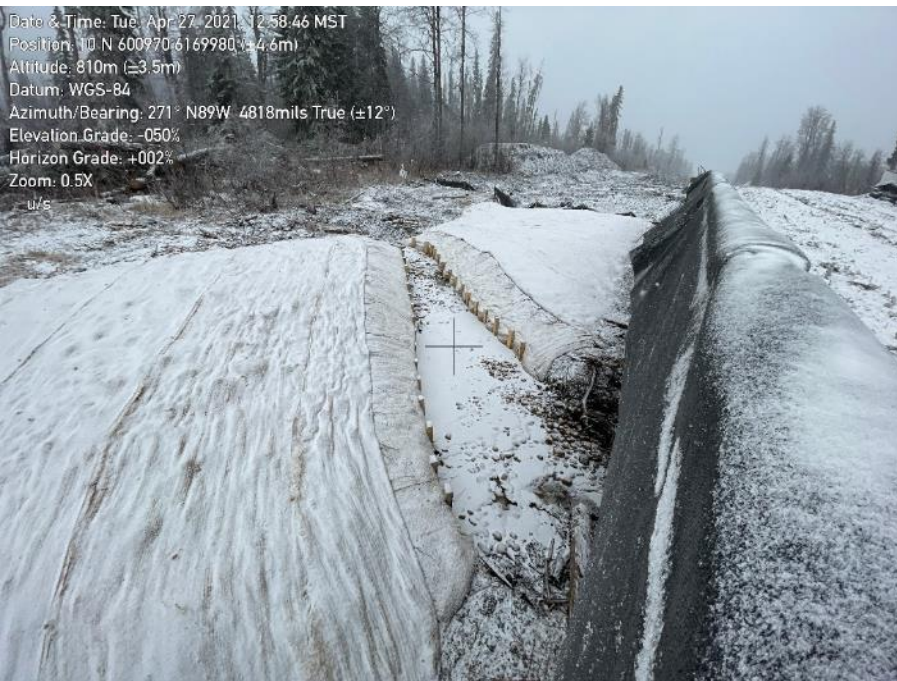
Photo 73. Watercourse UN41-34, S4. Lack of channel profile through crossing. Potential barrier to fish passage.

*Coastal GasLink is currently reviewing the remaining watercourses identified in Requirement 7 to confirm the EAO's observations. If QPs confirm that the condition of those streams does not meet the relevant regulatory requirements, additional reclamation work will be required.*

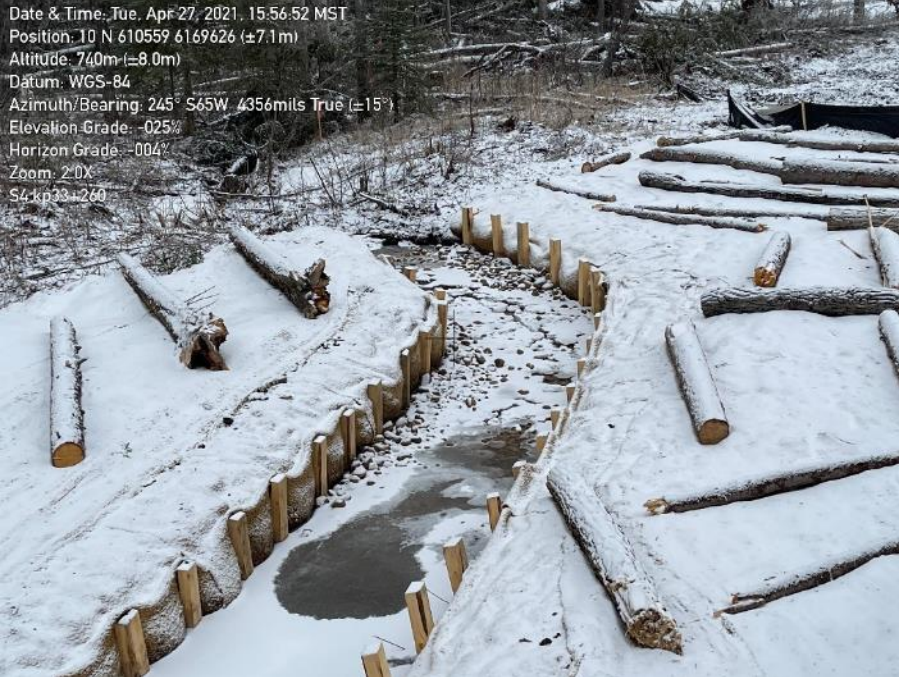
Photo 78. KP33+260, unknown watercourse number. Lack of channel profile through crossing. Potential barrier to fish passage.

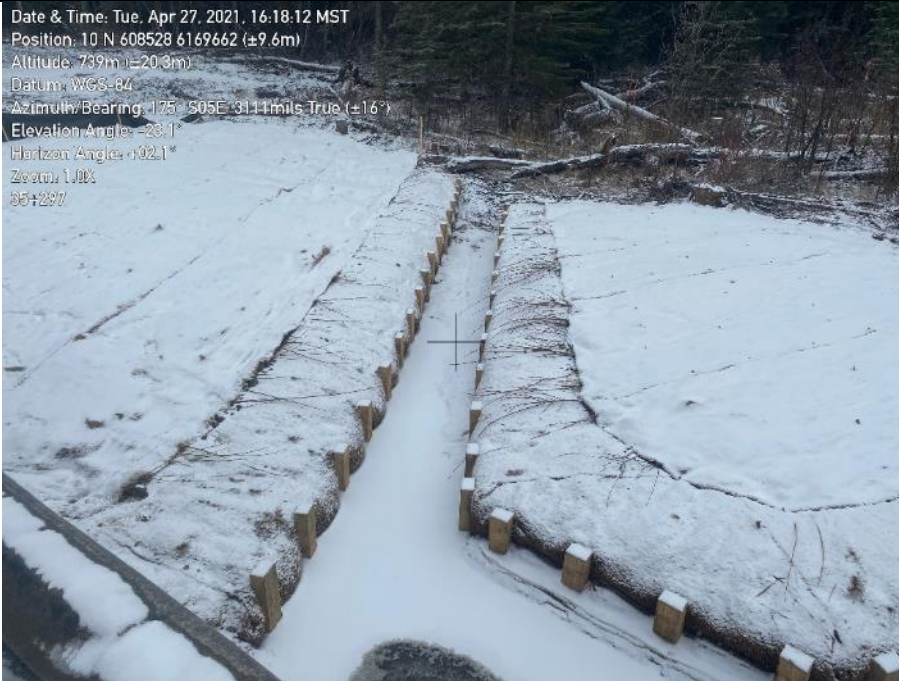
Photo 83. KP35+297. Overview of willows at site. Willows less than 2 – 3 m long, not planted to depth requirement, spacing not one stem per 15 cm.

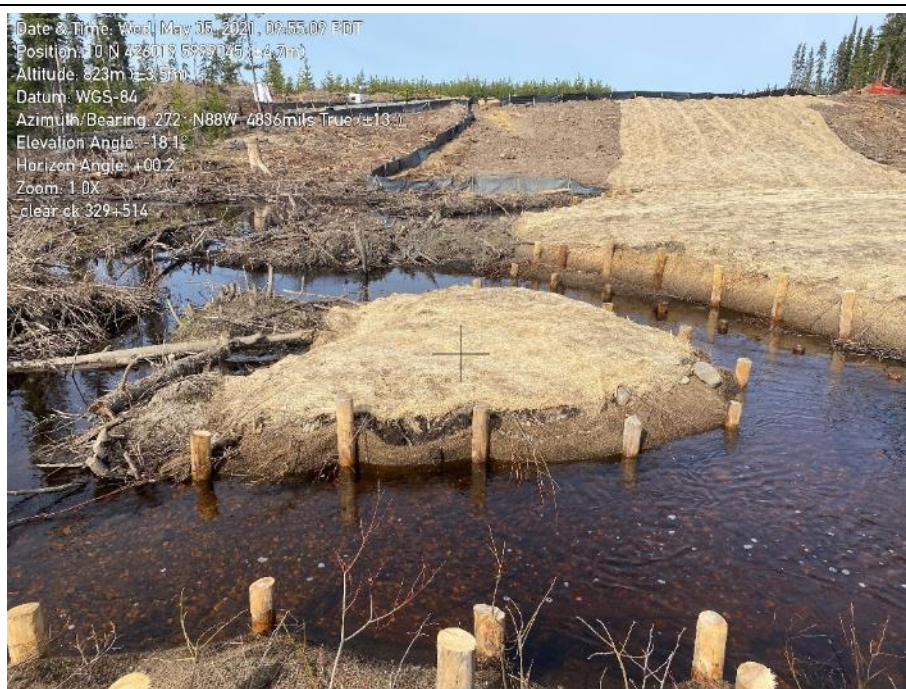
Photo 87. KP 329+300, Clear Creek. Willows not planted at one stem per 15 cm.

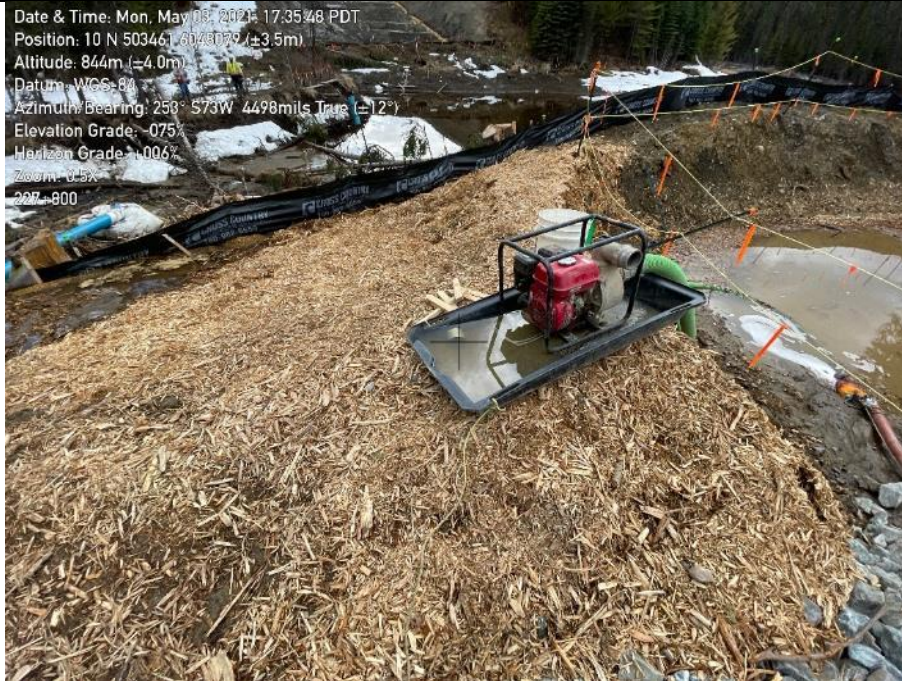
Photo 89. At capacity secondary containment within 100 m of watercourse at approximately KP 227+746. Water leaving containment structure.

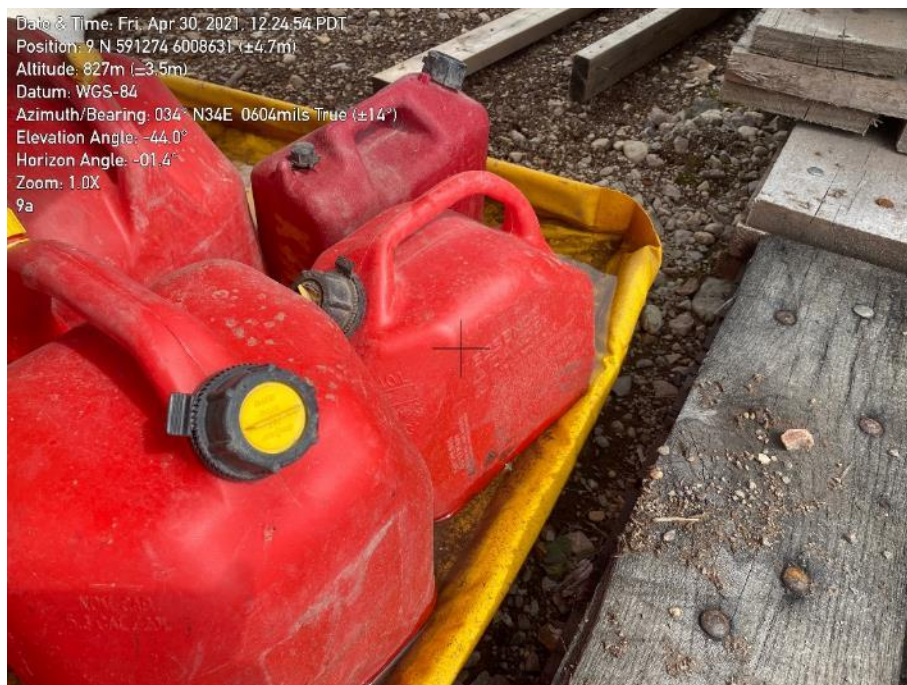
Photo 92. Secondary containment full and water leaving containment - Camp 9A.

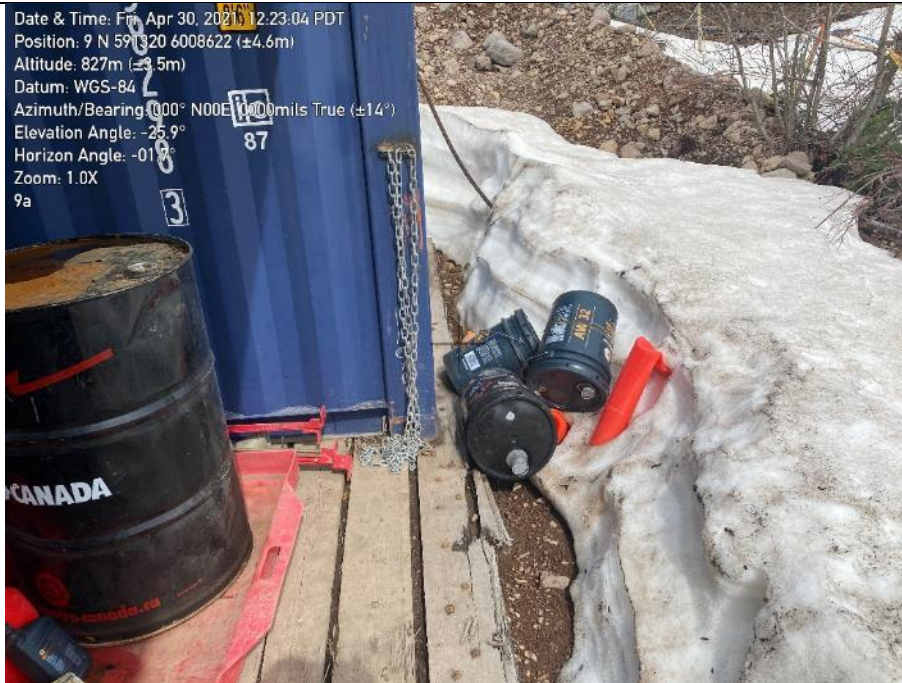
Photo 93. Used buckets of hydrocarbon products stored on side directly on ground - Camp 9A.

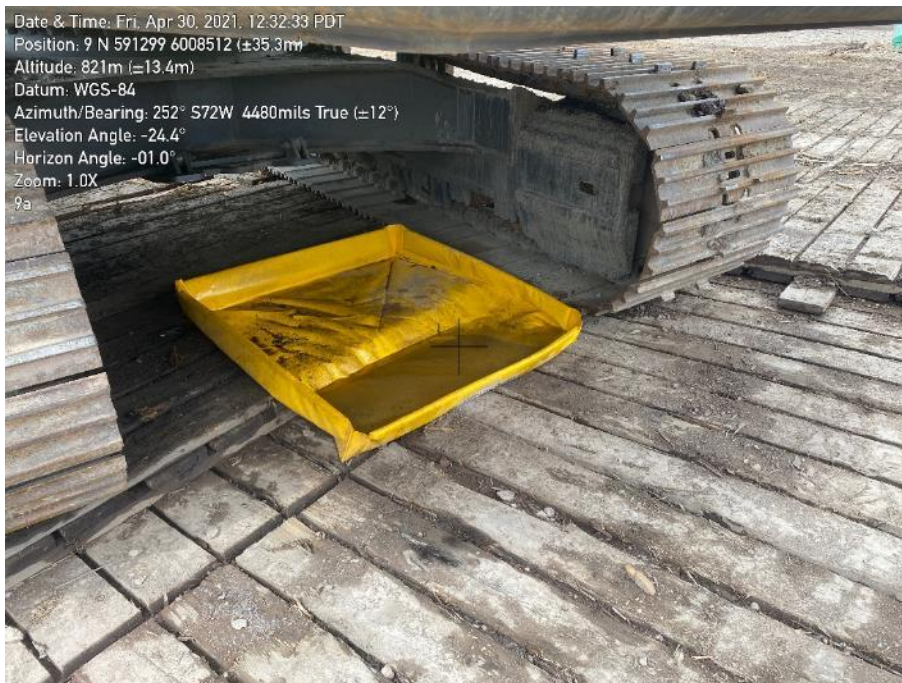
Photo 94. Secondary containment on angle and water at risk of leaving containment - Camp 9A.
